## Reservoir leaking assessment using electrical resistivity imaging (ERI) with capacitively-coupled system

Jeong-Ryul Choi<sup>1</sup>, Seung-Sep Kim<sup>1</sup>, Nackwon Sung<sup>2</sup>

**keywords:** Capacitively-coupled resistivity, ERI monitoring, reservoir assessment

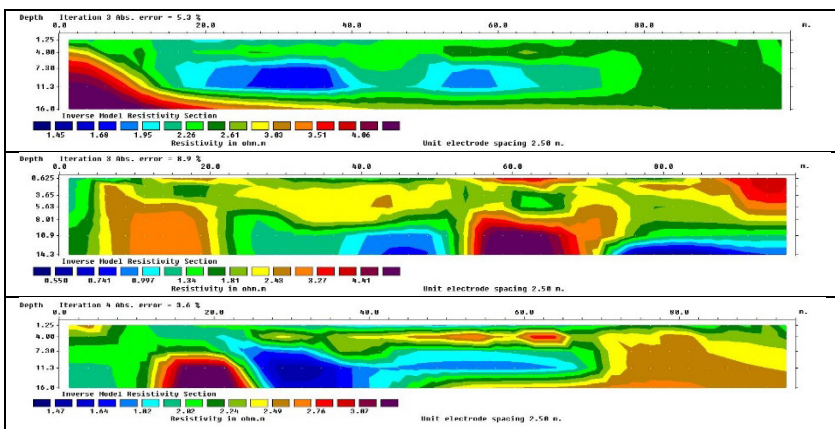
As of 2014, there are 17,477 agricultural reservoirs used in Korea. Among them, 12,148 reservoirs (~70%) were built more than 50 years ago. Thus, reservoir leaking assessment on such aged structures becomes very important to prevent massive leaking and sudden structure failures. Electrical resistivity imaging (ERI) is regularly applied to examine leaking points, if any, and verify effects of grouting to stop water leaking and reinforce the reservoir. In this study, we utilized the Ohm-Mapper resistivity meter with two receivers and one transmitter to assess reservoir leaking detection. For comparison, we also obtained the data from the electrical resistivity monitoring system, which installed measuring rods in a fixed space. The system was developed and operated by the Korea Rural Community Corporation. For the Ohm-Mapper survey, we pulled the system along the ground to produce continuous apparent resistivity data, whose locations were specified by a real-time kinematic (RTK) GPS receiver. The temporal variation of ERI monitoring results exhibits the variation of estimated resistivity values at the water leaking zone, especially before and after the grouting procedures, implying a slow redeveloping of the water leaking. Thus, we demonstrated that the ERI monitoring with the Ohm-Mapper system can be effective to perform a fast assessment on water leaking at reservoirs.

**Figure caption:** Electrical resistivity imaging results before grouting (top), 2 months after grouting (middle), and 1 year after grouting (bottom). The temporal variation implies the water leaking zone is slowly reactivated after application of grouting procedures.
