# Earthquake hazard and damage on traditional rural structures in Turkey

**Abstract.** During the last earthquakes in Turkey, reinforced concrete structures in the cities and masonry structures in the rural part were exposed to damage and failure. Masonry houses such as earthen, brick and stone structures are composed of building blocks with weak inter-binding action which have low tension capacity. Bending and shear forces generate tensile stresses which cannot be well tolerated. In this paper, the performance of masonry structures during recent earthquakes in Turkey is discussed with illustrative photographs taken after earthquakes. The followings are the main weakness in the materials and unreinforced masonry constructions and other reasons for the extensive damage of masonry buildings. Very low tensile and shear strength particularly with poor mortar, brittle behaviour in tension as well as compression, stress concentration at corners of windows and doors, overall unsymmetry in plan and elevation of building, unsymmetry due to imbalance in the sizes and positions of walls and openings in the walls, defects in construction such as use of substandard materials, unfilled joints b

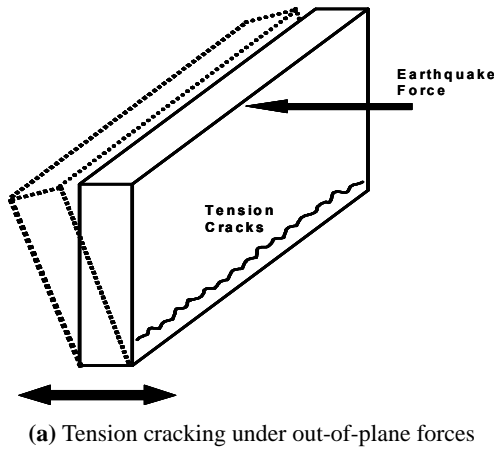
(a) Tension cracking under out-of-plane forces

In order to understand the behaviour of a masonry structure under earthquake effects, behaviour of a single free wall must be studied. If the earthquake forces act on a wall perpendicular to the wall plane, it tends to overturn it. The resistance of the wall is provided by the weight of the wall and the tensile strength of the wall material, which is very low. At the premature stage of the failure, tension cracks on the bottom of the wall (Fig. 4a) are propagated. At the failure stage, the wall overturns out of its plane.

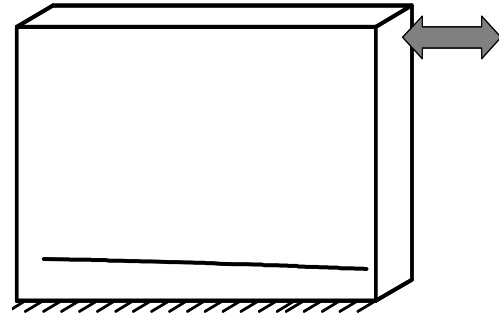
(b) Shear crack at the base

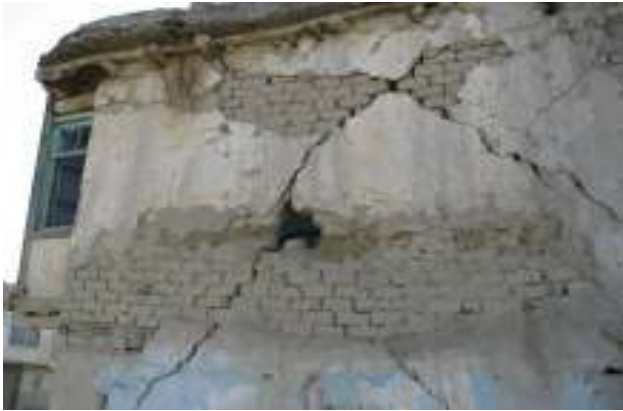
(c) Diagonal shear cracking (Source: H. H. Korkmaz)

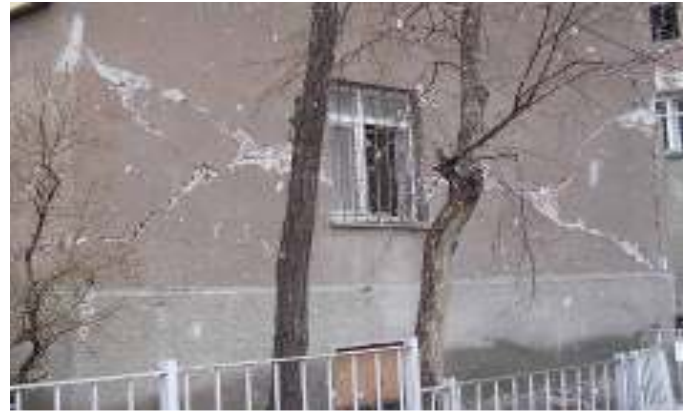
(d) Stepped shear cracking (Source: A. Turer)

When the earthquake forces are directed parallel to the wall plane, the resistance of the wall would be much higher. Due to their orientation, these walls provide the lateral load resistance of the building and undergo in-plane deformation and stresses. The resulting form of damage is a function of axial compressive load level, wall aspect ratio and quality of the mortar in components that compromise the wall. Depending on these factors, in-plane damage may take the form of diagonal, stair stepped, and horizontal flexural cracks. If the length-to-width ratio of the wall is small, sliding or shear cracks are formed (Fig. 4b). In the case of walls with moderate length-to-width ratio and strong mortar combinations, diagonal tension crack is formed (Fig. 4c). This crack becomes X type when the earthquake is reversed. For low axial load and weak mortar combinations masonry units slide horizontally on each other forming a stair-stepped diagonal crack along the joints (Erbay, 2004). Diagonal cracks are turned to stepped type diagonal crack with a horizontal shear crack in the middle for the walls with large length-to-width ratio (Fig. 4d).

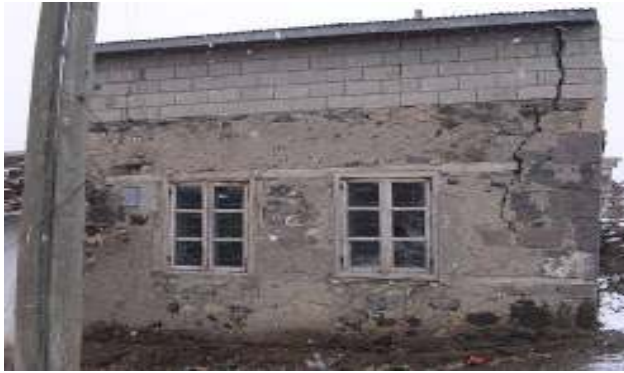
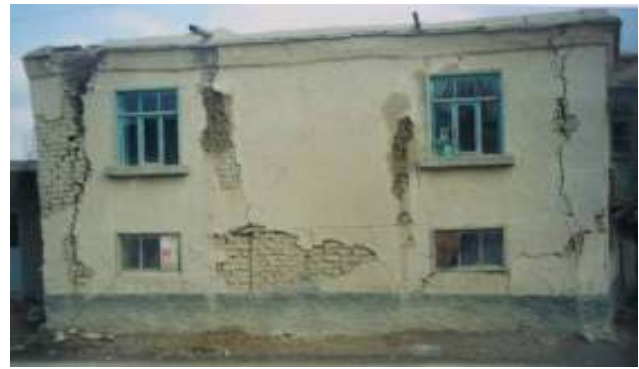
(a) Stone structure (Erzurum-2004) (Source: A. Turer)

(b) Kerpici structure (Aksehir, 2003)  
(Source: H. H. Korkmaz, S. Z. Korkmaz, M. S. Donduren)

**Fig. 5.** Vertical cracks near support edges of out-of-plane walls.

their lateral ends. If the roof of the structure is flexible, as it is the case for most “kerpic” structures in Turkey, formed by parallel beams that are not braced together, then the roof cannot act as a rigid diaphragm and it is unable to restrain the upper edge of the walls against movements perpendicular to their plan. Out of plane walls behave like free standing wall, vertical cracks formed along the support edges, that initiate near the roof and propagate downwards (Fig. 5), and the walls starts vibrating as a cantilever.

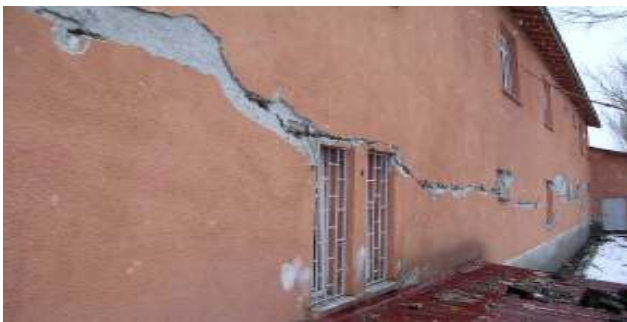
**Fig. 6.** Cracking of masonry wall with many openings (Erzurum, 2004) (Source: A. Turer).

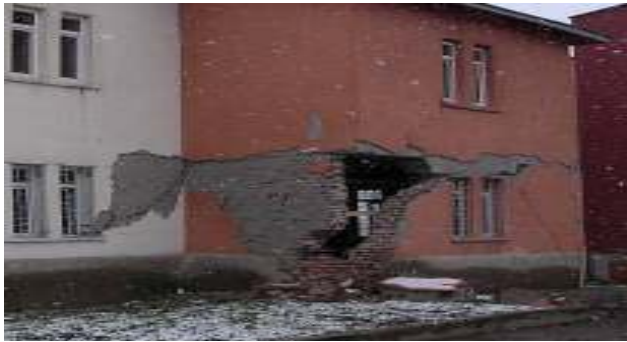
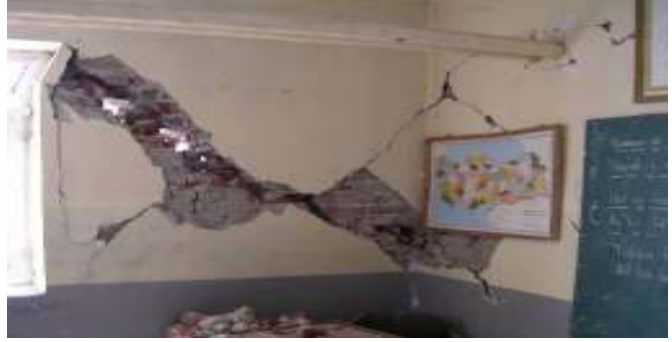
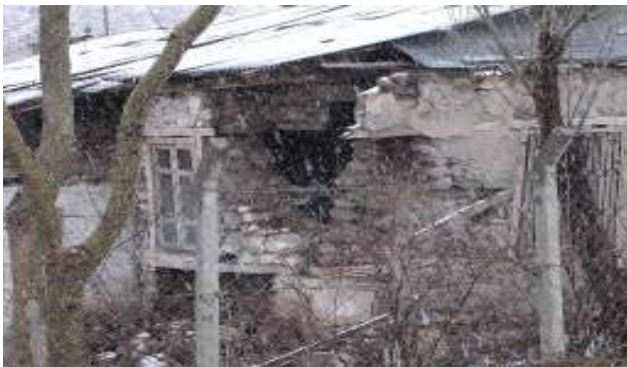
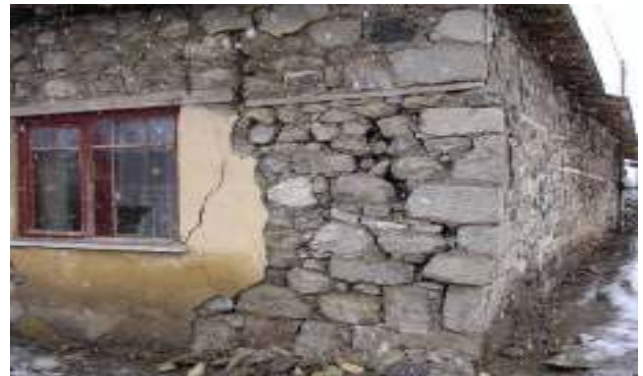
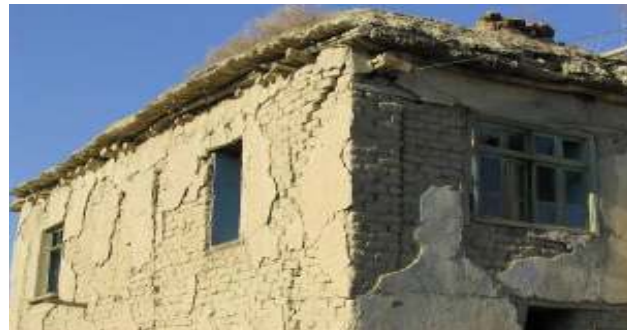
(a) Brick structure (Erzurum, 2004) (Source: A. Turer)

(b) Stone structure (Erzurum, 2004) (Source: A. Turer)

(c) Kerpik structure (Aksehir, 2003) (Source: H. H. Korkmaz, S. Z. Korkmaz, M. S. Donduren)

**Fig. 7.** Corner failure of masonry structures.

subjected to earthquakes are strongly dependent on how the walls are interconnected at the top levels. Corner separations are the most observed type of failures after earthquakes (Fig. 7). Once the corners have failed, the adjacent walls are more likely to fail out-of-plane and overturn (Fig. 8). Also, as the length of the walls increases, the out-of-plane and in-plane resistance of walls decreases.

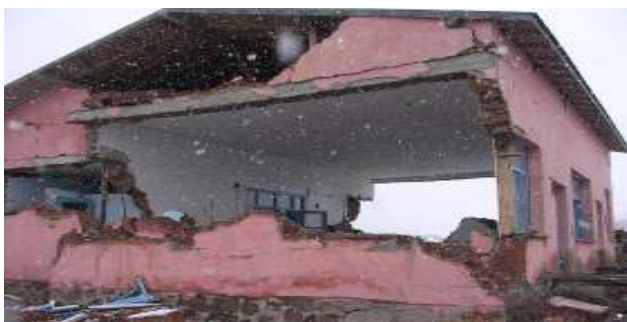
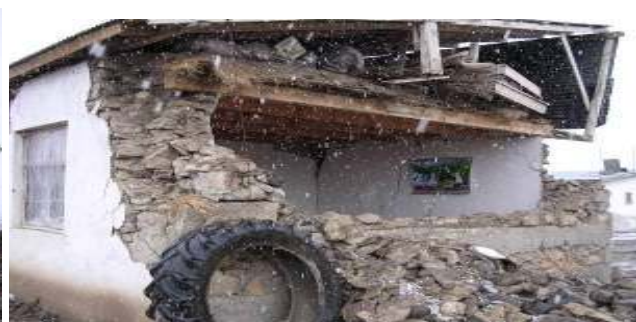
**Fig. 8.** Out-of-plane failure of masonry walls (Erzurum-2004) (Source: A. Turer).

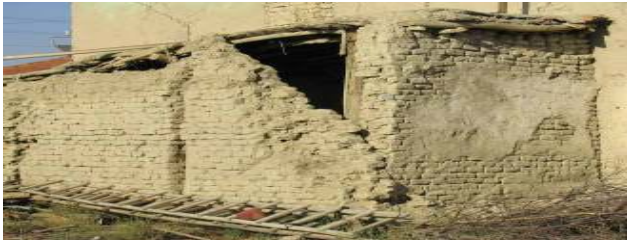
**Fig. 9.** Inadequate (no) connection between two intersecting walls and damage (Source: H. H. Korkmaz).

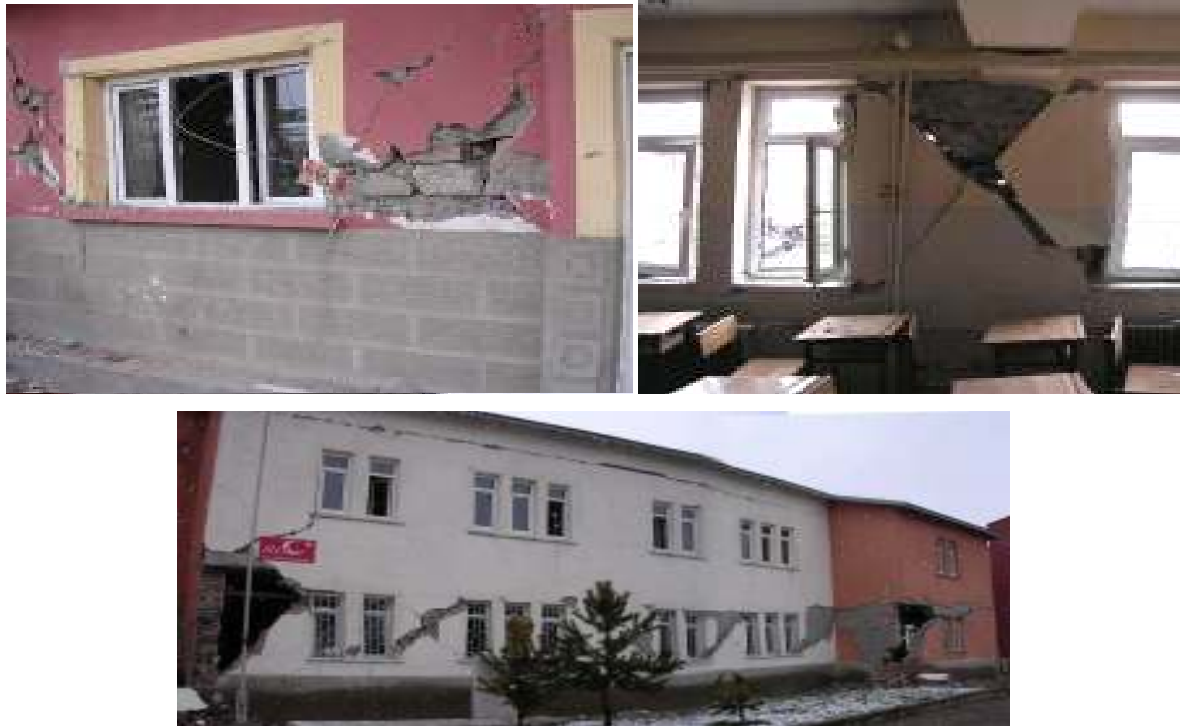
there exist opening in the wall such as door or windows, the wall portion between openings are become more flexible. The sections at the level of the top and bottom of opening are found to be the worst stresses in tension as well as in compression and those near the mid-height of piers carry the maximum shears. Under reversed direction of horizontal loading the sections carrying tensile and compressive stresses are also reversed. Thus it is seen that tension occurs in the jambs of openings and at the corners of the walls. The pier may fail either in shear due to diagonal tension or in flexure due to the vertical compression at the compressed corners (Fig. 10).

**Fig. 10.** Shear cracks of piers between windows (Erzurum, 2004) (Source: A. Turer).

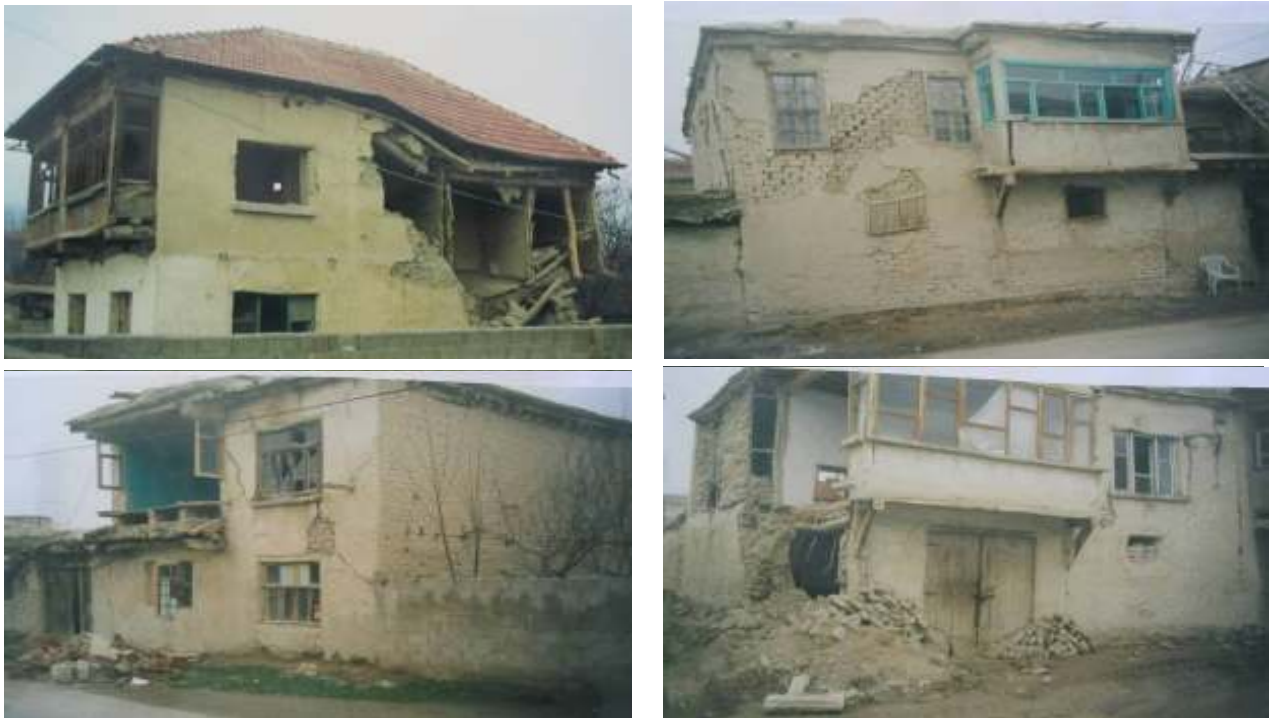
Usually houses with two or three stories receive much more damage than those with one story (Fig. 11). The geometry of a house in plan as well as in elevation has a significant effect on the distribution of the seismic forces. If there are no sudden changes, in stiffness and walls are uniformly distributed in both orthogonal directions then the behaviour of masonry building may be expected to be better. Unsymmetrical houses develop additional shearing forces due to twisting and warping. Irregular distribution of walls in plan can result in torsional effects and over stressing the wall in critical zones. Building with load bearing walls in one direction only represent an example of bad structural layout. Also peripheral walls with many openings, can not resist earthquake forces (Fig. 12).

**Fig. 11.** Damage of multistory houses (Source: D. Aydin).

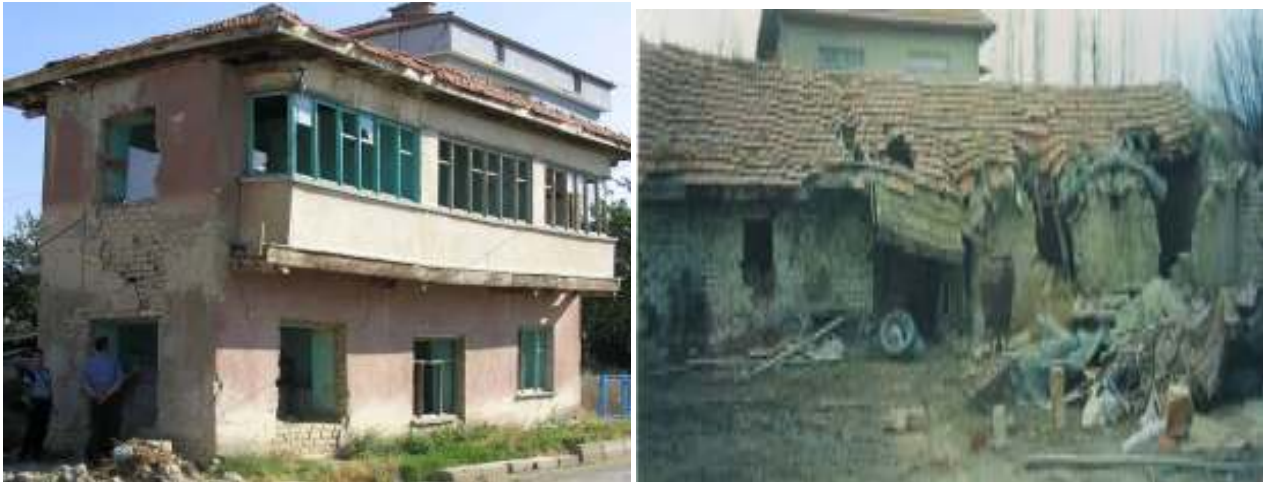
**Fig. 12.** Failure of structures with bad geometry (Aksehir, 2003) (Source: H. H. Korkmaz, S. Z. Korkmaz, M. S. Donduren).

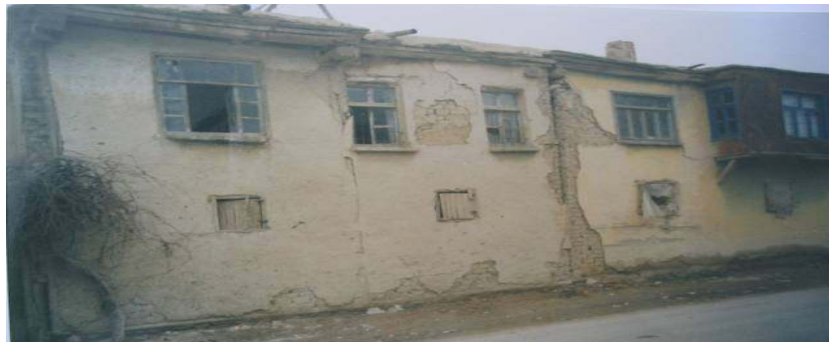
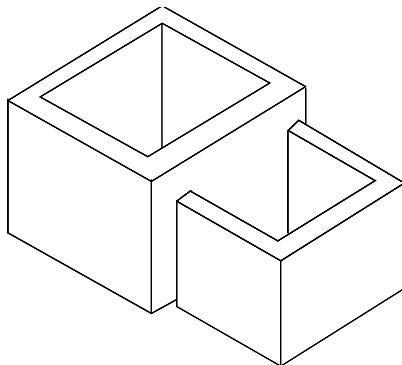
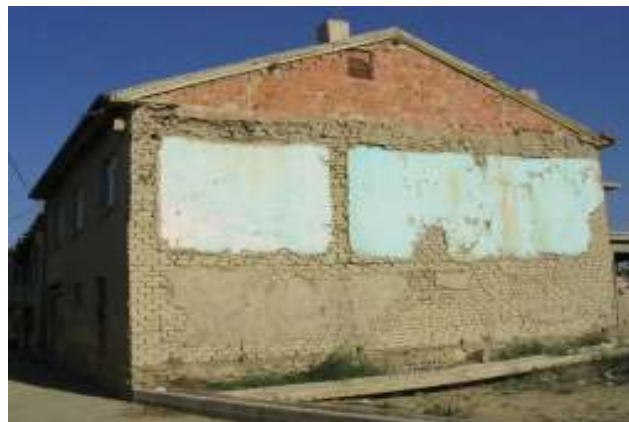
In some cases dwellings are constructed adjacent to each other. This creates hammering effect during earthquake (Fig. 13a). Sometimes, for a new building adjacent to the other older building, only 3 walls are constructed and common wall of the older building is used for other side (Fig. 13b, see also Fig. 9). In this case, a box type structure can not be formed and failure is unavoidable. In Fig. 13c the neighbouring structure was failed and only common wall of the older building is seen.

(a) Cases dwellings are constructed adjacent to each other  
(Source: H. H. Korkmaz, S. Z. Korkmaz, M. S. Donduren)

(b) Other side

(c) Neighbouring structure  
(Source: H. H. Korkmaz, S. Z. Korkmaz, M. S. Donduren)

**Fig. 13.** Problems of adjacent buildings (Aksehir, 2003).

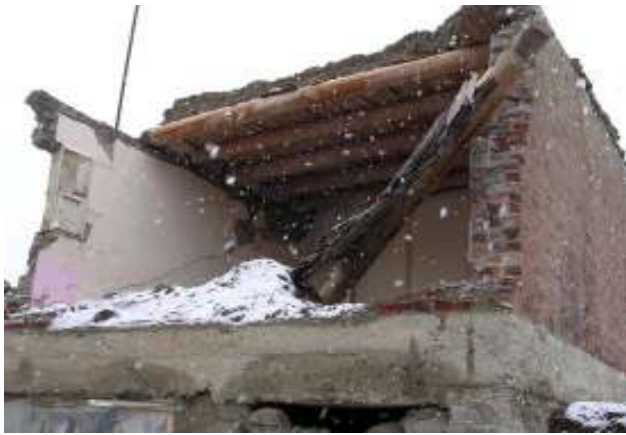
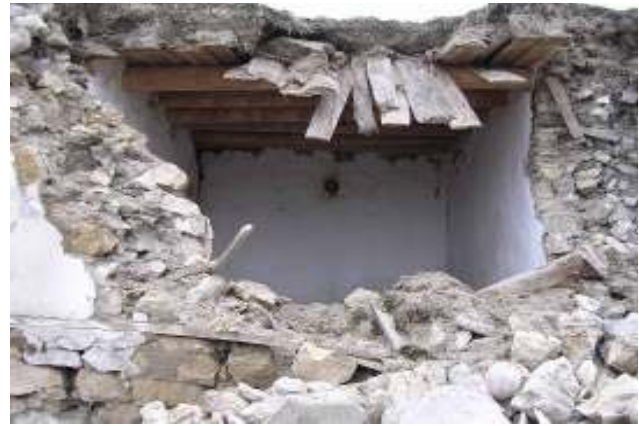
In Turkey, it is very common to use round wooden logs (unshaped) as roof beams. Those beams are placed on two parallel walls. As a result other two walls become unrestrained at the top (roof level). The damage is likely to occur for those unrestrained walls. The probable failure mode is out-of-plane collapse of the walls (Fig. 14). Also in Fig. 14b, it is seen that, the round beam member is rolled and failed in the living space of the structure. Another factor leading to failure of roof beams is that they are not fully rest on the top of the walls. Only a small portion of the beams are rest on the walls. Beams must be extended, at least, 50 cm beyond the walls towards outside.

(a) Out-of-plane collapse of the walls (Source: A. Turer)

(b) The round beam member is rolled (Source: A. Turer)

**Fig. 14.** Failure of unrestrained wall and failure of rounded roof beam (Erzurum, 2004) (Source: A. Turer).

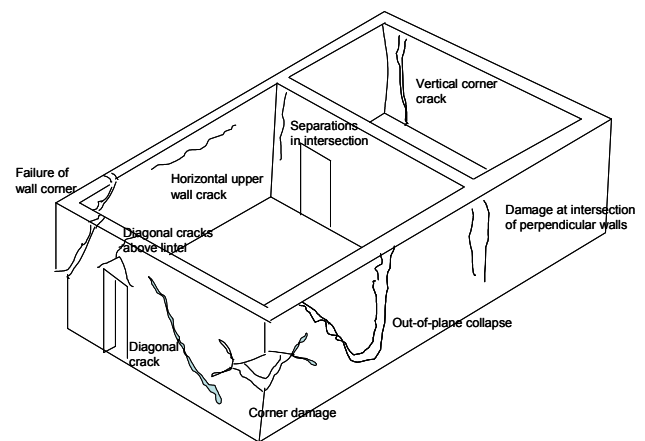
In Fig. 15, several crack and failure types are summarized for masonry structures. Sequences of failure and occurrence of damage types suggest that the points which govern damage progression are:

1. Corners are more likely to fail than mid-wall elements.
2. Any panel between two corner failures is unrestrained and is unlikely to remain standing.
3. Non-load bearing panels are more likely to fail than load bearing.
4. Elements generally fail one after another.
5. The failure of one element increases the probability of failure of neighbouring elements (Yarar, 1985).

**Fig. 15.** Summary of typical damage and crack types.

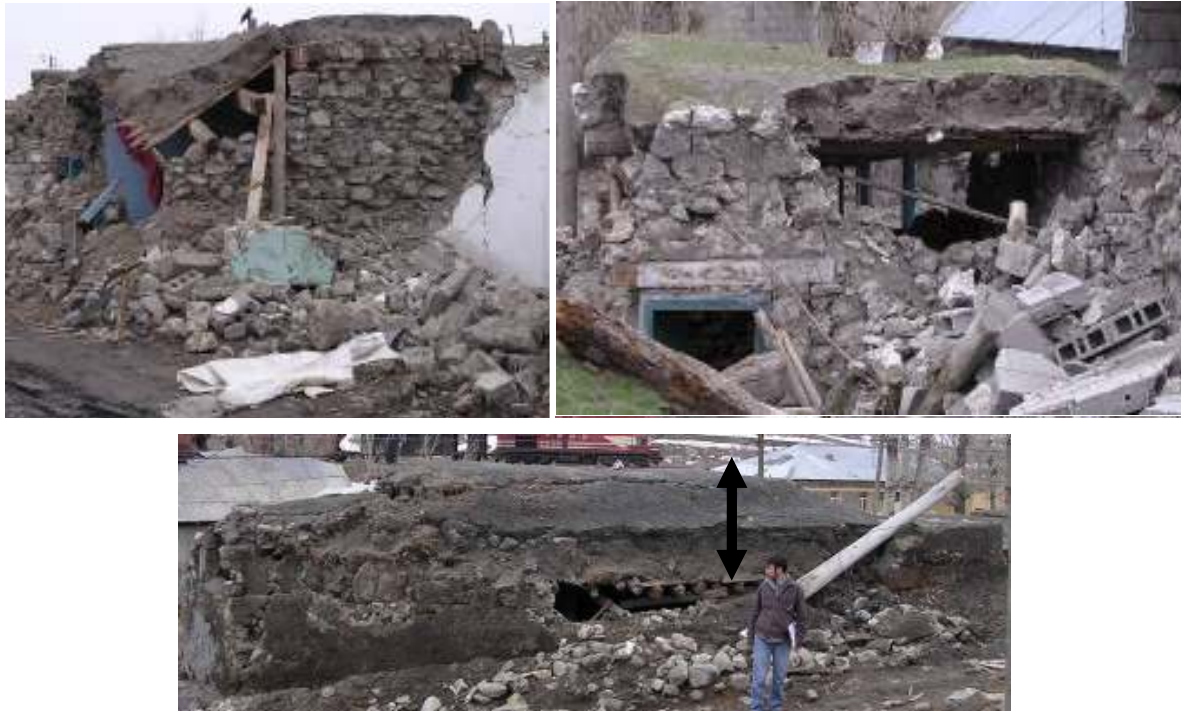
In eastern of Anatolia, general structural type is stone masonry and especially random rubble debris stone is used and many structures incorporated timber reinforcement and had timber roofs. Those stones are collected from river basins and have round shapes. Sometimes the surface is covered with moss. As a mortar, mud is commonly used. After the mud shrunk, the only force that can withstand shear forces is the friction between stone blocks. The general roof type is flat earth roof. Construction of stone buildings is easy because they do not require formwork or reinforcement workmanship. On the other hand, wall thicknesses of such building are very thick. Especially on the east part of Turkey, due to temperature differences between day and night, walls may be 50–70 cm, which creates high seismic forces. It is known that the thickness of the earth layer over the roof can reach up to 50 cm causing excessive loading on the structure. The dead weight of the earth roof can be 0.75–1.0 t/m<sup>2</sup>. Snow accumulated on the roof during winter times is stripped off.

**Fig. 16.** Heavy roof of Eastern Anatolia houses (Erzurum, 2004) (Source: A. Turer).

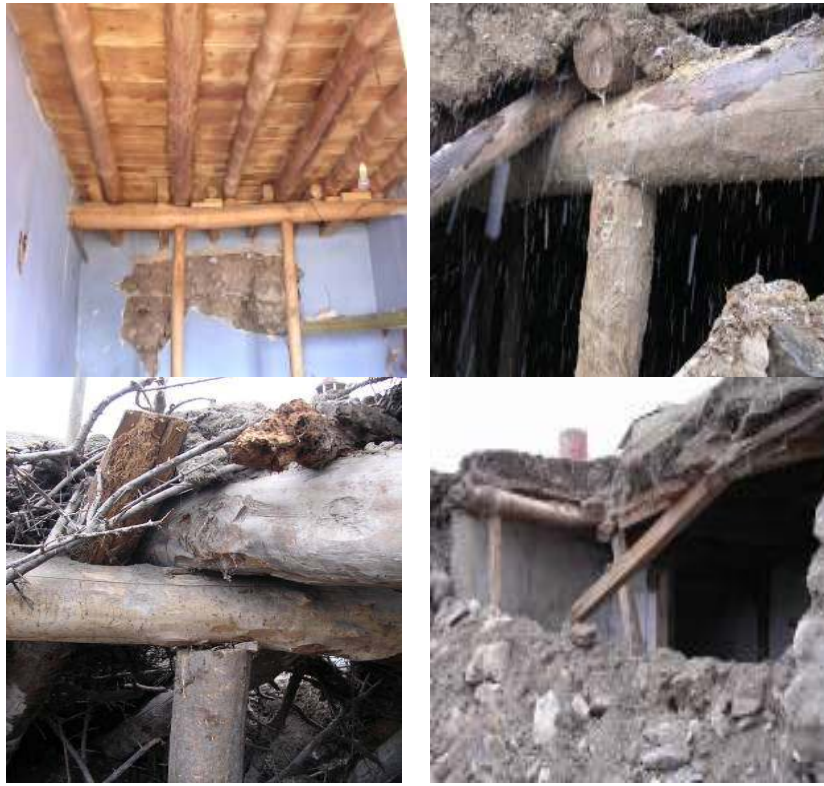
**Fig. 18.** Wooden frames, connection of them and failure observed in east Anatolia (Source: A. Turer).

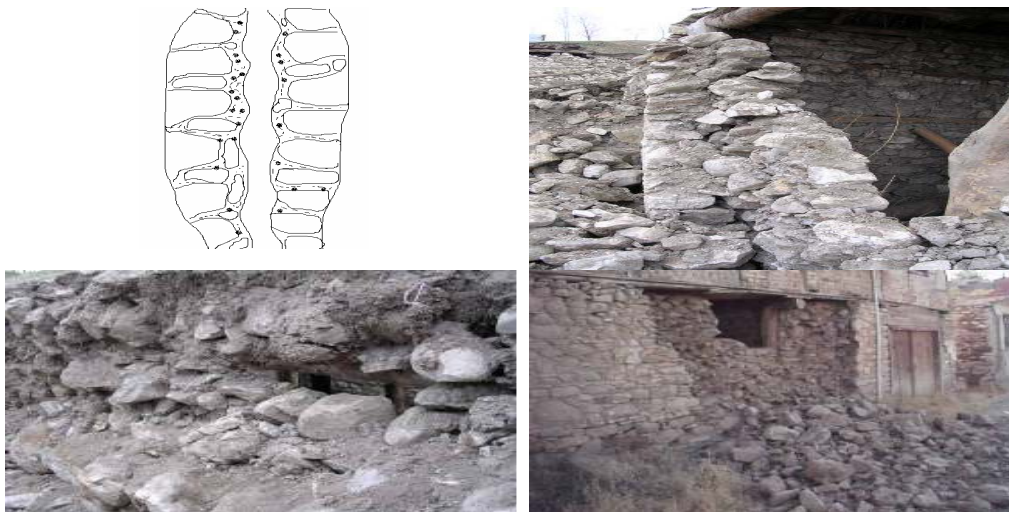
internal and external surfaces (Fig. 19) the walls cannot act as one single unit and this lead to failure of outer skin outwards due to plate action. The reason for that is, inner and outer skins do not have enough transverse connection “through” or “bond stones” and weak mortar filling between the skins. In half-dressed stone masonry, the surface stones are pyramidal in shape having more or less an edge contact one over the other, thus the stones have an unstable equilibrium and easily disturbed under shaking condition.

**Fig. 19.** Wall delaminated with buckled skins (Source: T. Wasti).

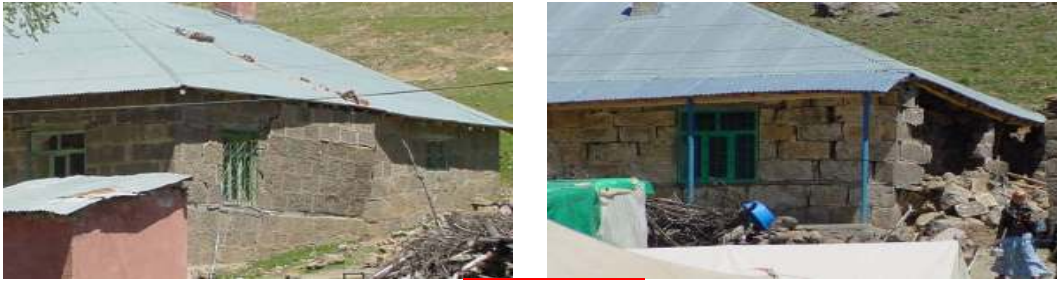
**Fig. 20.** Failure of block stone masonry houses (Source: A. Turer).

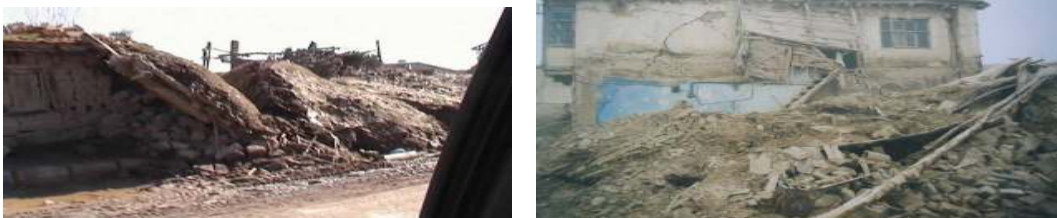
**Fig. 21.** Failure of heavy roof of kerpik houses (Sultandagi Earthquake) (Source: D. Aydin).

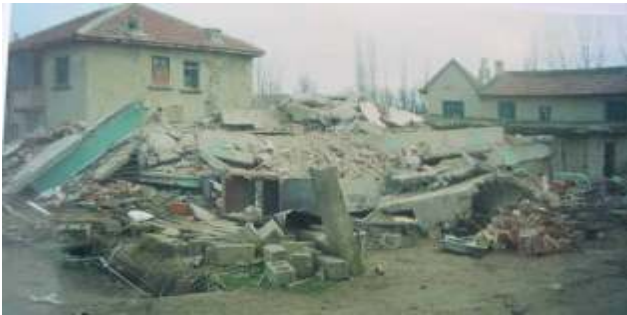
**Fig. 22.** Collapsed reinforced concrete building after Sultandagi earthquake (Source: H. H. Korkmaz, S. Z. Korkmaz, M. S. Donduren).

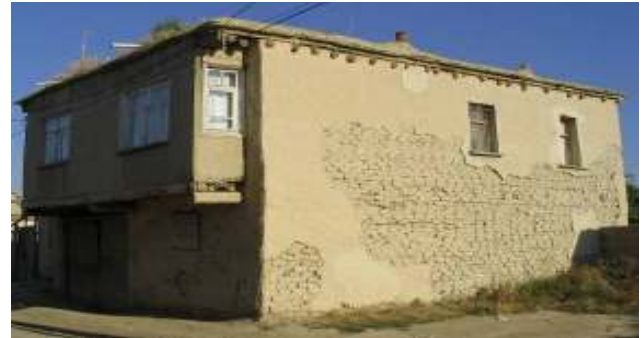
**Fig. 23.** A kerpik structure in Aksehir with two storeys and absence of hatil (Source: H. H. Korkmaz, S. Z. Korkmaz, M. S. Donduren).

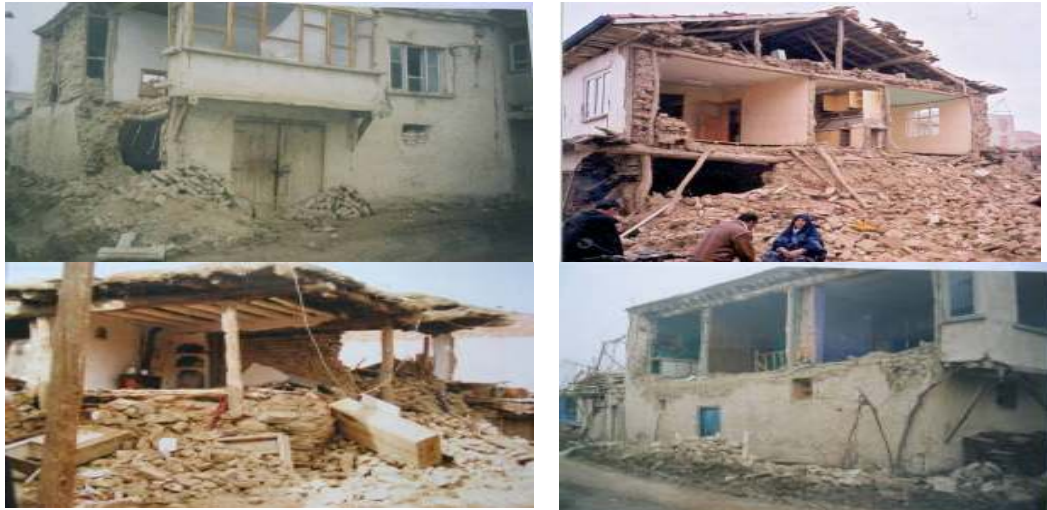
tions between wooden beams and vertical frame elements are inadequate. Out-of-plane failures of earthen infill walls were observed frequently (Fig. 24).

**Fig. 24.** Out-of-plane failure of masonry walls (Source: D. Aydin).

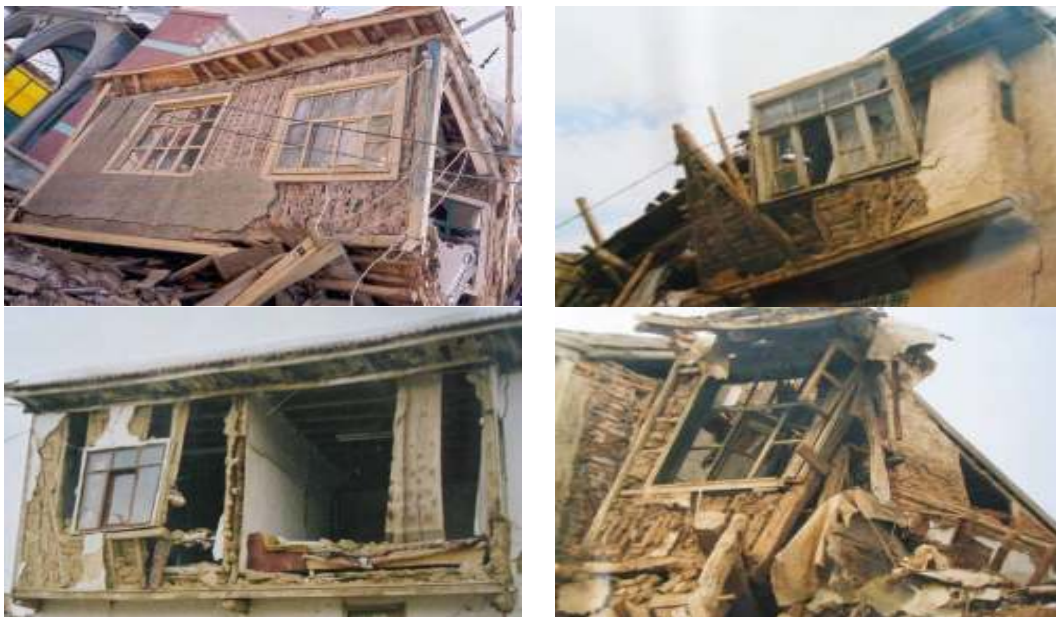
action, most of the walls responded individually during the seismic attack. Moreover as a consequence of weak connections between the perimeter and orthogonal partitioning walls, separation occurred and most of the walls collapsed in the out of plane direction (Fig. 25).

**Fig. 25.** Failure and damage of himis buildings (Source: D. Aydin).
