## 2010 Karakocan-Elazig earthquake and masonry structures

**Abstract.** Karakocan-Elazig-Turkey earthquake with  $M = 6.0$  occurred on 8 March 2010 at 04:32 a.m. (local time) in eastern Turkey and caused the loss of life and heavy damages, as well. The majority of the damaged structures were seismically deficient, unreinforced masonry buildings. In this paper, a site survey of the damaged buildings is presented and the reasons behind the damages are discussed.

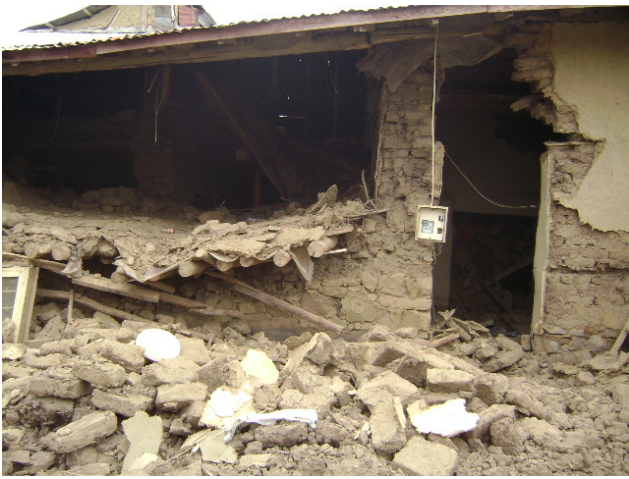
The masonry buildings in the region affected by the earthquake were constructed using mud bricks, stones collected from the river beds, soft natural stone blocks and lime hollow/solid blocks. Most of the buildings were one-storey with a very heavy roof over a wooden skeleton (Fig. 5). This type of heavy roofing significantly increases the seismic demands. These buildings were not earthquake resistant according to previous or existing Turkish seismic codes (MPW, 1975, 1998, 2007).

**Fig. 5.** Heavy roofing with wooden skeleton.

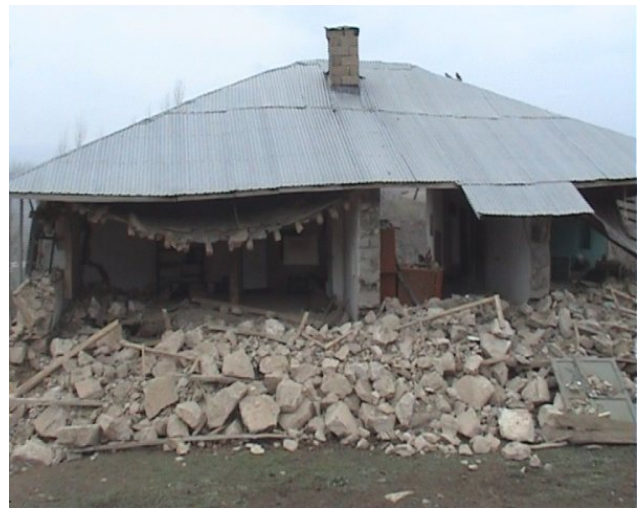
**Fig. 7.** No connection to partition walls.

Another common reason for the damages was the insufficient connection of the walls to each other. There was either no connection or the connection was not constructed properly to transfer the loads. This kind of damage is shown in Fig. 7. The construction of the exterior walls was

completed without any connection to partition walls. For this reason, the free span of the external wall was too much to resist against out-of-plane failure.

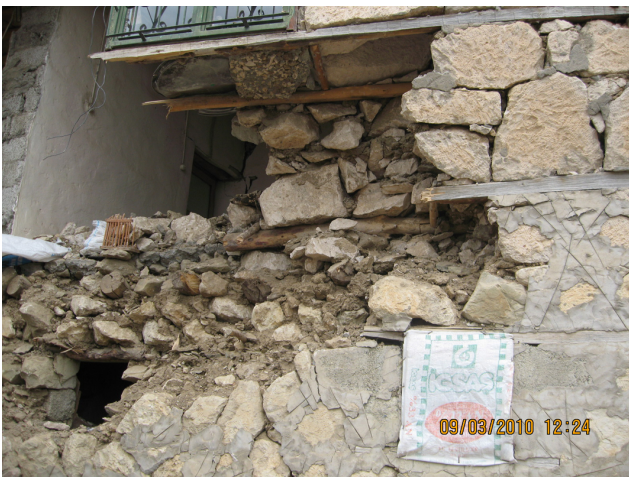
**Fig. 6.** No interlocking between wall leaves.

The stone masonry walls were constructed as inner and outer leaves with a total thickness of 50 cm in general. There was no interlocking element to connect the inner and outer leaves to each other. Because of this deficiency, the unsupported length of the outer leaf of the wall was doubled, but its effective thickness was decreased to half of the wall thickness. So, the out-of-plane failure risk was considerably increased. This type of damage is shown in Fig. 6.

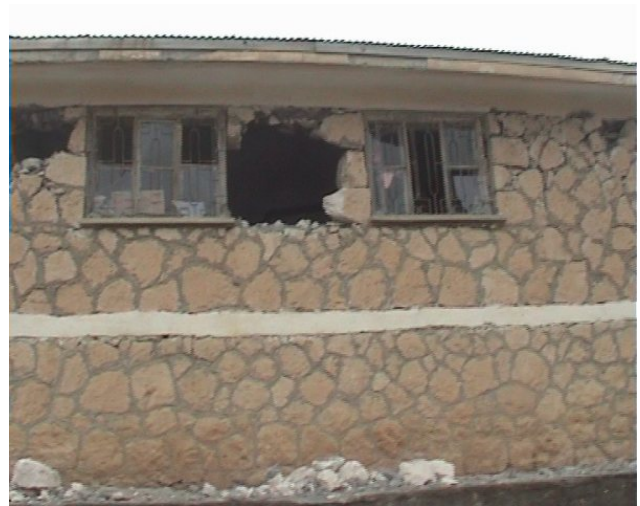
**Fig. 8.** Short distance between two openings.

Wrong placement of the openings in the walls was among the most common reasons for the damage. Since the masonry walls are the only lateral load bearing structural elements of the masonry buildings, seismic design codes restrict the distance between the two openings and the distance between the opening and corner of the walls (MPW, 1975, 1998, 2007). The minimum distance between two openings should be 1 m and the minimum distance between an opening and a building corner should be 1.5 m. The damage due to the insufficient distance between two windows is shown in Fig. 8. Irregular shape of the masonry units in Fig. 7 is also as important as the insufficient wall length. Besides, it should be noted that the damage level in that wall could be higher

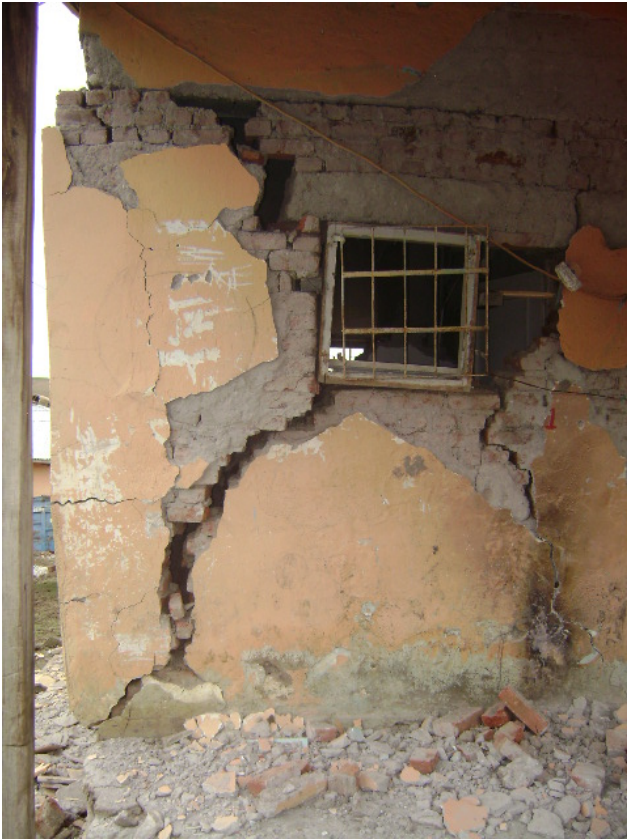
**Fig. 9.** Wall opening close to the building corner.

if the bonding beams at mid-height and at the top of the walls were not. The damage shown in Fig. 9 was due to the insufficient distance between the opening and the building corner.

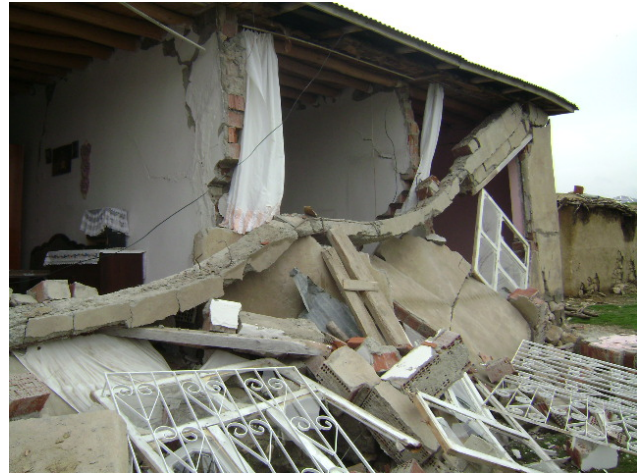
The lack of bond beams on top of the walls and a heavy roof with insufficient in-plane stiffness, which does not provide a rigid diaphragm effect, are also important reasons for this type of damage (Fig. 10). Walls, bond beams and roof were not connected to each other to transfer the seismic loads. Therefore, the walls acted as free standing walls.

**Fig. 10.** Out-of-plane failure due to long span.

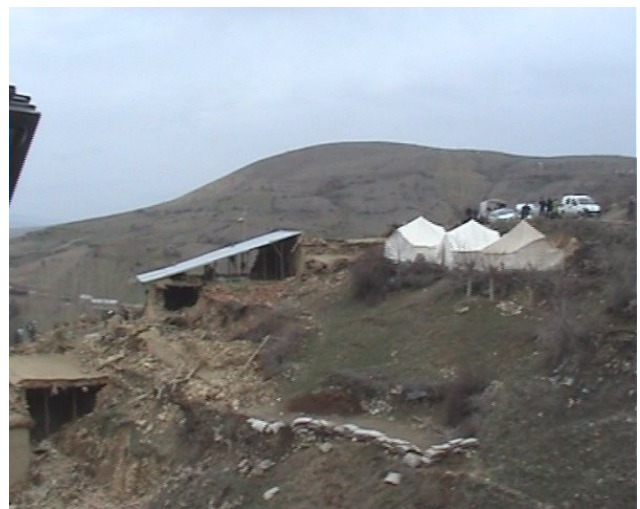
Topography of the region was also effective in the damages. Many of the damaged buildings were located on the hills with a high slope. According to Kramer (1996), topographical irregularities on ground surface may affect ground acceleration significantly. Because of the amplified ground accelerations, the number of the damaged buildings increased significantly. The damages on the buildings located on a hill are shown in Fig. 11. Due to the

**Fig. 11.** Damaged buildings on a hill with high slope.

concentration of seismic energy and amplification of the ground acceleration at the top of the hill, the damage level of the building becomes heavier than those located on the foot of the hill.
