19 May 2011 Kütahya – Simav earthquake and evaluation of existing sample RC buildings according to the TEC-2007 criteria

M. H. Arslan¹, M. Olgun¹, M. A. Köroğlu², I. H. Erkan¹, A. Köken¹, and O. Tan¹

Abstract. This study examines the damage caused to reinforced concrete structures by the 2011 earthquake that occurred in Simav, Turkey. The study briefly reports on post-earthquake field observations, tectonic characteristics of the earthquake area, geotechnical characteristics of the field, and seismic characteristics of the earthquake. The main part of the study comprises a field study, material experiments, and performance analyses of two reinforced concrete buildings that survived the earthquake with medium level damage. The building performance was calculated and assessed according to the Turkish Earthquake Code requirements for existing building stock, and recommendations were made based on the findings.

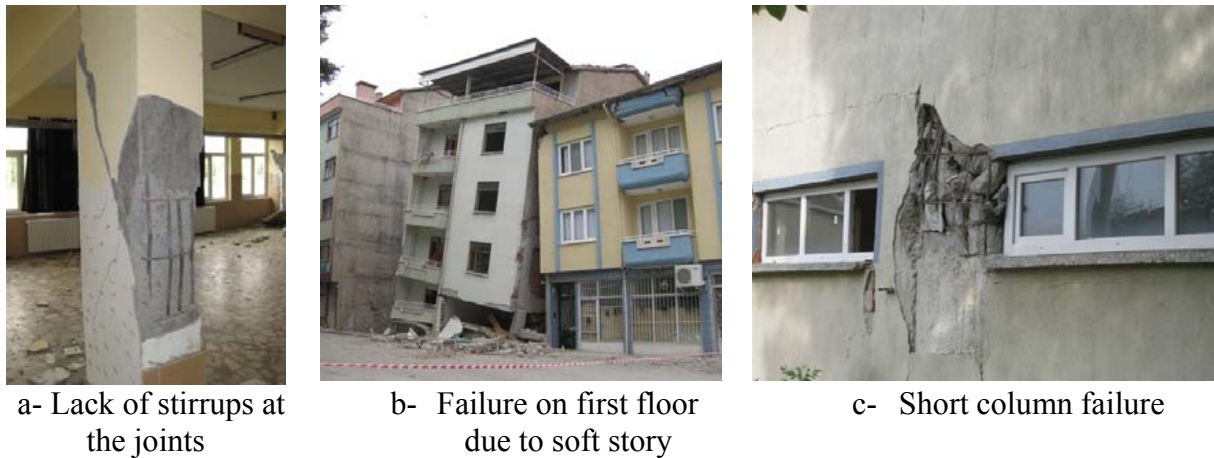
Wide spacing of lateral ties is a common shortcoming observed by authors in Turkish RC structures. During site observations after earthquakes, it is noted that the stirrup spacing was much more than the maximum value allowed by the design code (Sandıkkaya et al., 2011; İnel, 2011; Kaplan et al., 2011), as seen in Fig. 6a. In most damaged columns, a tie spacing of less than 100 mm was not observed.

Taller first stories and disuse of walls for exterior cladding, in order to use the first floors as shops because of high residential densities in Simav center, caused weak and soft story problems. The building in Fig. 6b collapsed as the moment frame was both flexible and weak in the first story compared with the upper stories. Deformations are concentrated in the first story of this building since the front of the building was opened on the first story. The first-story columns in this building were severely damaged and leaned onto the adjacent building. Soft story failures occur in buildings due to the sudden change of story stiffness with open fronts on the ground floor or tall ground story (excessive story height with respect to others). The most common examples are shopping malls, offices, and hotels, etc.

a- Lack of stirrups at the joints

b- Failure on first floor due to soft story

c- Short column failure

Fig. 6. Three damage types from epicenter region.

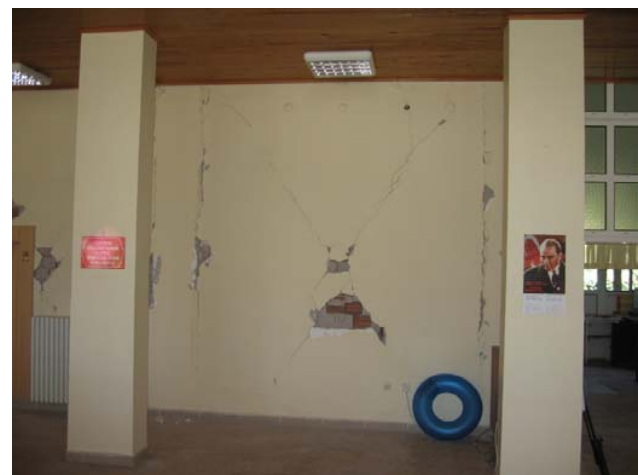
Fig. 9. Filled wall damage.

Non-load partition walls were particularly badly damaged in the earthquake. Partition walls were separated from the frame due to both in-plane and out-of-plane movements. Damage was especially severe around the walls of subfloors (Figs. 9 and 10). The architect of the project removed significant parts of the ground story walls due to the projected usage of the building even though the project originally included them.

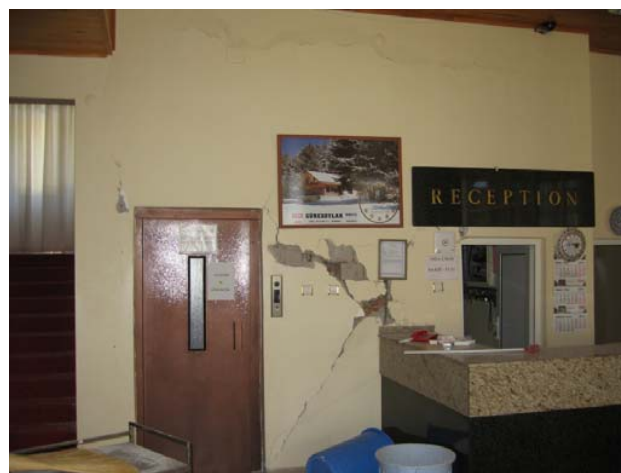
**Fig. 10.** Filled wall damage.

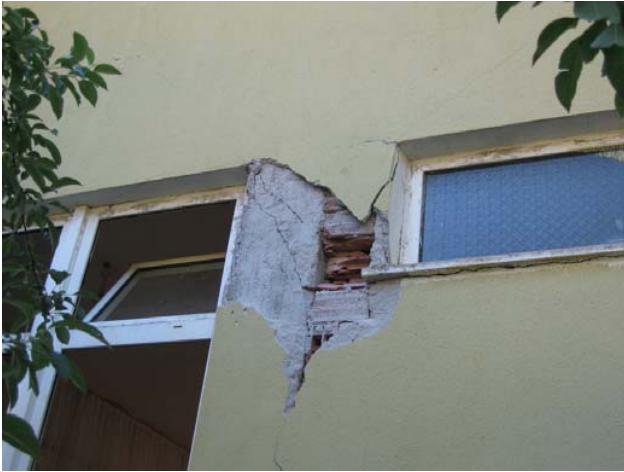
Diagonal fractures occurred in significant parts of the infilled walls through the dissipation of energy. Therefore, no significant damage was observed in load-bearing elements (column, beam, etc.). In addition, the ribbon windows of the basement story in the rear facade of the building caused shear cracks in upper bearings of columns (short column mechanism). Figure 11 shows the appearance of short column forming.

Fig. 11. Shear-column damage.

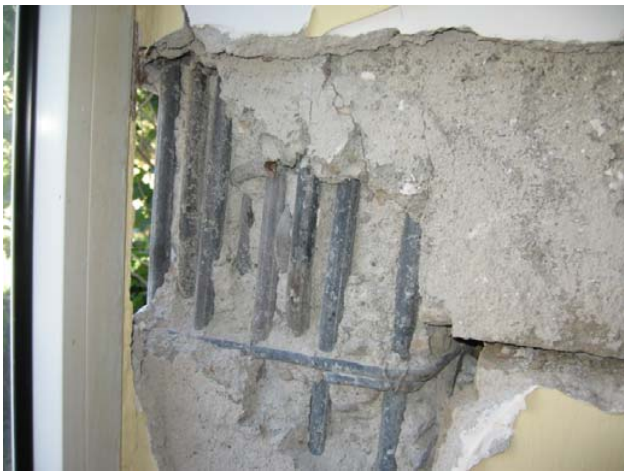
Fig. 12. Utilized rebar (beam-column node of ground story).

that cannot be explained with principles of RC construction. The basic causes of damage are defects in the placement and the mechanical characteristics of transverse and longitudinal rebar, low concrete quality, inappropriate wall construction, and the increased height and low rigidity of the ground story compared to other floors. The beam-column connection region shown in Fig. 12 demonstrates that the building is far from complying with the provisions of TEC-2007. There is no stirrup in the column and beam connection region, stirrups hooks have 90 degree angles, there is hooking in the compression rebar, and the distance between rebars is non-compliant.

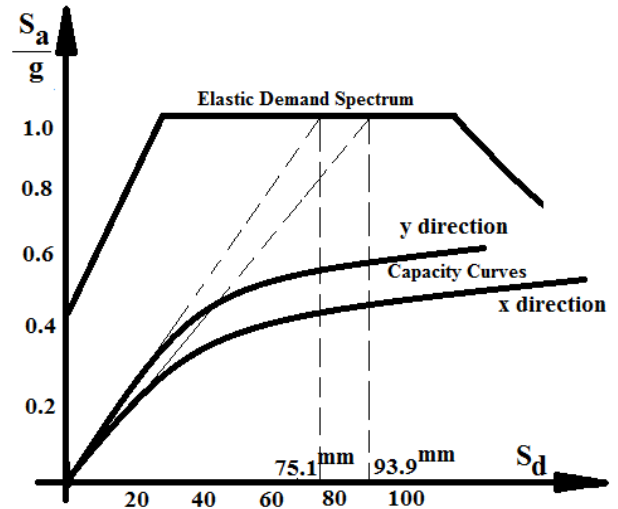
Fig. 15. Capacity curves at x and y directions for case study 1.

Figure 15 shows load-displacement (capacity) curves for both directions, where the elastic spectrum curve is the level of design earthquake for 1st degree earthquake zone determined in TEC-2007. In addition, Figs. 16 and 17 show the damage criteria of columns and beams comprising the load system, shown according to floors and proportionally, respectively. According to the analysis results, 100 % of the columns are in the significant damage region in the first story. Using this method, the global performance level of the building was determined to be total collapse (CP) according to TEC-2007.

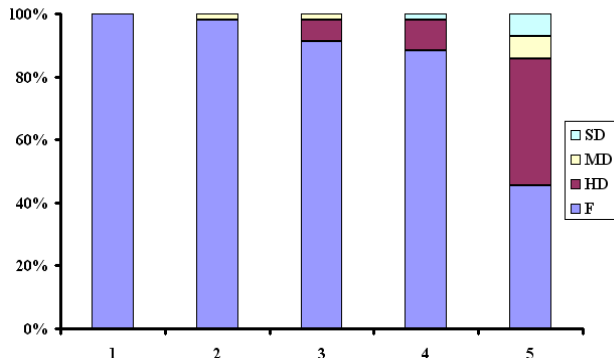
Fig. 16. Column cross-sectional damage.

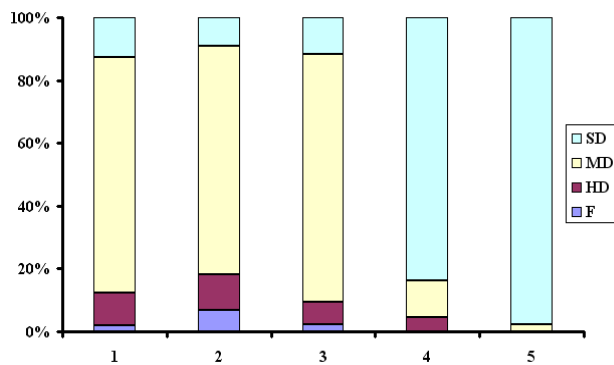
Fig. 17. Beam cross-sectional damage.

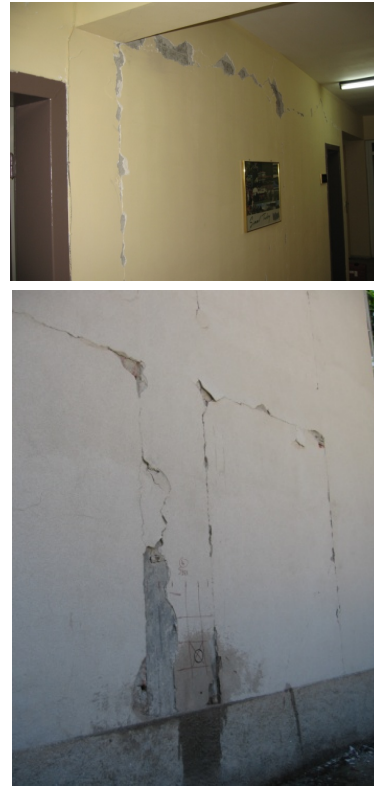
After the earthquake, damage was observed to be especially severe in non-load partition walls. Partition walls were separated from the framework system as a result of in-plane and out-of-plane movements. Figure 19 shows some samples of such damage. Damage was more severe in lower floors. In addition to filled walls, cross-sectional cracks were observed in shear columns ($\sim 30 \text{ cm} \times 180 \text{ cm} - 30 \text{ cm} \times 200 \text{ cm}$ size) in the ground story. These elements, which serve for the safety of the building, had slight–medium damage and prevented total collapse of the building.

Fig. 19. Damage of filled wall.

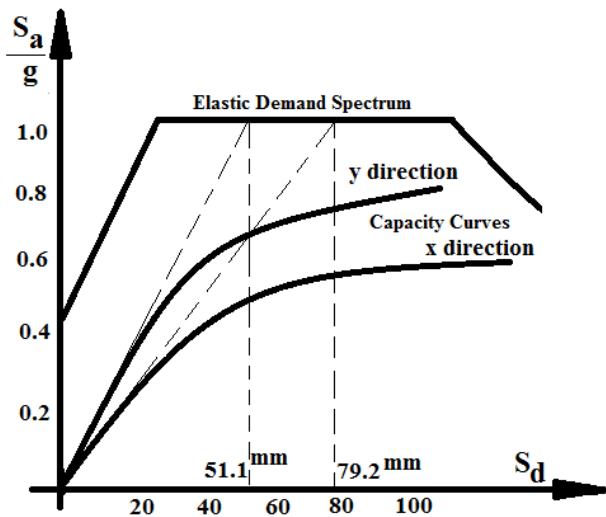
After modeling, the performance of the building was determined according to TEC-2007 norms. Figure 21 shows load-displacement (capacity) curves for both directions of the building in plan plane. In addition, Figs. 22 and 23 show individual damage measures of columns and beams comprising the load system. Even though this second case study building showed better performance than the first building, the global performance level in this building was found to be CP according to TEC-2007 criteria.

Fig. 21. Capacity curves at x and y directions for case study 2.

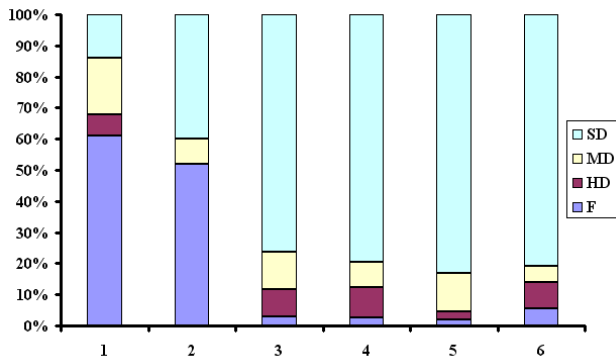
Fig. 22. Column cross-sectional damage.

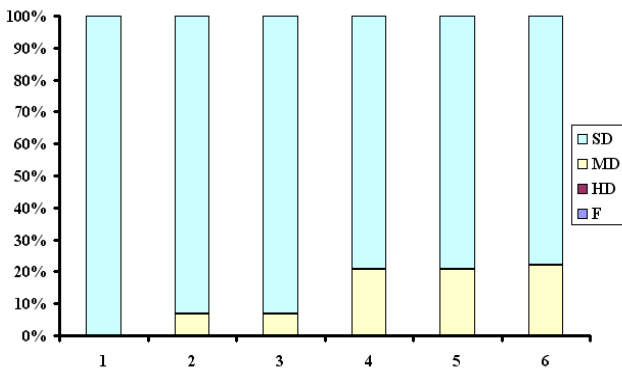
Fig. 23. Beam cross-sectional damage.
