Construction and design defects in the residential buildings and observed earthquake damage types in Turkey

M. T. Cogurcu

Selcuk University, Engineering Faculty, Department of Civil Engineering, Konya, Turkey

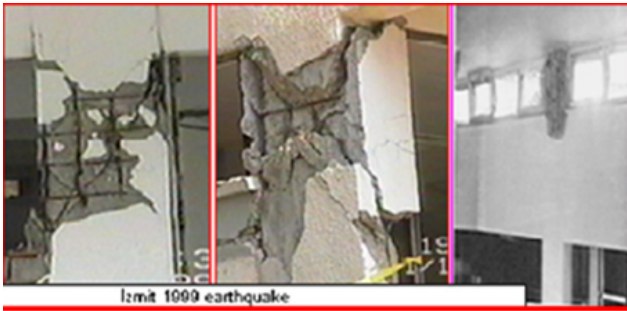
If there is a difference between the lengths of columns on the same floor, it can become a damage mechanism during an earthquake (Fig. 3). Ribbon windows that are made from column to column in the halls of structures such as schools and hospitals and the presence of which are not considered in static projects can cause brittle fractures in columns.

M_a and $M_{\bar{u}}$ are the moments of the top and bottom parts of the column where the wall is not placed, and l_k is the length of the short column. As shown in Eq. (1), the shearing force in a short column is inversely proportional to the length of the short column, l_k . Accordingly, when l_k is short, the shearing force is high. The height of the short column is generally kept to 40–50 cm for lighting applications. Shearing forces due to earthquakes may cause great damage if adequate preventions are not taken in the short columns.

Figure 3. Several short column failures observed after earthquakes (Isik G., 2006).

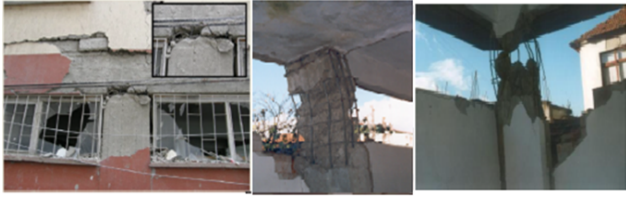
Examples of damage that occurred in reinforced concrete buildings due to window bays left in infilled walls and column edges are shown in Figs. 6 and 7.

Figure 6. Examples of damage caused by the formation of short columns (METU/EERC, 2011).

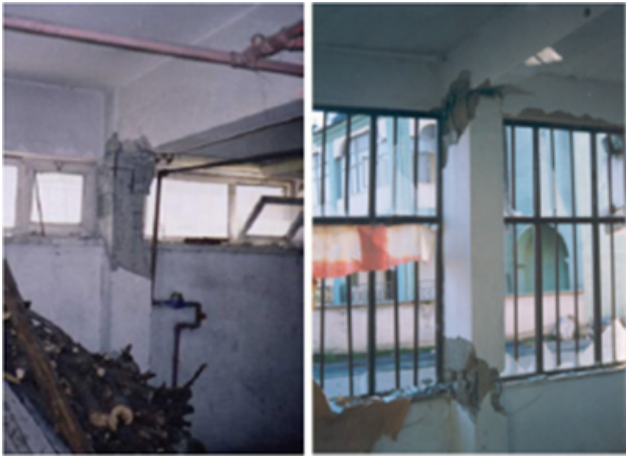
Figure 7. Short column formation caused by ribbon windows (METU/EERC, 2011).

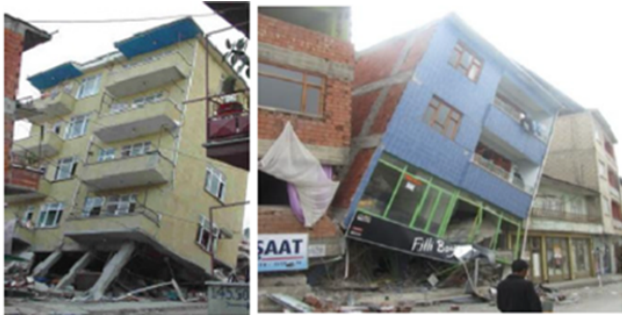
In Fig. 8, many examples are shown of soft-story and weak-story damages observed in the 2011 Van earthquake.

**Figure 8.** Examples of damage related to soft-story and weak-story irregularities (source: Ahmet Topçu).

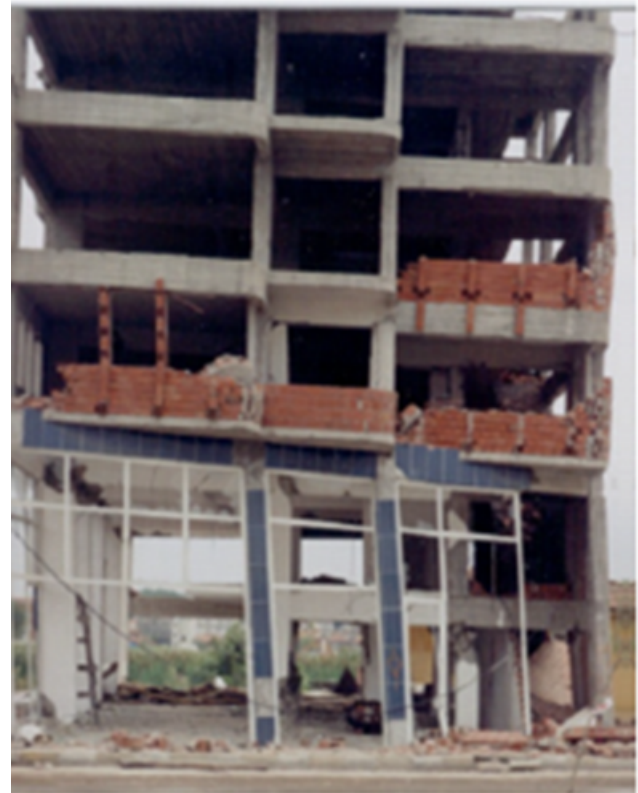
Many buildings were heavily damaged in the 17 August 1999 Kocaeli earthquake (M_w : 7.4). Those buildings did not have masonry-infilled walls on their ground floors in order to leave space for commercial uses on Izmit and Golcuk Street and especially on AdapazarıInonu and Cark Street. The upper floors of the incomplete five-floor building shown in Fig. 9 were designed as residential floors, and the ground floor was designed for shops. This building, in which the ground floor was quite high and lacked masonry-infilled walls, was heavily damaged and collapsed due to weak-story syndrome.

According to the η_c weak-story and η_k soft-story criteria in the TEC 2007, weak-story and soft-story irregularities were not found in this building. Instead, the building collapsed due

to the weakness and softness of the ground floor. In this case, the TEC 2007 could not identify a weak or soft story in the building. Thus, the design engineer and the assignors were misled as to the threat to human life because the building was viewed through rose-colored glasses.

**Figure 9.** Heavy damage in the weak story of a five-floor building in Adapazari (17 August 1999 Kocaeli earthquake, $M = 7.4$) (Isik G., 2006).

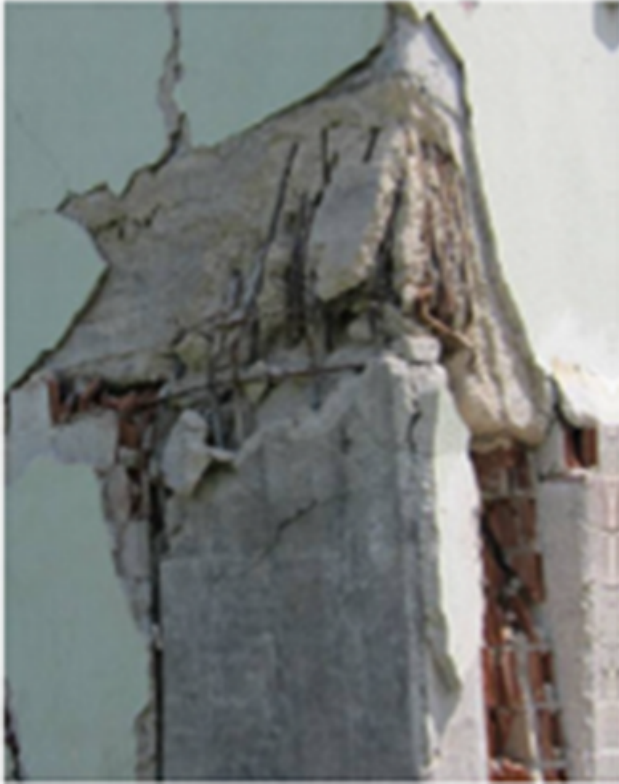
It was observed that hooks were attached to the ends of the longitudinal reinforcements in old reinforced concrete structures. In Fig. 10, a heavily damaged column element can be seen. The building, which was used as a primary school, contained many application and detailing defects. Beam lateral reinforcements were applied adjacent to the end region, and they were not integrated with concrete. Hooks were attached to the ends of the beam longitudinal reinforcements and continued at the end region, except for the lateral reinforcement. Column lateral reinforcements did not continue at the joint region of the column and beam. Moreover, the interlocking length of the column longitudinal reinforcement was inadequate. For these reasons, the reinforcements were pulled away from the joint region (Caycı, 2012).

Figure 10. A reinforced concrete structure that was heavily damaged at the joint region during the 19 May 2011 Simav earthquake (Cayci, 2012).

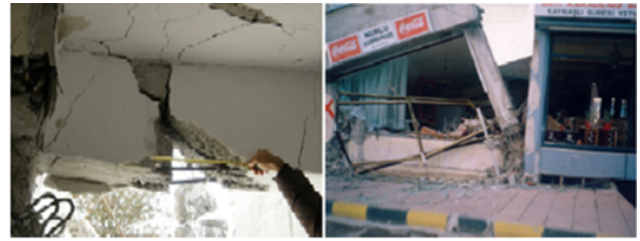
According to the earthquake code, non-deformed reinforcement steel cannot be used except for stirrup and tie reinforcements that are combined with slab reinforcement. This decision was accepted in earthquake regulations in 1998. Non-deformed construction steel was used in many of the old buildings in Turkey's structural stock that were constructed before the 1998 earthquake code. The adherence of non-deformed steel with concrete is weak. Under reversible-repeatable loads, adherence is required by reinforcements that are consistently exposed to tensile stress and compressive stress to transfer the load to the concrete. After losing adherence, reinforcement steel will be pulled away from the concrete, and the column or beam elements will be removed, especially from the column-beam joint points (Fig. 11).

Figure 11. Pulling away of longitudinal reinforcements.

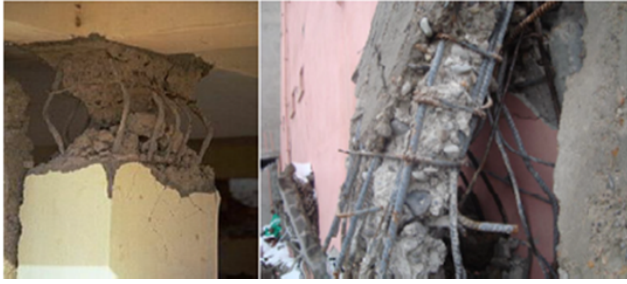
When stirrup hooks are made with a 90° angle, the reinforcement hook only bonds with the cover concrete. The cover concrete first flakes off by cracking because it is not exposed to the confinement effect under repeatable loads. In this case, the stirrup hook will easily open outwards because the core concrete confinement of the stirrup is removed. The opening of the stirrup will result in loss of the confinement effect on the concrete core, which is forced to expand outwards. Moreover, because the buckling length of the longi-

Figure 13. Damage caused by reinforcement detailing mistakes (Source: Erdal Camci).

tudinal reinforcement is increased, buckling in the reinforcements can easily occur. Element ductility and bearing capacity will decrease. In Fig. 13, various examples are given for the opening of stirrups and the buckling of longitudinal reinforcements.

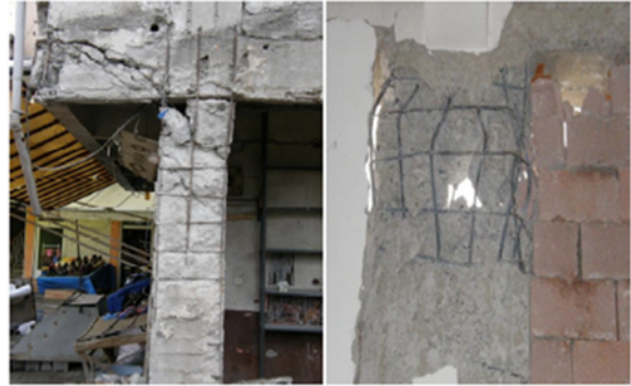
Figure 14. Damage caused by excess stirrup intervals in the confinement zones of columns (Onen et al., 2011).

In the TEC 2007, although confinement zones are defined at the end points of columns and beams and it was determined that the stirrup frequency in the confinement zones should not be less than 10 cm, it was observed that such confinement zones were not formed in reinforced concrete elements damaged in the Van earthquake (Fig. 13). It was observed that the stirrup frequency at the end zones of the columns and beams was approximately 20–30 cm. Plastic hinges are formed at the column ends due to strong-beam-weak-column formation under reversible loads. Because of the infrequent stirrups under excess spinning caused by the ductility request and because hooks with 90° adequate ductility were not obtained, correspondingly heavy damage was observed in many of the buildings. Inadequate concrete quality also contributed to these failures. In Fig. 14, examples of column damage and stirrup frequency are given.

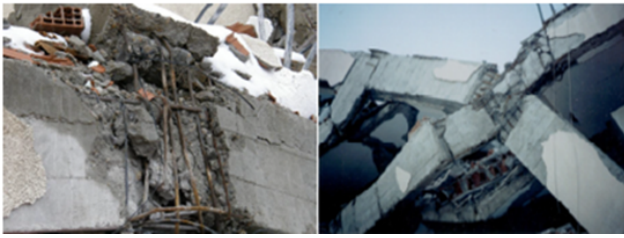
Figure 16. Damage to column-beam joint region (Onen et al., 2011).

Examples of damage in column-beam joint regions are given in Fig. 16.

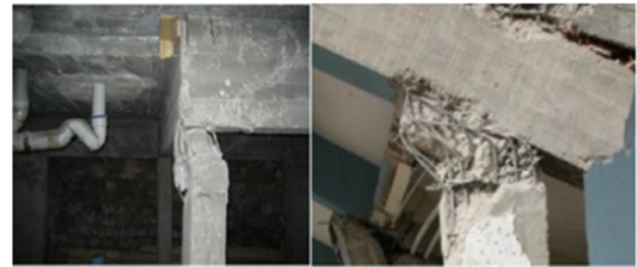
Figure 18. Examples of strong-beam-weak-column damage.

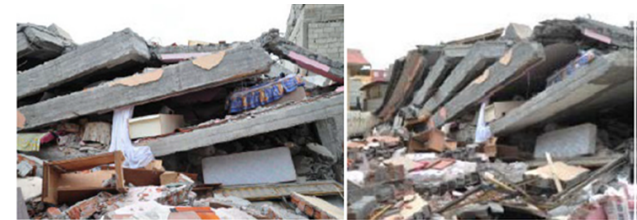
Figure 19. Full collapse of a building as a result of plastic hinges in the bottom and top zones of columns in a reinforced concrete structure in Van-Ercis (Onen et al., 2011).

Although it was stated in the earthquake code that columns should be stronger than beams and that hinging occurred in columns investigated after earthquakes, it was observed that the damage to beams was limited and that in some cases there was no damage. Several examples of this type of damage, which is called strong-beam–weak-column damage, are given in Fig. 18. As the damage becomes progressively worse, hinges occur in the columns, decreasing the horizontal stability and causing the building to collapse in a way that floors collapse one after another, which is called a “pancake” collapse. Pancake collapses are the most common type of collapse (Fig. 19).

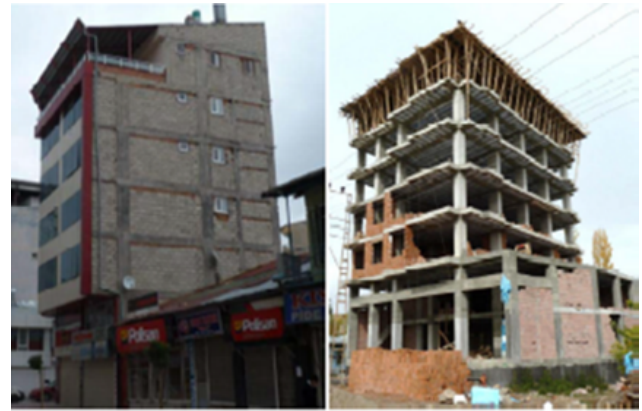
Figure 20. Buildings that do not have adequate shear walls.

Buildings must have adequate shear walls in both directions in order to have adequate lateral rigidity. However, the construction of shear walls is not sufficient to rehabilitate old buildings. The building shown in Fig. 20 was constructed near Van Lake.

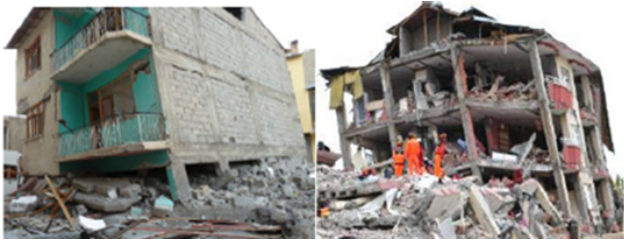
Figure 21 shows examples of earthquake damage and collapse observed in reinforced concrete buildings with insufficient lateral rigidity.

Figure 21. Damage observed in buildings with insufficient lateral rigidity.

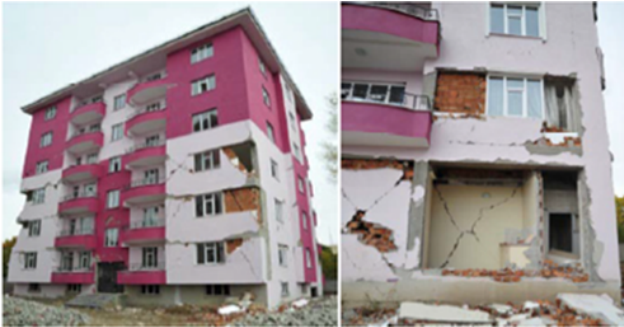
Figure 22 shows examples of damage in non-bearing brick-infilled walls as a result of excess translation of buildings.

Figure 22. Damage observed in non-bearing brick-infilled walls.

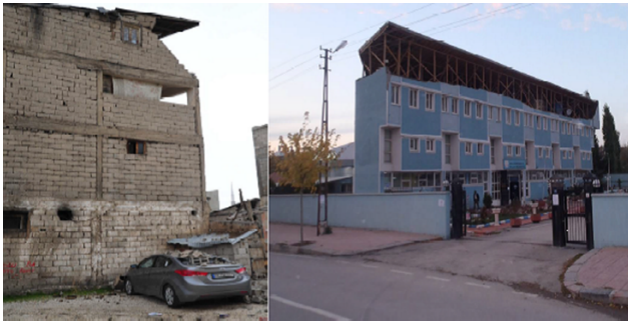
Walls with upper sides that are clear and supported at the bottom, such as vertical corbels or garden walls, frequently collapse under horizontal loads because the gable walls are not combined with overhead beams in garrets. The collapse of these walls does not pose a problem in terms of the veering of the building. However, the collapse of these walls on the street or in other buildings might put people in danger. Figure 23 shows examples of gable wall damage.

Figure 23. Gable wall damage (www.dramaistanbul.com.tr).

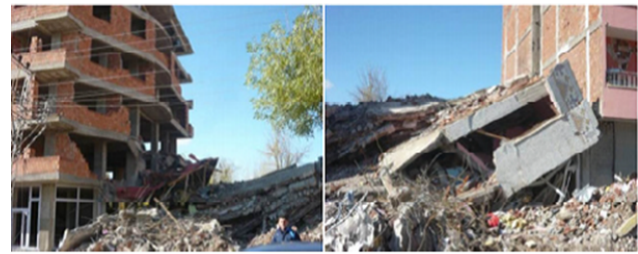
Figure 25 shows examples of the types of damage that occur when there is not an adequate earthquake joint between attached buildings.

Figure 25. Reinforced concrete multi-story building that collapsed by colliding with adjacent buildings due to a hammering effect (Inel et al., 2011).

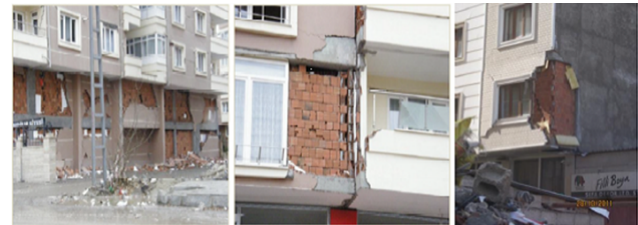
Figure 26. Damage in the outer walls of a reinforced concrete building in Van city due to separations in the walls (Cagatay I.H., 2007).

In two-row brick walls that are not connected to each other mechanically throughout the wall gaps, diagonal cracks and large out-of-plane motions have been observed. For this reason, there have been many cases of buildings with no damage in load-bearing components but with severe loss of life and property due to wall damage (Fig. 26) (Celebi et al., 2011).

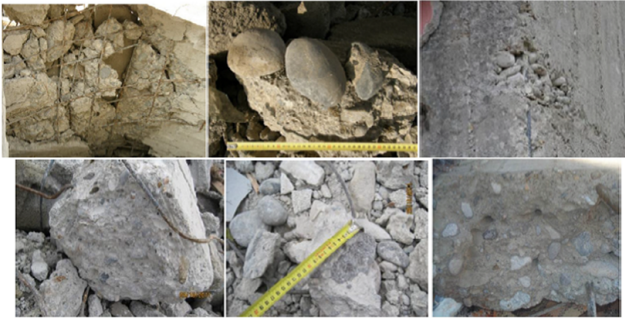
In the concrete that is generally used for construction, segregations and reinforcement placement defects are observed. Such defects were observed in all investigated buildings (Fig. 27).

Figure 27. Concrete and aggregate samples in a single-story reinforced concrete building that collapsed in the Van organized industrial site (20) and a concrete cross section displayed in the wreckage (Kizilkanat et al., 2011).
