Gschlifgraben / Traunstein Mt.

(Ivo Baroň, Robert Supper, Edmund Winkler, David Ottowitz, Klaus Motschka, Srri Seren, Wolfgang Gasperl, Günter Moser, Katharina Heibl)

Type of the slope failure: complicated complex of earthflows, rotational and translational slides, rockfalls, topples and Deep-Seated Gravitational Slope Deformations at different activity stages

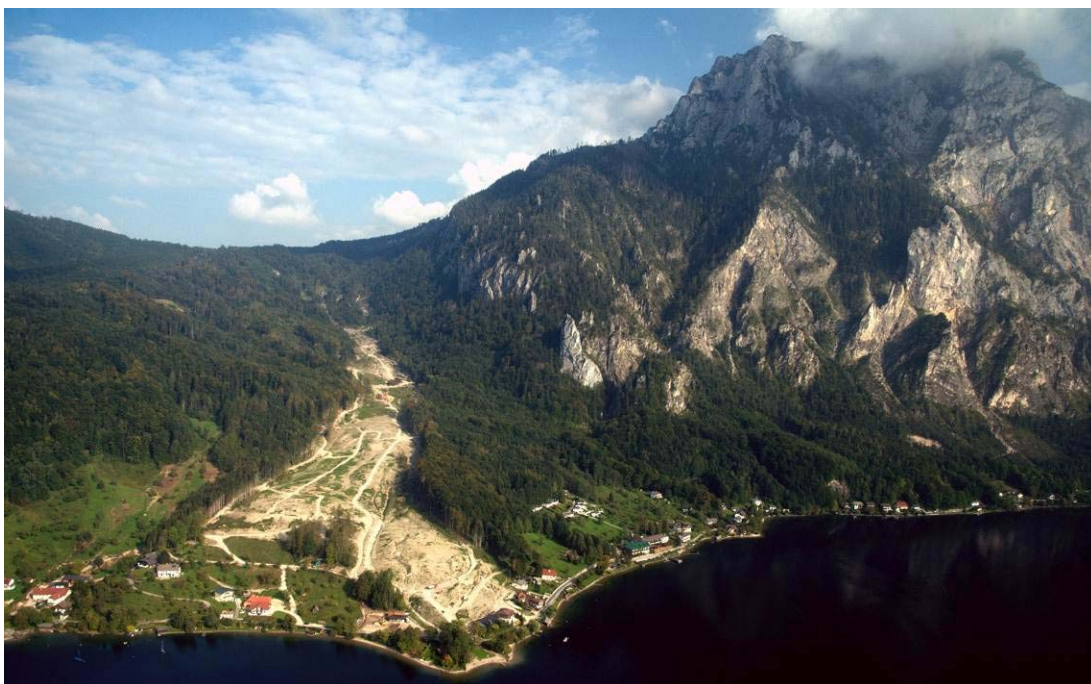
Figure 1. Aerial photo of the Gschlifgraben Valley and Traunstein Mt. from W (Photo by: R. Supper, 2009)

The Gschlifgraben is a 2.85 km long and 0.85 km wide valley along the foot of the Northern Calcareous Alps (Fig. 1) south of the town of Gmunden. The front of the Northern Calcareous Alps forms here a steep cuesta with the summit of Mt. Traunstein (1,691 m a.s.l.). The valley is divided into small sub-parallel catchments; its topography is controlled by complicated tectonics and a very complex lithology, as well as by mass wasting that has been active here at least since the end of the last glacial period.

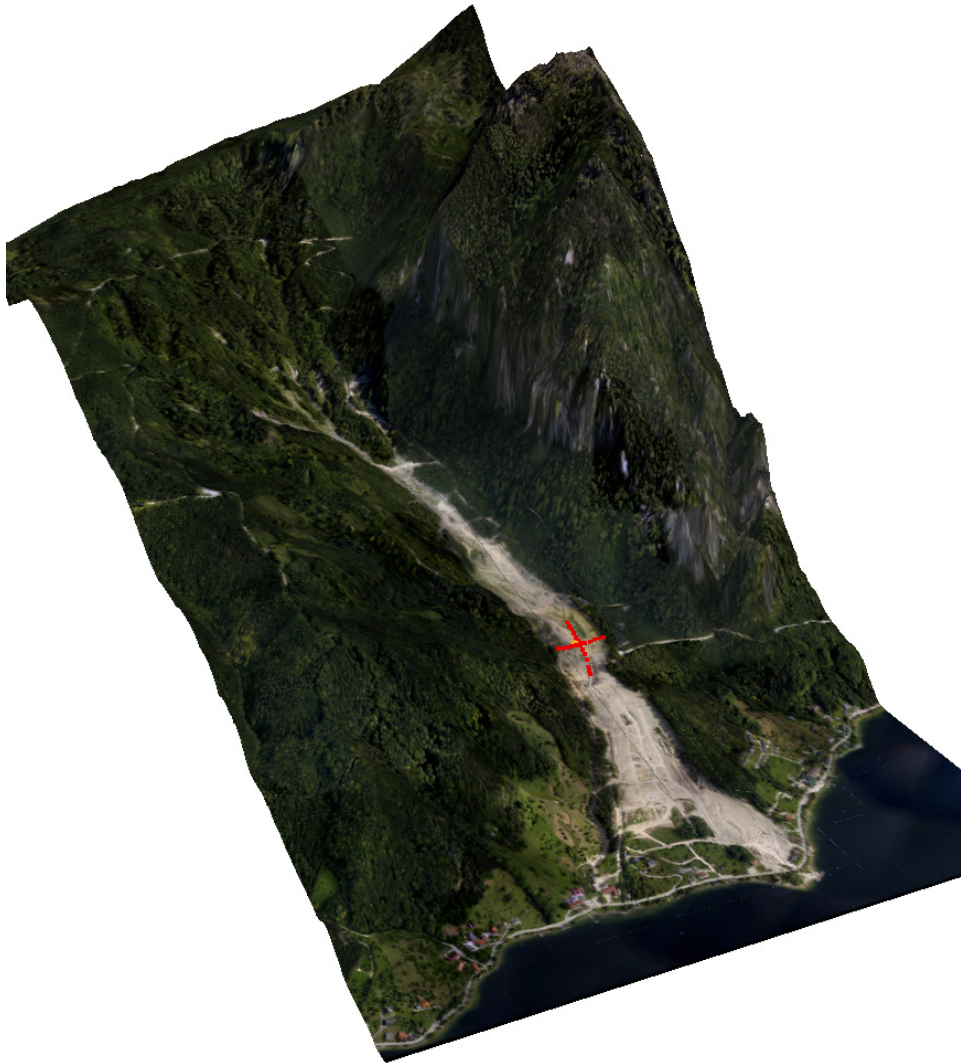
Figure 16. Location map showing the position of the geoelectric monitoring profiles (red lines) on the landslide of Gschlifgraben

As a part of the early warning approach at the Gschlifgraben test site, a geoelectric monitoring system of the type Geomon^{4D} was installed in the upper central part of the active earthflow of Gschlifgraben in September 2009 (Fig. 16).
