Oselitzenbach Torrent – Reppwand Landslide

(Michael Lotter)

Coordinates: UTM WGS8433N: 369000 E 5159900 N
Site, county: Tröpolach-Nassfeld/ Gail Valley/ Carnic Alps, Carinthia
Type of the slope failure: complex; predominantly rock slide – debris slide, deep-seated creep (“valley closure”/“Talzus Schub”)
Other specifications: highly active toe zone (scarps, ridges, cracks) with different slope failure scenarios; very low to not active upper parts of the landslide; remedial measures to prevent undercutting by the torrent
Specific area: slope between Reppwand (main scarp) and Oselitzenbach (toe), 1700-760 m asl
Volume: different estimations acc. to different geotechnical models; maybe around 150 Mio. m³
Age: Lateglacial to Holocene, possibly older than the last glacial maximum

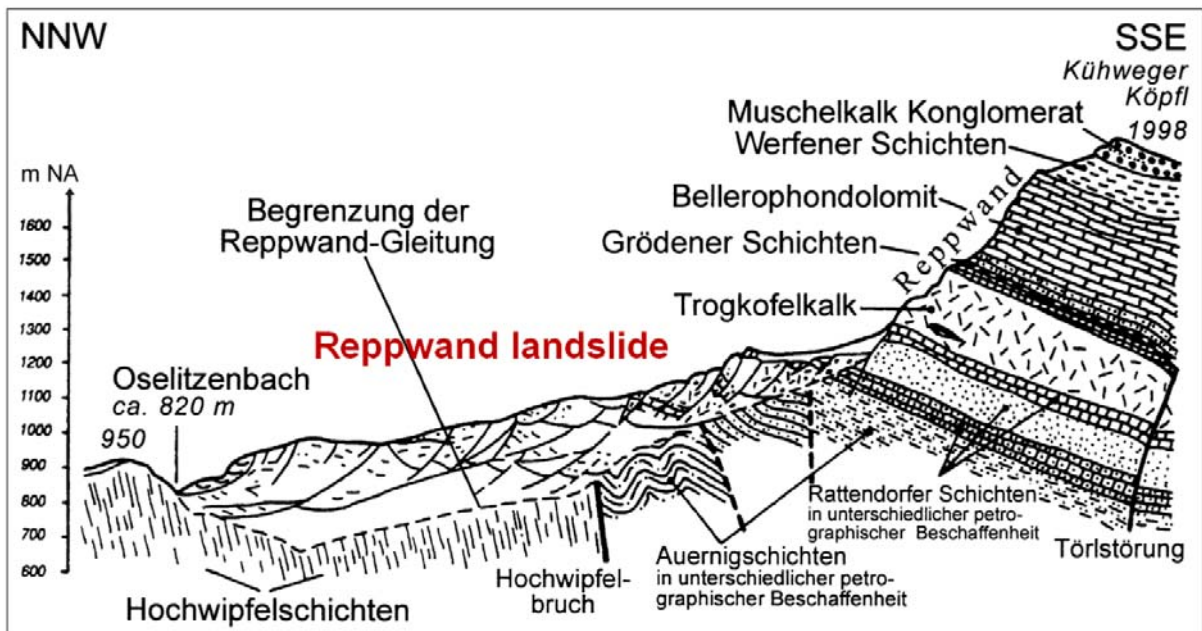
Figure 3. Geological cross section Oselitzenbach – Reppwand – Kühweger Köpfl, which illustrates the probable extent of the Reppwand landslide (WEDNER, 2000, mod. after KAHLER & PREY, 1963).

Our second stop is located at the natural monument of Lake Bodensee (Fig. 11; location 2 in Fig. 1). From the toe to this medium level of the landslide gradual decreasing displacements have been detected. Significant scarps, particularly downward the slopes, are observed in the area (Fig. 12). Possible causes of the existence of the lake itself (and a former smaller lake to the East) in this part of the landslide will be discussed in the field (e.g. crop-out of springs because of near-surface stable rock, and/or course of secondary shear planes, and/or dense till material covering the landslide, etc.). As no drilling exists which penetrates the landslide to its basal surface of rupture, very different estimations of its thickness are in discussion, and there is still few knowledge of its spatial structure (Fig. 3).

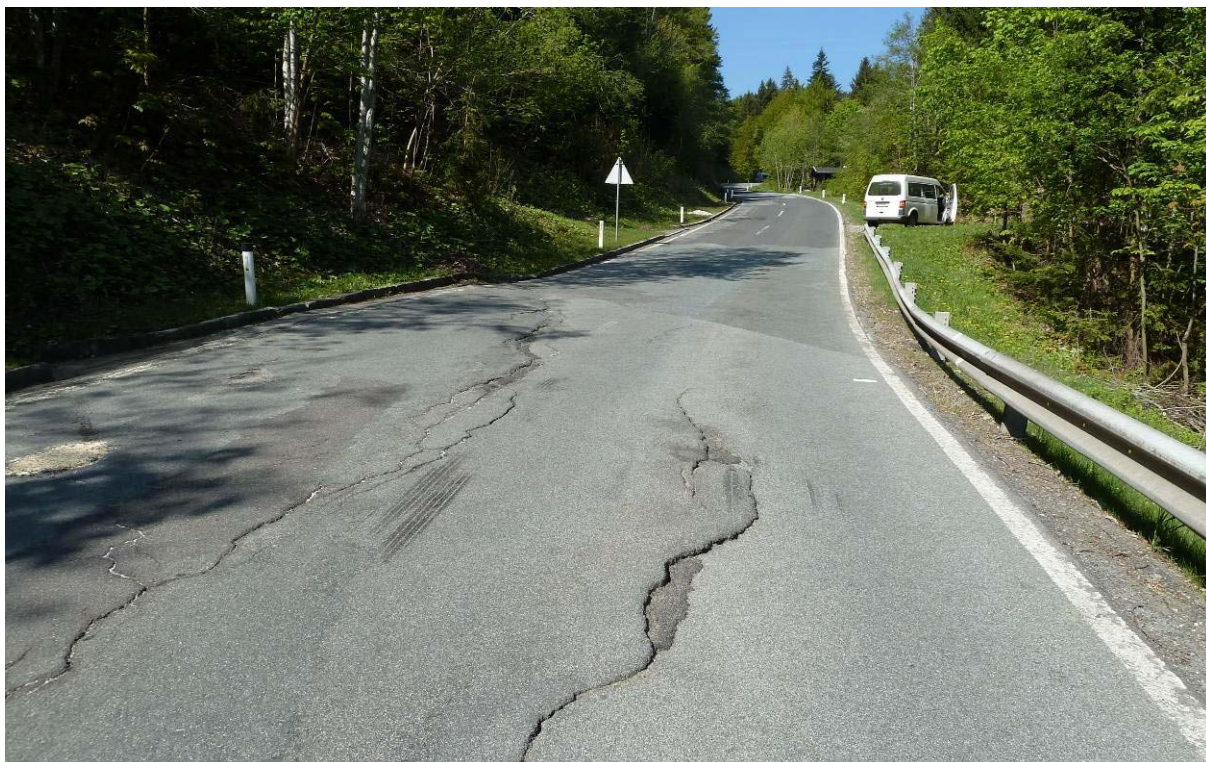
Figure 7. Damage of the Naßfeld road (May 2011) where it crosses the most kinematic active section at the toe of the Reppwand landslide. Average velocities of horizontal displacement of more than 7 cm/a have been detected between 1991 and 2006 (see also Fig. 10).

The Naßfeld road is an important touristic traffic route between Carinthia and Italy. It crosses the active toe zone of the Reppwand landslide and has been damaged or even interrupted in the past by repeated undercutting of the toe of the landslide and flooding (Fig. 1, 2, 7). Therefore, extensive remedial measures have been realised to stabilise the toe of the landslide together with the road as well as to prevent infrastructure in the nearby Gail Valley from catastrophic debris flows (Fig. 5, 6).

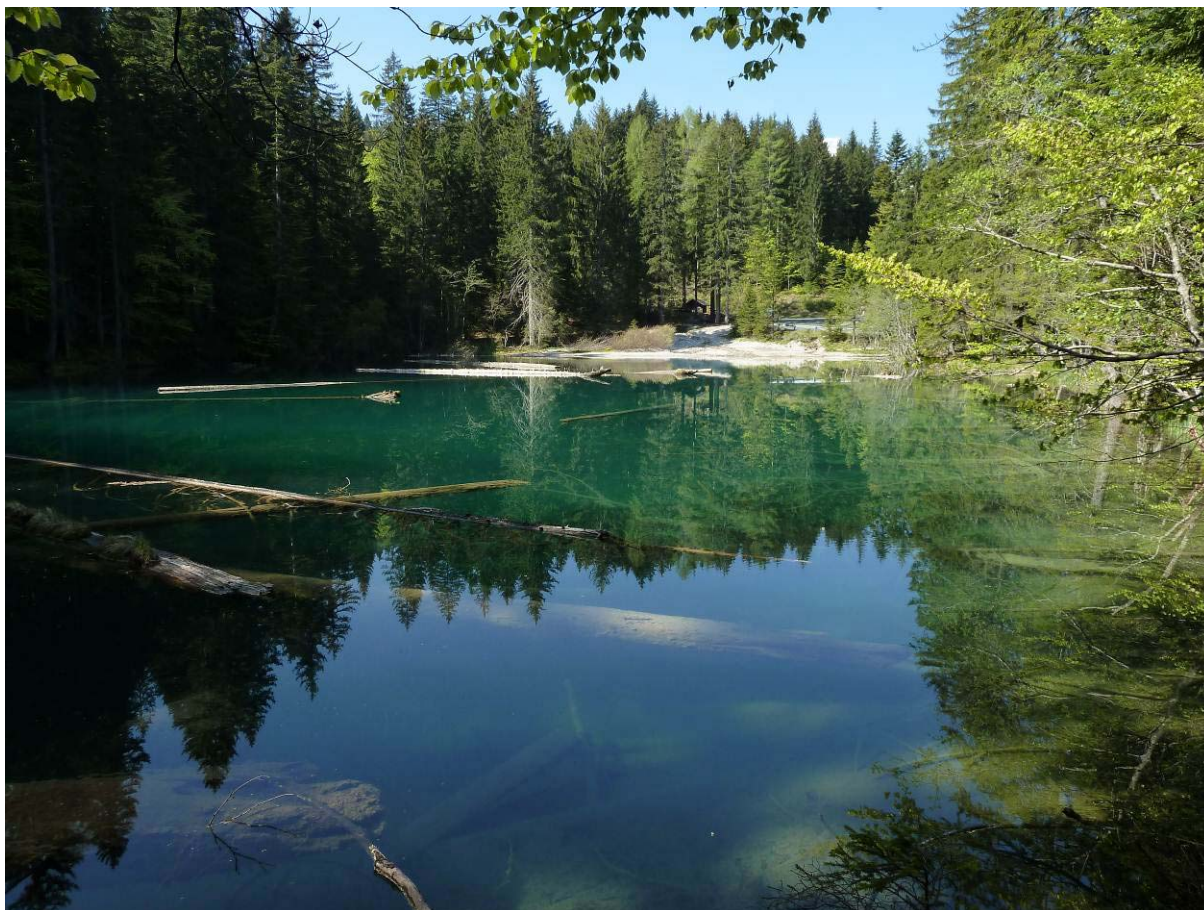
Figure 11. The natural monument of Lake Bodensee (location 2 in Fig. 1), situated in the middle part of the Reppwand landslide. From the toe up to this area recent kinematic activity is detected.

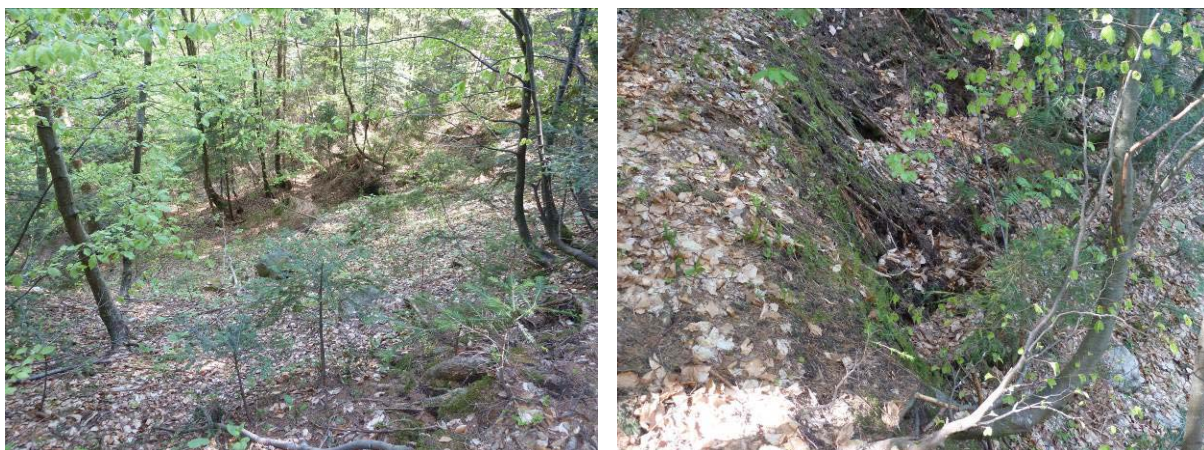
Figure 12. Signs of active slide processes in the easternmost part of the Reppwand landslide close below the level of Lake Bodensee.

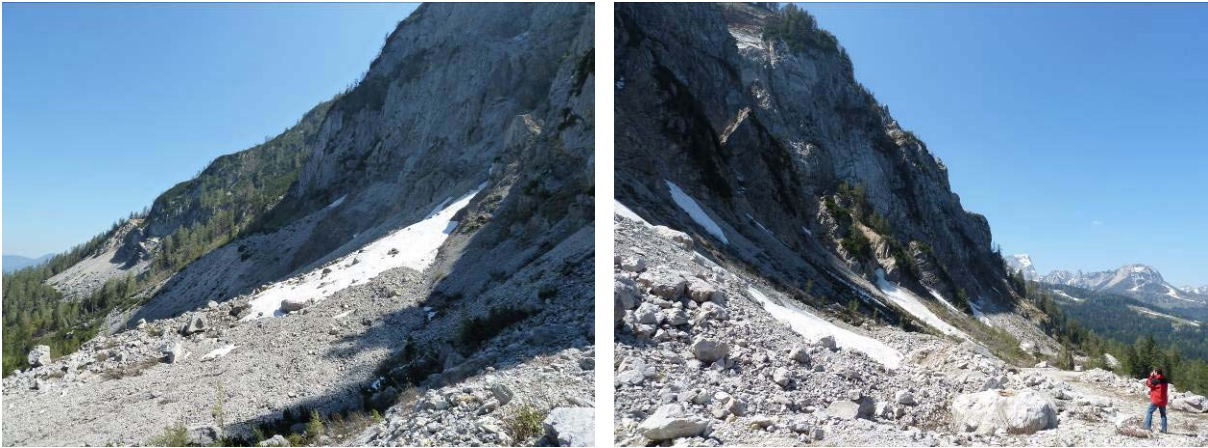
Figure 14. Foot of the rock face of Reppwand (left photo view to the East, right photo view to the West; location 3 in Fig. 1), which indicates the main scarp of the landslide. Rock fall, topple and rock spread processes are evident.

To reach the third stop, we come along a forest road upward to the foot of the rock face of the Reppwand, passing a system of deep-seated scarps, cracks and ridges, which are overlain by rock fall material in the upper parts (location 3 in Fig. 1; Fig. 13, 14, 15). Processes and phenomena of specific mass movements along the main scarp of the landslide can be observed, as described above. The Reppwand reveals an impressive South Alpine normal lithological sequence reaching from the Lower Permian Grenzland Fm. to the Middle Triassic Muschelkalk Conglomerate at the Kammlaiten site (=Kühweger Köpfl in Fig. 3; 1998 m asl.). The red beds of the Middle to Upper Permian Gröden Fm. and the Lower Triassic Werfen Fm. are striking sections of clastic influence within the rock face. The sequence is completed by the Middle to Upper Triassic Schlern Dolomite of the Gartnerkofel Mountain (2195 m asl.) to the south of the landslide area (see Fig. 2, 3, 4, 13).

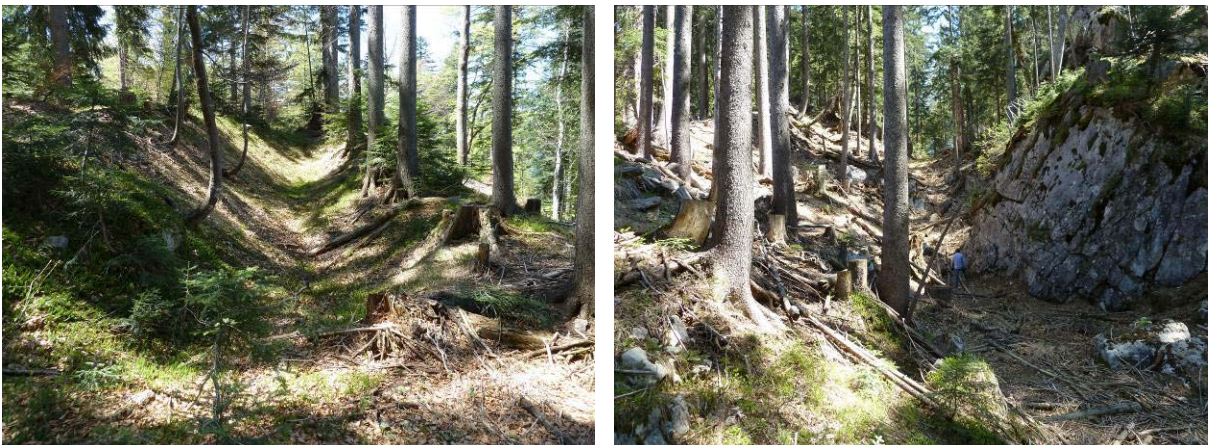
Figure 15. Signs of deep-seated gravitational slope deformation (minor scarps, transverse cracks and ridges) within the head of the Reppwand landslide.
