Mitt. naturwiss. Ver. Steiermark	Band 132	S. 43–62	Graz 2002
----------------------------------	----------	----------	-----------

The influence of landuse on the stability of slopes with examples from the European Alps

Von Andreas KELLERER-PIRKLBAUER¹
Mit 11 Abbildungen und 2 Tabellen

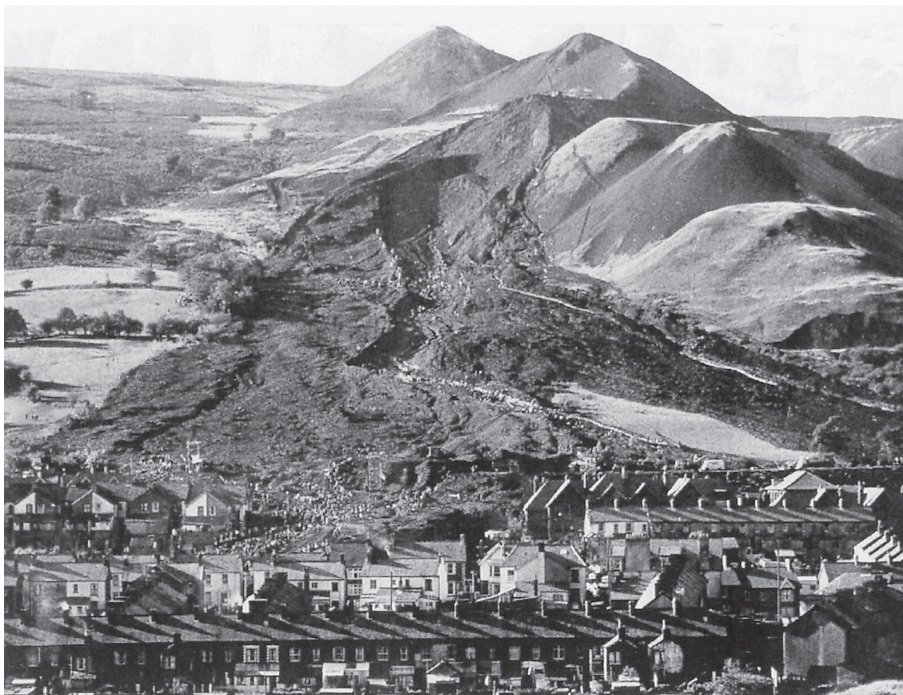
Fig. 1: Photograph to show the extent of the 1966 Aberfan landslide (JOHNES & McLEAN 1999).

Aberfan is a small town in Wales, situated in a coal mining area of the Welsh mountains. In this coal mining region, heaps of excavated debris from the coal mine were being piled on a hillside above the town. The spoil heaps or tips had been there for more than 20 years on top of the local Brithdir Sandstone, a highly porous rock layer. The sandstone contains many springs and several of the tips were placed above these springs. This had led to destabilization of some of the tips in 1944 and 1963 with the result of minor landslides. But at 9:15 a.m. on the 21st October 1966 on one of the seven artificial tips a huge slope failure occurred. About 160,000 m³ of coal mining waste slumped abruptly on the valley sides and flowed downhill at high speed. The front part of the debris became liquefied and moved as a series of viscous surges down slope. Approximately 120,000 m³ of debris were deposited on the lower slopes of the mountain and about 40,000 m³ came to rest in the urban area of Aberfan (Fig. 1). The landslide destroyed part of the town and killed 144 people (ALEXANDER 1993).

The tip consisted of mine waste debris in different grain sizes. High annual rainfalls, the disturbance of the natural drainage system, unstable slopes and the presence of fine grained so called "tailings" caused the failure in Aberfan (BOLT & al. 1975, WALTHAM

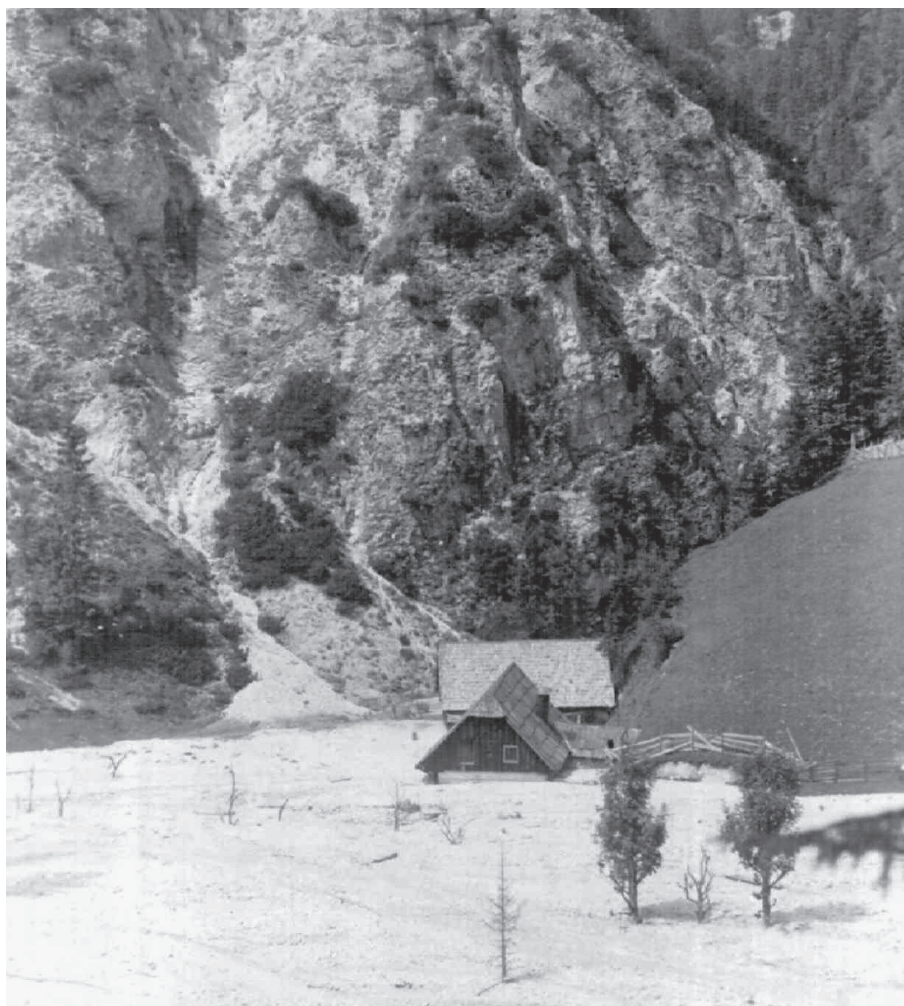
Fig. 3: Debris filled valley bottom of the Holzaepfel Valley around 1950. Note the partly buried buildings and the almost unvegetated steep slopes with debris cones in the background (by courtesy of WLV, Vienna, Austria).

Transported material from higher areas of the drainage catchment covered the agricultural land at the valley bottom with a thick layer of debris. Figure 3 shows the situation at the valley floor and the neighbouring hillside around 1950. Debris from the adjacent slopes and the side valley deposited on the valley floor, thereby destroying a farmhouse and the agricultural land around it. Clearly visible in the same figure are the almost unvegetated steep slopes behind the buildings. Today, a broad braided river is covering the whole width of the valley floor in some sections. No agricultural use of the valley floor is possible and most adjacent slopes are again covered with mature forest (Fig. 4). Yet, many slopes with till material depots, especially in the valley bottoms of small side

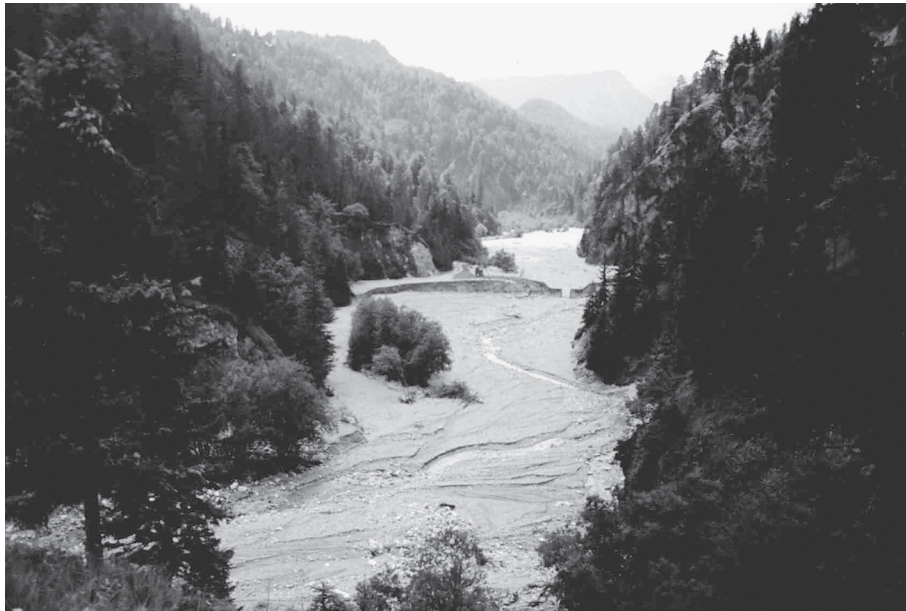
Fig. 4: The situation of the Holzaepfel Valley in 1998. The whole valley floor is covered with debris. The adjacent slopes are covered with mature mixed forest. (by courtesy of Herwig PROSKE, Joanneum Research, Graz, Austria).

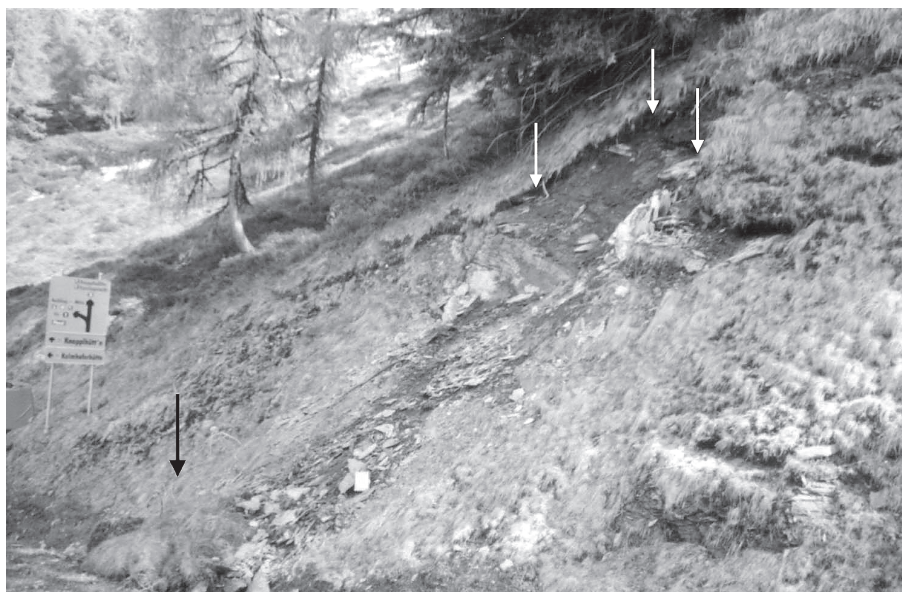
Fig. 5: A shallow translational slide on the upslope edge of a human-modified ski-run in the Hauser Kaibling ski-area. Note the ~20 cm long field book for scale in the centre. The white arrows indicate the area of release. The underlying bedrock material (schist) is visible. The black error indicates the landslide deposits (KELLERER-PIRKLBAUER 2001).

The main reason for destabilisation at the study area are changes of the natural topography due to digging off and relocating of slope material during the construction of ski-lift and ski-run infrastructure. But also the building of supply-roads for the skiing infrastructure caused slope instabilities. Further reasons for altered stress conditions on slopes are changes in the hydrological system (altered groundwater flow, higher surface runoff), in the pedological system (destruction of soil structure due to heavy machinery) and the vegetation system (destruction of forest and closed vegetation cover) (KELLERER-PIRKLBAUER 2001).

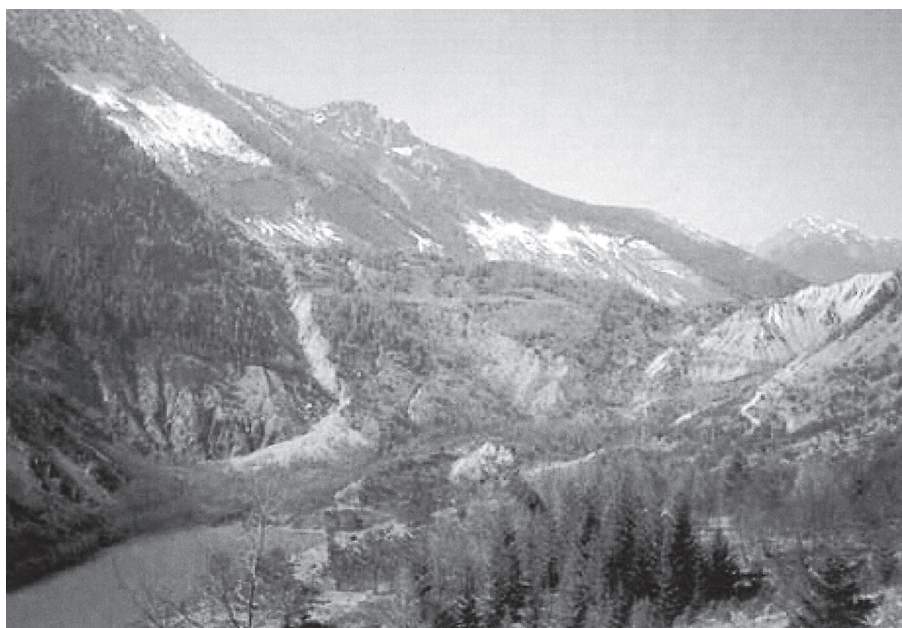
Fig. 11: The Vaiont landslide: Note the rock mass in the centre of the valley, the area of release (covered partly in snow) and the transition zone to the left and the residual lake at the left bottom corner of the photo. View of the landslide from upstream to West (BROMHEAD 2000).

Catastrophic failure: At 10:38 p.m. on October 9th, 1963 catastrophic failure of the 1.8 km long and 1.6 km wide landslide occurred. This tremendous mass on the northern slope of Monte Toc, consisting of an estimated 240 million m³ or 0,24 km³ (LONGWELL & al. 1969), slid approximately 500 m northwards at up to 30 m per sec. This movement was setting even seismic waves that were recorded throughout much of Europe.

Within about 1 minute, debris had filled the reservoir and had piled up to more than 150 m higher than the water surface. The mass completely blocked the gorge to a depth of up to 400 m (Fig. 11). At the time the reservoir contained 115 million m³ of water. Air compressed by the rapidly flowing debris, water and rock masses moved up the opposite wall of the reservoir where it destroyed the village of Casso, 260 m above the former lake level, before spilling over the dam by approximately 100 m. The water, estimated to have had a volume of about 30 million m³, then rushed down to Val Serpentine, where it almost completely destroyed the large village of Longarone (Fig. 9). The smaller rural villages of Pirago, Villanova, Rivalta and Fae were totally destroyed. In total about 2500 lives were lost. All of this occurred in about seven minutes. The disaster came too fast to allow the slightest chance of escape. Remarkably the dam remained
