ART. XXVI.—*Preliminary Report on the Messina Earthquake of December 28, 1908*; by FRANK A. PERRET, K.I.C., former Honorary Assistant at Royal Vesuvian Observatory.

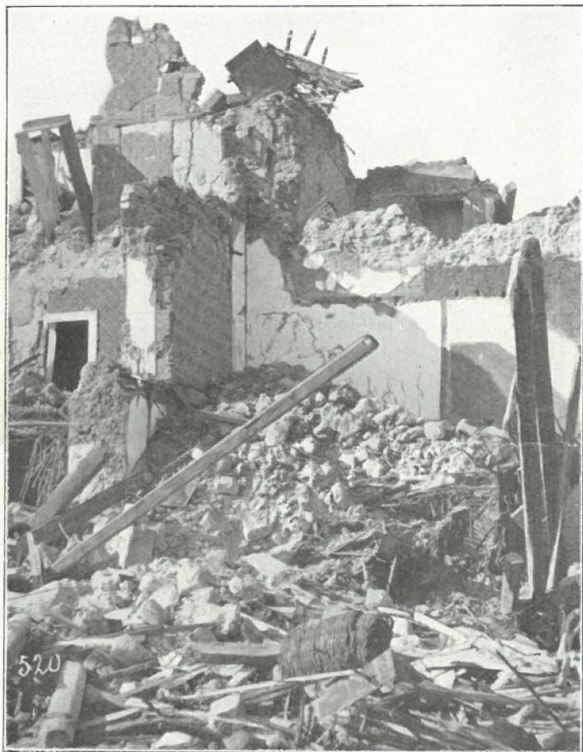
FIG. 6. Showing rubble construction.

The “rubble” construction of the buildings was apparent all along the quay, broken arches of the “Palazzata” revealing the small round stones set in mortar of poor quality (figs. 6, 7).

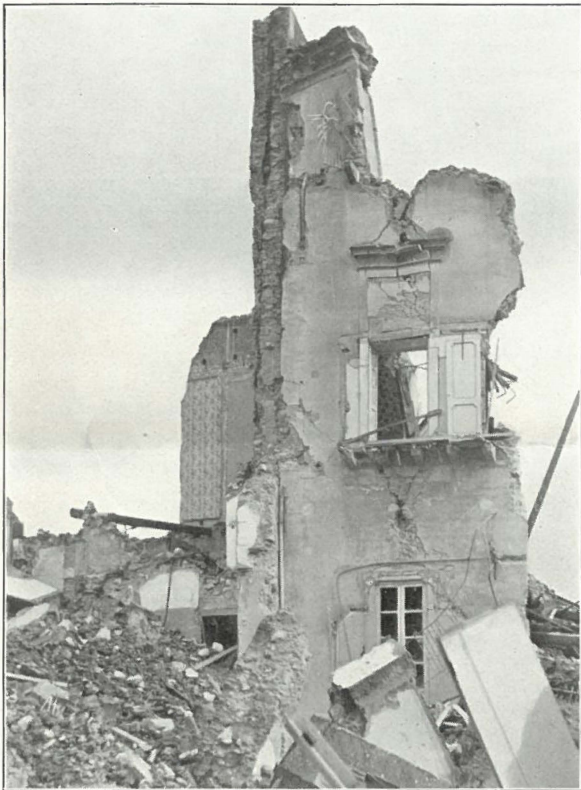
FIG. 8. Ruin of French Consulate. Walls fairly thick and well built but floors weak and house too high for this type of construction.

A conspicuous exception was seen in the building occupied by the French Consulate, the walls of which were fairly thick and built of tiling or thin brick, its chief defect being the weakness of the floors and its height of four stories (fig. 8). The relative stability of these walls was shown by a seven-foot pier glass which was not even cracked. The American Consulate building had collapsed to a compact heap of mortar and stone.

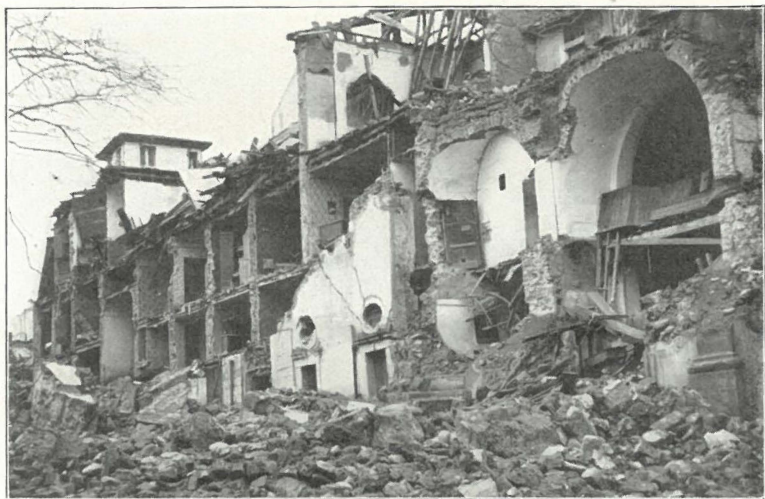
FIG. 11. Fronts fallen from houses, lying East and West.

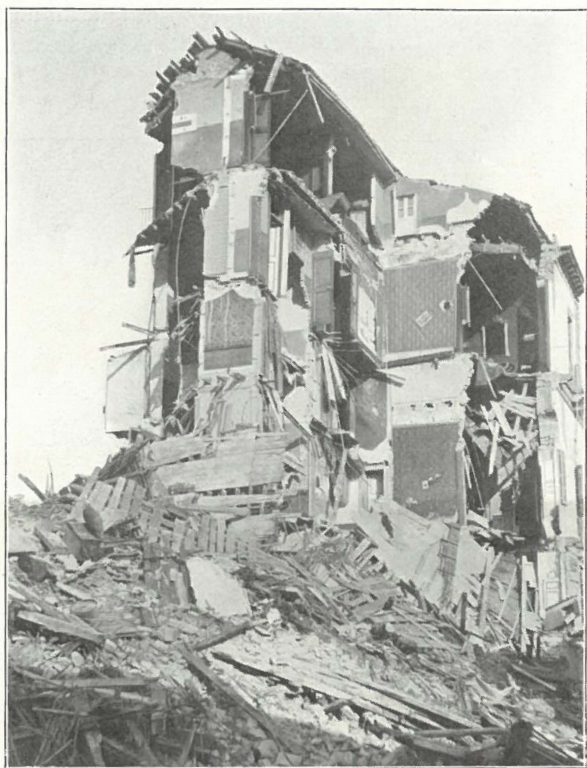
FIG. 13. Wreck of a tall, poorly constructed building.
