# Floodplain sediment from a 100-year-recurrence flood in 2005 of the Ping River in northern Thailand

**Abstract.** The tropical storm, floodwater, and the floodplain-sediment layer of a 100-year recurrence flood are examined to better understand characteristics of large monsoon floods on medium-sized rivers in northern Thailand. Storms producing large floods in northern Thailand occur early or late in the summer rainy season (May–October). These storms are associated with tropical depressions evolving from typhoons in the South China Sea that travel westward across the Indochina Peninsula. In late September, 2005, the tropical depression from Typhoon Damrey swept across northern Thailand delivering 100–200 mm/day at stations in mountainous areas. Peak flow from the 6355-km<sup>2</sup> drainage area of the Ping River upstream of the city of Chiang Mai was 867 m<sup>3</sup>s<sup>-1</sup> (river-gage of height 4.93 m) and flow greater than 600 m<sup>3</sup>s<sup>-1</sup> lasted for 2.5 days. Parts of the city of Chiang Mai and some parts of the floodplain in the intermontane Chiang Mai basin were flooded up to 1-km distant from the main channel. Suspended-sediment concentrations in

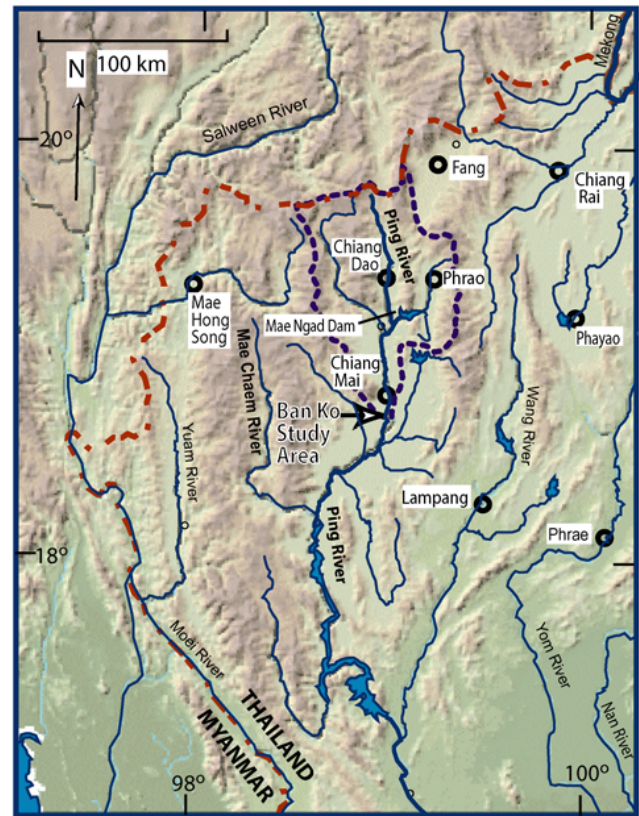
**Fig. 2.** Outline of the Ping River drainage (dotted line) upstream of the study area showing the location of the dam on the Nam Mae Ngad which regulates flow from 1/5 of the drainage. Labeled cities are those which reported major flooding 12 August–4 October 2005.

The Ping River drains a mountainous area of northern Thailand with steep hills up to elevation 1500 to 2000 m, and valleys at 330 to 500 m (Fig. 2). The Ping River basin is underlain by older Paleozoic gneissic granites, Paleozoic sediments and volcanics, Mesozoic granitic rocks, and Tertiary continental basin-fill sediments (Hess and Koch, 1979; Rhodes et al., 2005). The lowlands are underlain by alluvial fan, terrace, and floodplain deposits (Margane and Tatong, 1999). Upland areas and older terrace and fans have deep weathering profiles of saprolite one to tens of meters thick overlain by red-yellow argillic soil horizons one to several meters thick. Surface soils are dark brown loams up to 25 cm thick. Valley bottoms are mostly clayey silt with gleyed soils in the paddy areas.

The Ping River above gage P.1 has a drainage area of  $6355 \text{ km}^2$  (Fig. 2). Of this drainage area, 1/5 is regulated by the Mae Ngad Dam (active volume of 90 million  $\text{m}^3$ , total volume of 302 million  $\text{m}^3$ ), which has controlled drainage from about  $1300 \text{ km}^2$  since 1985.

The Ban Ko village study area (Fig. 2) is located in the Chiang Mai basin, 12 km downstream from the P.1 stream gage at the Nawarat Bridge in the city of Chiang Mai. No major tributaries or diversions exist between the P.1 gage and Ban Ko; therefore, this gage is a good measure of flow to the study area.

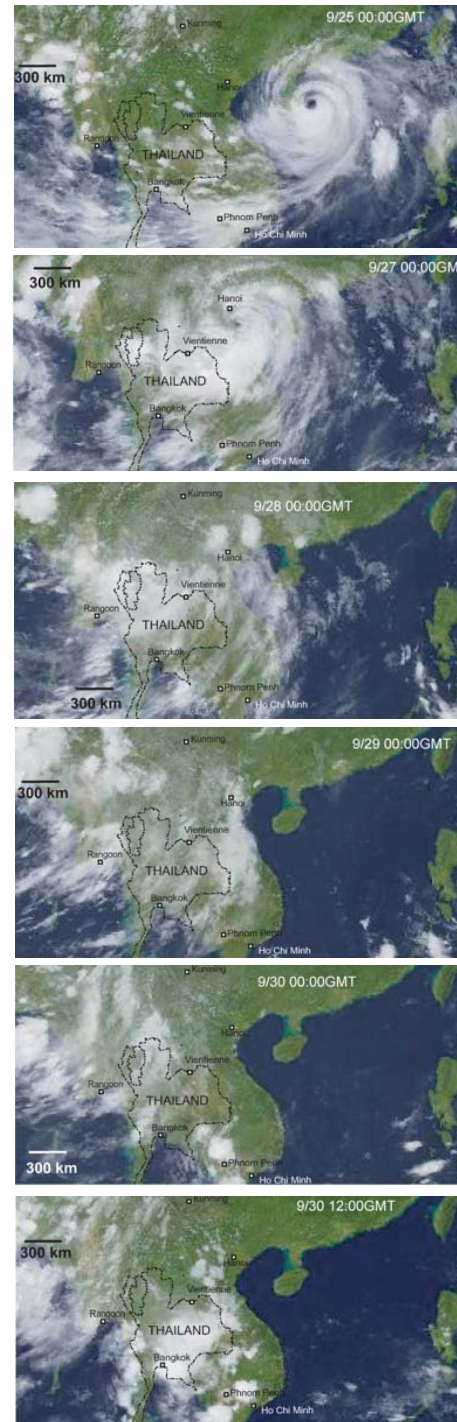
**Fig. 3.** Satellite images showing the westward traveling tropical storm from Typhoon Damrey, 25–30 September 2005. From archive of EEI-lab, Kochi University, MTSAT IR1 JMA. Thailand local time is 7 h later than GMT.

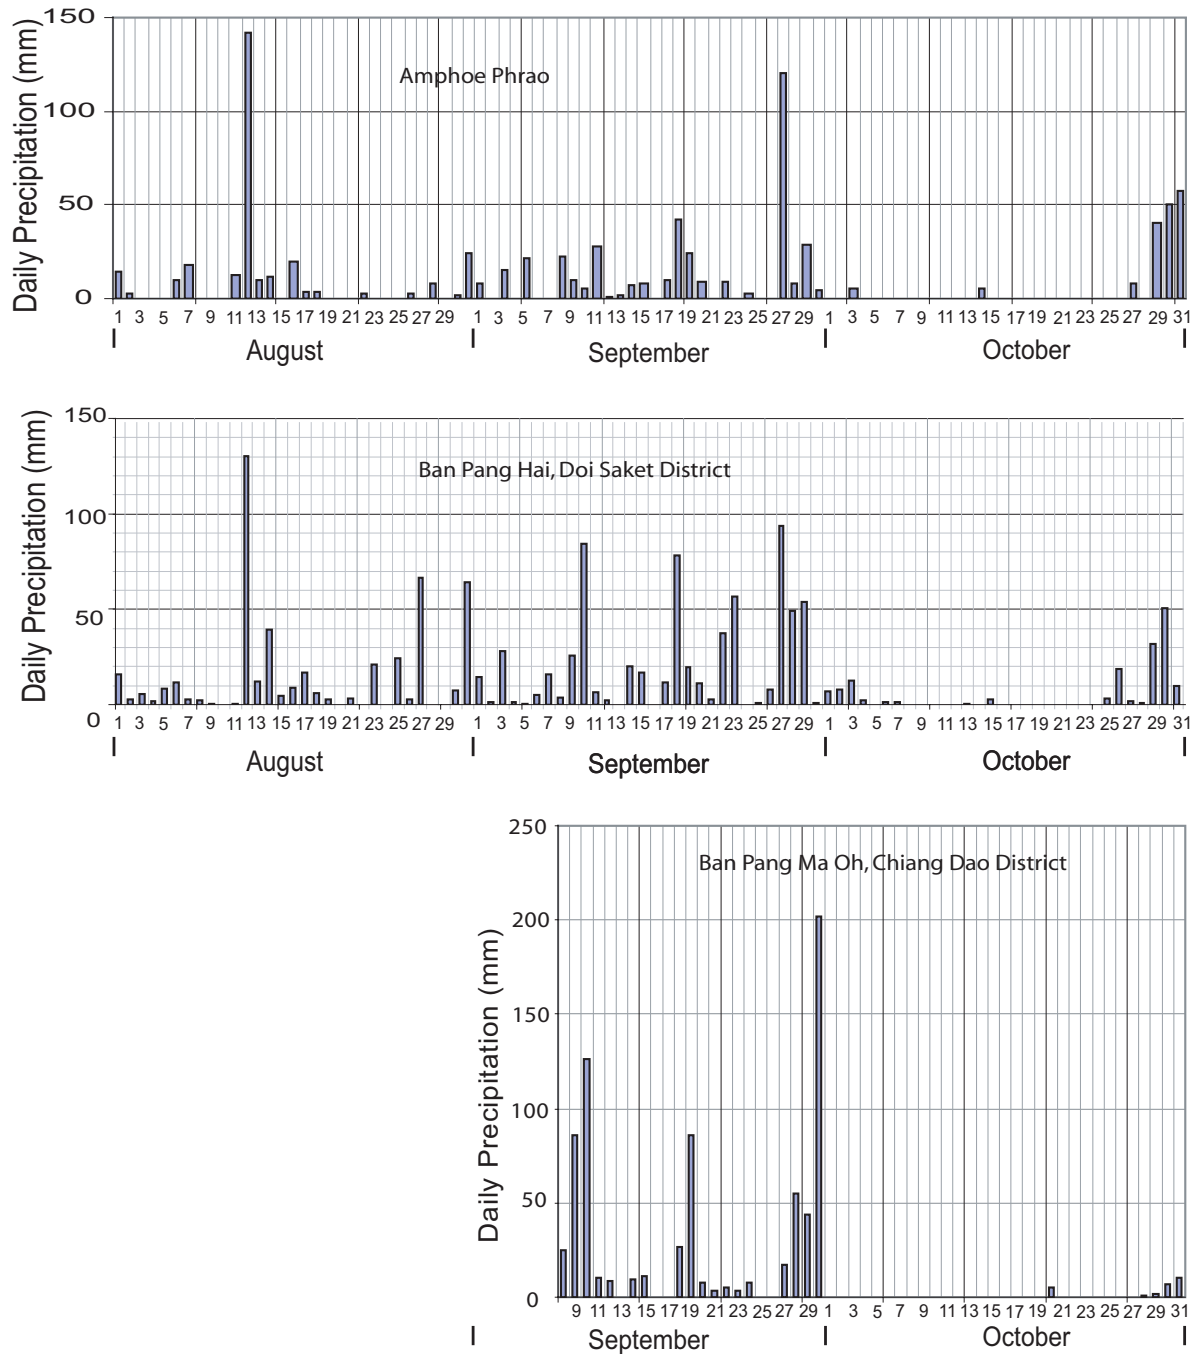
**Fig. 4.** August–October, 2005 daily precipitation at stations within the Ping River basin: Amphoe Phrao ( $19^{\circ}21.0'N$ ,  $99^{\circ}11.0'E$ , 410-m elevation); Ban Pang Hai, Doi Saket District ( $18^{\circ}57.4'N$ ,  $98^{\circ}49.1'E$ , 810-m elevation, 25 km northwest of Chiang Mai); Ban Pahng Ma Oh Watershed Research Station, Mae Na Subdistrict, Chiang Dao District ( $19^{\circ}16.3'N$ ,  $98^{\circ}54.4'E$ , 1100-m elevation, 12 km southwest of Chiang Dao, data available since 8 September 2005).

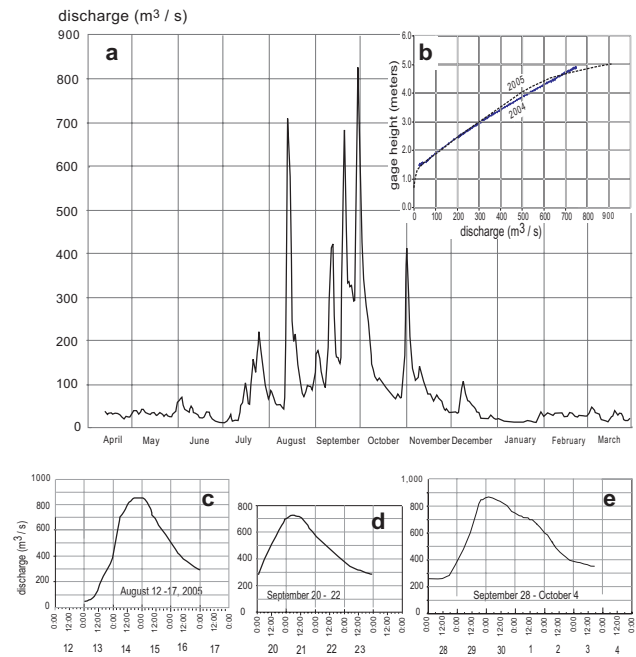
**Fig. 5.** Hydrographs of daily-mean flow readings at the P.1 gage at Narawat Bridge in Chiang Mai. (a) the mean-daily flow 2005 hydrograph, (b) Stage-flow relationship, (c) hourly flow – 12–17 August, (d) hourly flow – 20–22 September, and (e) hourly flow – 29 September–2 October, (Data from Royal Irrigation Department, Hydrology and Water Management Office).

In the first version of this paper we used flood-flow data provided by the Royal Irrigation Department based upon the 2004 stage-discharge curve for the P.1 gage (Fig. 5b). After the flood, the Royal Irrigation Department re-surveyed the channel and revised the rating curve, which significantly increased the flood flows by about  $100 \text{ m}^3 \text{ s}^{-1}$ . The revised

days when the flood exceeded  $700 \text{ m}^3 \text{ s}^{-1}$  (Fig. 5e). In other words, the water delivered during that time to the point of sedimentation was well mixed from top to bottom. 2) Alternatively, because the flood levels at P.1 gage fell from a peak of 4.9 m, to 4.66 m in that 1.8 days of maximum depth, the height of water over the platform probably declined 0.24 m, and then after 3 days fell below the level of the platform, and sedimentation on the platform ceased. The ground was still inundated with 0.8 to 0.4 m of water and sedimentation continued, thus explaining the greater sediment thickness on the ground.

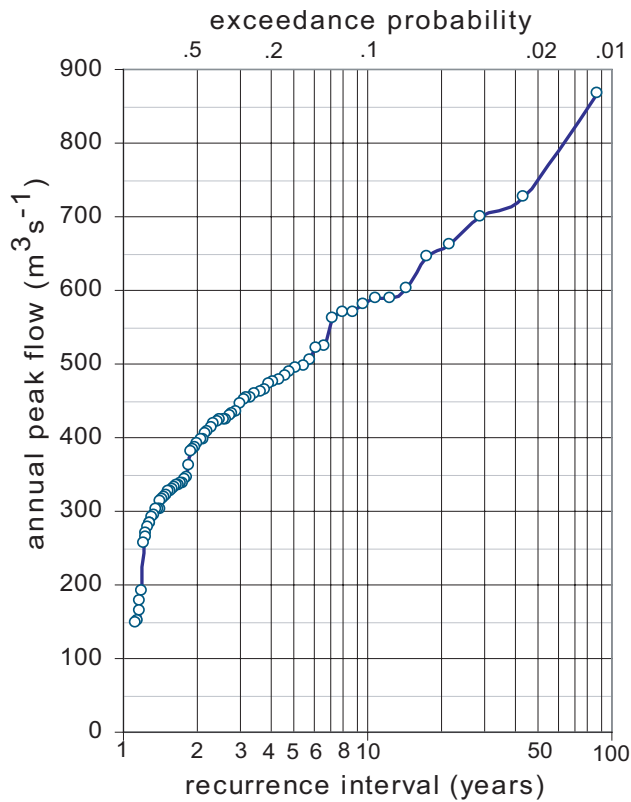
**Fig. 6.** Flood frequency graph constructed from the 1921 to 2005 record, including the record peak flood flow of  $867 \text{ m}^3/\text{s}$  of 2005. From data provided by the Hydrology and Water Management Center for the Upper Northern Region of the Royal Irrigation Department.

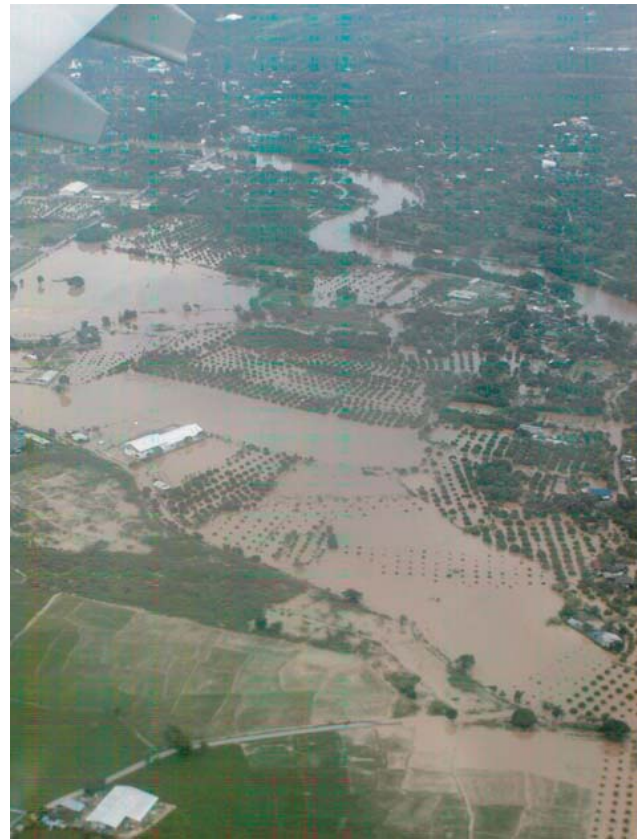
**Fig. 7.** Photo from airplane of the flooded area of the Ping River at peak flood flow 16:00, 29 September 2005. View is to the east toward the bridge at Ban Mae Kha. Tributary channel joins the river on the right (downriver) side of photo. The village of Ban Ko is along river at the right side of photo. Area of mapped sediment thickness (Fig. 11b) extends from the white building (left center of photo) to the river.

The flooded Ban Ko study area is shown in the 29 September photograph (Fig. 7). Water delivered to this area flowed over the levee on the main channel of the Ping River, as well as up a low-gradient tributary channel—and then most likely set up a weak current over the floodplain area that exited over the levees (Fig. 11). Based on water level stains (Fig. 8a) and the level survey (Fig. 9), the average depth of floodwater in the back-levee area was 1.2 m. Because the bed of the tributary channel grades to the low-water main-channel bed, the tributary channel at flood stage could accommodate flow through a cross section 5 m deep and 12 m wide. This particular tributary channel did not have a flood gate, as many channel/canals in the area do. Floodwater overtopping roads did not damage the levees; and no substantial breaches occurred, despite floodwater reaching 0.5 m over levees at some places.

Figure 7 shows that the southeast side of the river was not significantly flooded, because the levees were higher and there were no major openings in the levee. In addition, sandbags placed along the road held back some of the floodwater.

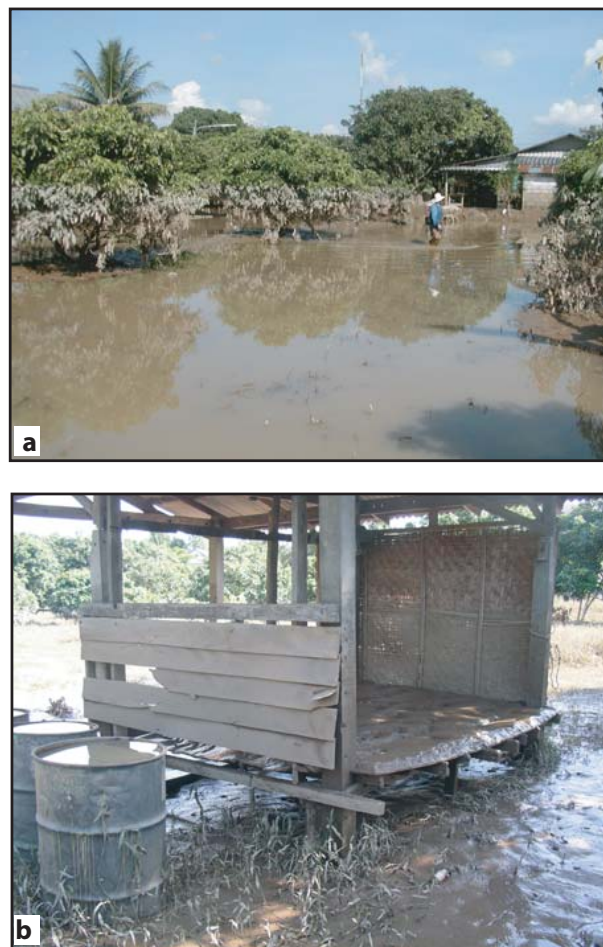
**Fig. 8.** (a) High water line on fruit trees. Floodwater depth was 1.3 m. Location is at point B of Fig. 11. View is to the southeast. (b) hut located at point H1 on Fig. 11. Five cm of sediment deposited on platform elevated 0.55 m above ground and 8 cm of sediment on surrounding ground (see Fig. 12). Photos taken on 2 October.

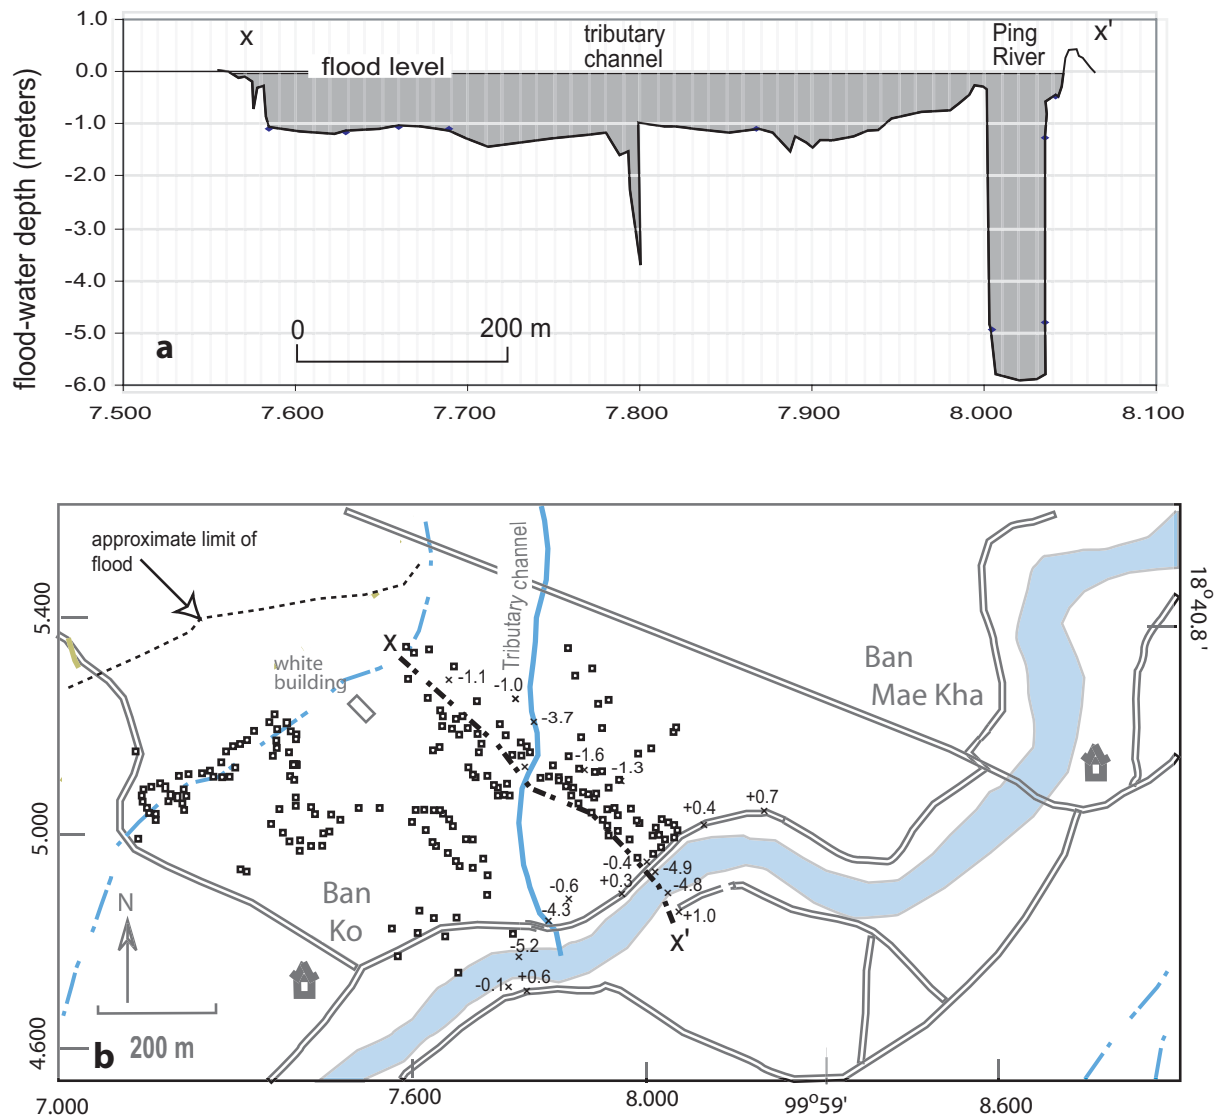
**Fig. 9.** (a) Elevation profile along line x-x' showing maximum flood level in area of sediment thickness survey. (b) Map of surveyed ground elevations below maximum flood level and locations of sediment-thickness measurements.

Department using a US D-49 depth-integrating sampler. Sediment-thickness measurements were made on 2 October, and also on 7 October to cover those areas that were under deep water on 2 October. Our method was to slog through the wet mud-mantled fruit orchards and rice fields and measure soft mud thickness with a millimeter ruler at more than 200 locations over a 0.324-km<sup>2</sup> area (Fig. 8a). Map locations were determined with hand-held GPS units to a  $\pm 7$  m precision. Where thickness was questionable, the light-brown mud was scraped away to the darker, firmer, gray mud assumed to be the August flood deposit. Sediment thickness was also measured on floors of four elevated bamboo shade huts, where farmers rest in the heat of the day (Fig. 8b). Sediment from the upper part of the water column had settled on these elevated platforms; and therefore, provided information to compare with the sediment thickness on the surrounding ground that received sedimentation from the full water column. We determined the wet density and water content of 6 samples (representative of the slight differences in sediment types over the area) taken at the same time as the thickness measurements. These determinations are used to convert measured thicknesses to equivalent dry sediment. Grain-size analyses were made on the same samples using the sieve and hydrometer method. In the discussions that follow, the names of sediment are based on visual observation at the time of measurement, and confirmed or corrected by later grain-size analyses. In late November, 2 months after the flood, pits were dug and the sedimentary layer was photographed. In March, 2006 an elevation profile (accuracy  $\pm 0.05$  m) was surveyed using a laser level to better understand the pattern of flooding. (Fig. 9).

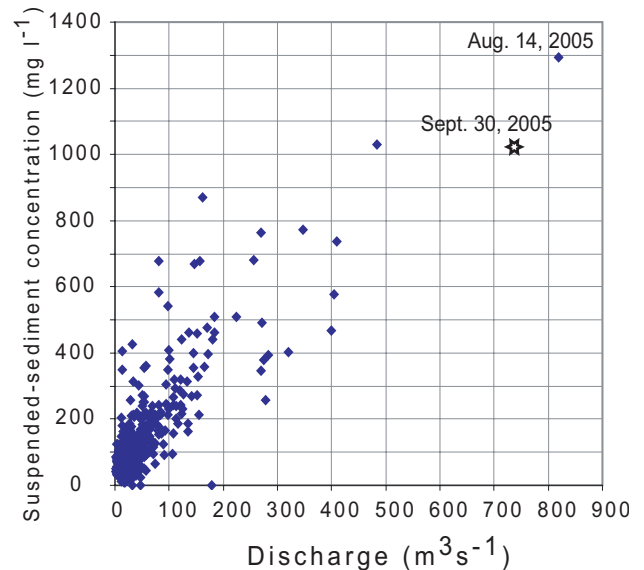
**Fig. 10.** Suspended-sediment rating data for the Ping River at the Chiang Mai P.1 gage site from Royal Irrigation Department for 1991–August, 2005. Samples obtained monthly and bimonthly using a US D-49 depth-integrating sampler. Shown on the graph are the high values of the one near-surface sample taken on 30 September, and also the one depth-integrated sample taken by the Department during the August 14 flood.

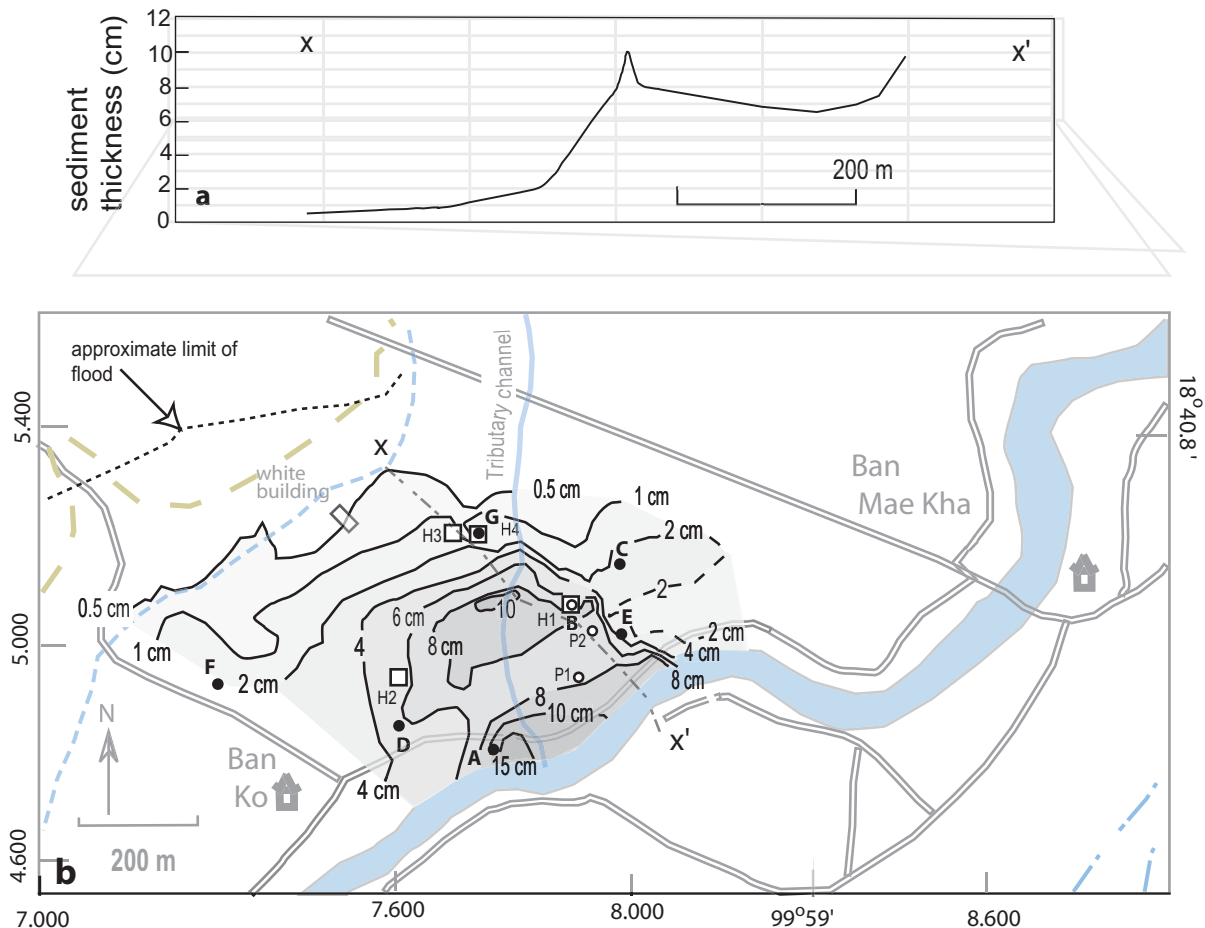
**Fig. 11.** (a) Profile of wet sediment thickness along line x-x'. b: Isopach map of wet-sediment thickness deposited on floodplain and levee during the 29 September–2 October flood. Points A–G are locations of samples for which grain size analyses are shown in Fig. 14. Points H1–H4 are locations where thicknesses were measured on elevated platforms as well as on the surrounding ground (data shown in Fig. 12). Line x-x' is the line of profiled thickness in Fig. 11a and profiled elevation in Fig. 9b. Photos of sediment are shown in Fig. 13 at locations A, B, P1, and P2.

Greatest thickness in the Ban Ko study area was 15 cm of silty-fine-sand sediment along the levee on the north side of the Ping River (Site A, Fig. 11). A pocket of thick sediment was located near the tributary channel. Sediment thicker than 8 cm covered 16 % of the study area, and extended no more than 250 m from the main channel. Sediment thicker than 4 cm covered 44% of the area and extended no more than 350 m from the main channel. At a distance of 450 m from main channel, sediment thickness diminished to 0.5 cm (Fig. 11). Thickness averaged over the 0.324-km<sup>2</sup> area is 3.3 cm; this equates to a wet sediment volume of 10 700 m<sup>3</sup>.

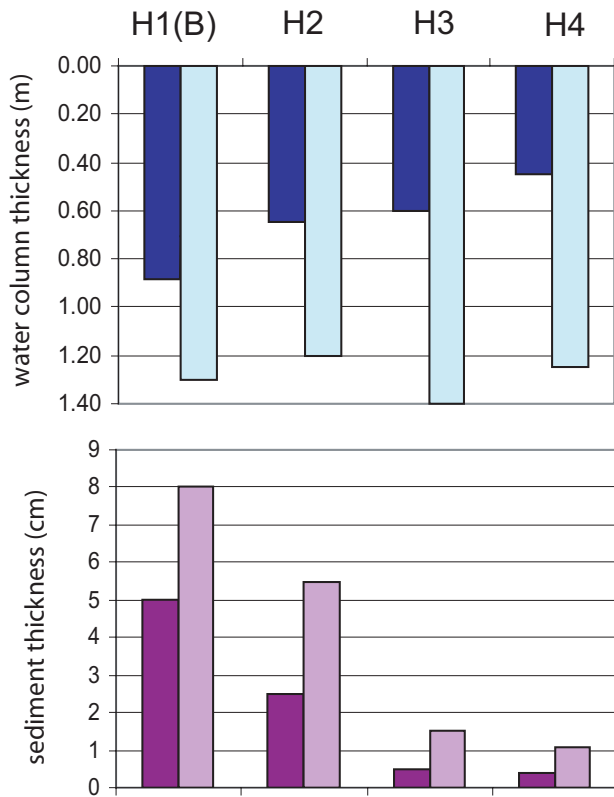
**Fig. 12.** Upper graph shows thickness of the column of water over elevated platforms (dark pattern) compared to the total depth of water at the site (pale pattern). Sediment thickness deposited on elevated platforms (dark pattern) compared to thickness on the surrounding ground (pale pattern) (Photo of typical hut platform shown in Fig. 8b). Locations of H1(B), H2, H3, H4 shown in Fig. 11.

Sediment thicknesses were measured on elevated platforms of 4 huts (Fig. 12). Thicknesses on the platforms are an accurate measure of suspended sediment that settled from the upper part of the water column. The bamboo slats on

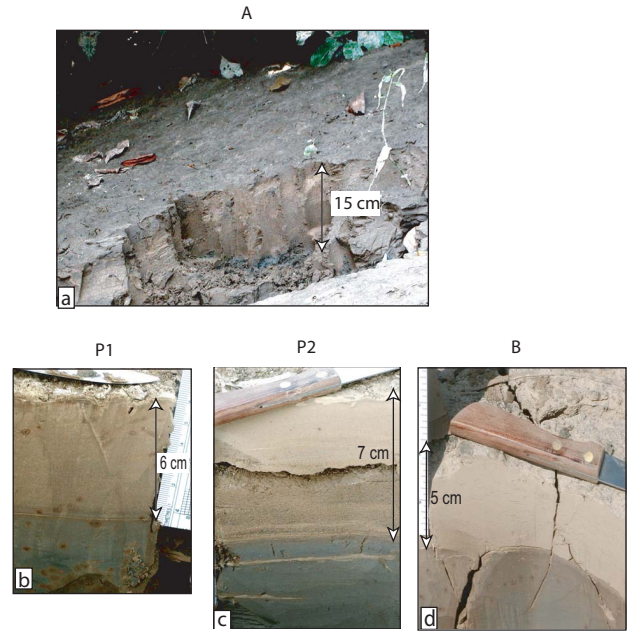
**Fig. 13.** Photographs of 29 September–2 October sediment at locations A, P1, P2, and B, shown in Fig. 11. (a) River-channel-facing levee deposit on a 20-degree slope at site A. Deposit is 15 cm of brown silty fine sand (grain-size analysis shown in Fig. 14). October 7 photo. (b) Brown, massive, clayey coarse silt overlying grey clay of the August flood at point, P1, 100 m from river channel. The 6-cm-thick layer shows slight upward fining, and has developed several tiny rust-stained burrows of macro-organisms when photographed 2 months after deposition. December 4 photo. (c) Sediment shows a basal 3.5-cm layer of brown clayey coarse silt overlain by 3.5 cm of pale brown clayey silt that has dried and parted from the layer below. The underlying gray August sediment has light-brown silty streaks. 4 December photo at point P2, 160 m from river channel. (d) Massive 5-cm layer of brown clayey silt at site B, 200 meters from the river channel (Grain-size analysis shown in Fig. 14). 4 December photo.

Sediment at point P.1 is composed of basal coarse silt with slight upward fining, 6 cm thick (Fig. 13b). The textural difference through the layer, deposited 100 m from the channel, is subtle but it may be detectable as a separate depositional layer in a section of floodplain sediment.

Sediment at Point P2 shows two distinct layers emphasized by drying, shrinking, and parting of the upper layer of clayey fine silt from the lower layer of faintly laminated coarse-medium silt (Fig. 13c). Point P2 is 160 m from the channel edge. This 7-cm thick layer is so conspicuously layered, it would likely be preserved within floodplain strata.

Sediment at Point B, 200 m from the channel edge, is 5 cm of massive clayey silt similar to the upper layer at Point P2 (Fig. 13d). Grain-size analysis shows this sediment to be 28 percent clay (Fig. 14). More distal sediments were massive clayey silt for which grain-size analyses show similar clay content, but finer silt size (Fig. 14).

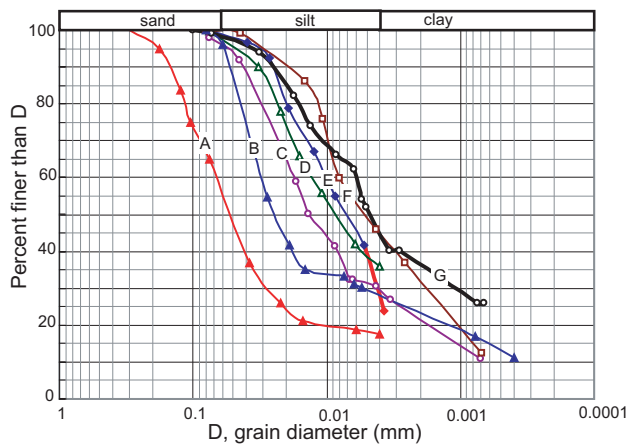
**Fig. 14.** Sediment grain-size analyses for sample locations shown by points A, B, C, D, G, and F in Fig. 11. Analyses by standard hydrometer and wet-sieving methods.

Although the sample from point E was only 90 m from the channel edge, it had a fine grain size (Fig. 14) similar to the more distal sediment. Probably irregularities in the floodplain topography isolated this site from moving flood water, so that it received only deposition from slowly moving floodwater.
