An experimental investigation for external RC shear wall applications

M. Y. Kaltakci, M. Ozturk, and M. H. Arslan

Civil Engineering Department, Selcuk University, Konya, Turkey

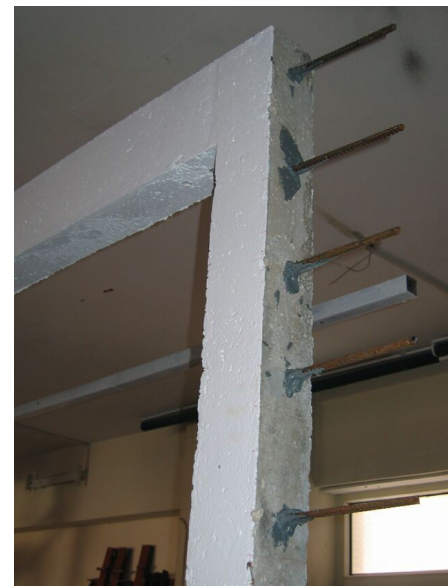
Fig. 2. Properties of anchor dowels (Arslan et al., 2010).

To ensure the simultaneous movement of the frame and the shear wall used to strengthen it, deformed bars (8 mm in diameter) were used for anchorage. These anchorage bars were located at 150 mm intervals, starting at 100 mm from the base. Holes (each being 80 mm in diameter) were opened on the side column, complying with 150-mm interval. After the holes were cleaned, dowels were inserted using Sika Anchor fix-2 anchoring adhesive. Length of the dowel part inserted in the shear wall was 20φ. Section dimensions of the external shear wall placed for strengthening were 85 × 595 mm. As per TEC-2007 (Turkish Earthquake Code, 2007) requirements, broad shear wall edges were formed (in the part from base level up to the height of the shear wall) and winded firmly to prevent plastic hinge effects. Properties of the anchorage dowels is given in Fig. 2.

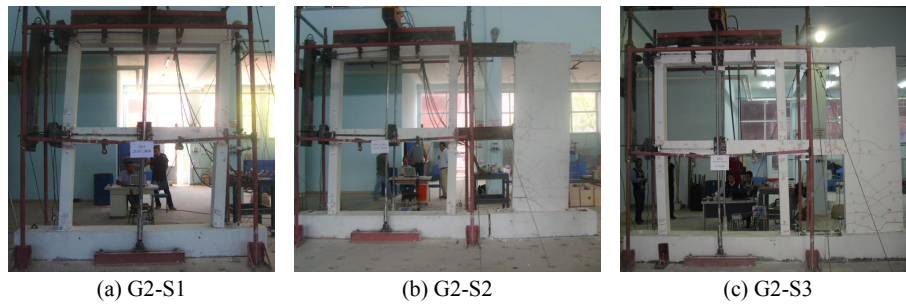
Fig. 9. Post-test views of the 2nd group test specimens (Ozturk, 2010).

Post-test views of the specimens are shown in Fig. 9. As seen from the views, damages were concentrated on the nodal points in G_2-S_1 and concentrated within the critical

shear wall height and on the coupling beam-external shear wall connections in G_2-S_2 and G_2-S_3 . No debonding was observed on the anchorages in G_2-S_2 and G_2-S_3 , which is an indication that the quadro-anchorage detailing produced positive results. However, anchorages formed apparent fracture cones on the shear wall when trying to debond from concrete. The height of the fracture cones and their width (starting from anchorage) was nearly equal to anchorage depth. This is an important result for implementation since the distance of the anchorage bars in the upper storey to the upper surface of the shear wall was significantly less than anchorage depth. Although no debonding was observed in the present study, a sudden debonding may develop when fracture cone reaches the upper surface of the shear wall due to faulty anchorage workmanship. Therefore, the construction of a shear wall higher (as much as the anchorage depth) than the frame will prevent possible debonding.
