## Risk management on an alluvial fan: a case study of the 2008 debris-flow event at Villar Pellice (Piedmont, N-W Italy)

M. Arattano<sup>1</sup>, R. Conte<sup>2</sup>, L. Franzi<sup>3</sup>, D. Giordan<sup>1</sup>, A. Lazzari<sup>2</sup>, and F. Luino<sup>1</sup>

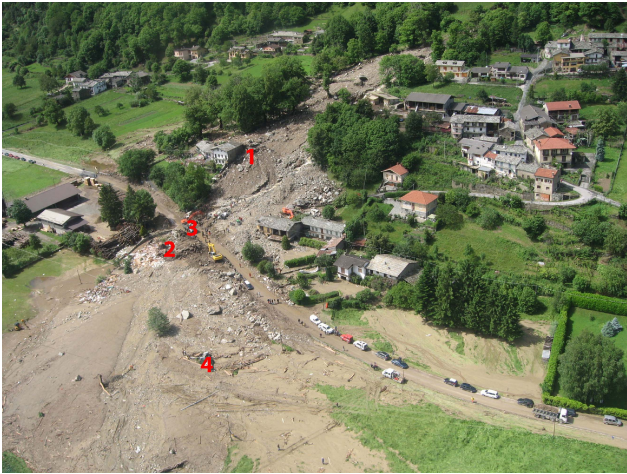
**Fig. 2.** Aerial view of Garin, affected by the debris flow of Cassarot creek occurred on 29 May 2008. 1 – destroyed house; 2 – more destroyed building; 3 – location where one of the cars hit by the flow was found (the fourth victim); and 4 – location where the ambulance and the tractor, hit by the flow, were found.

During the 28–30 May 2008 meteorological event, many soil slips originated in the Pellice Valley, generally triggered above 1500 m a.s.l. The debris flow in Villar Pellice hit the inhabited areas at 10h25 and was preceded by the activation of a series of soil slips that interrupted the viability at different points, making the area inaccessible. The deposits left by the flow covered an area of about 28 000 m<sup>2</sup>, with a maximum thickness of up to 3 m. The estimated total transported volume was about 40 000 m<sup>3</sup> (Lollino et al., 2008). Four people died, three were in the house destroyed by the debris flow (indicated with number 1 in Fig. 2) and another in a car (number 3 in Fig. 2). Another house was also destroyed (number 2 in Fig. 2) without losses.

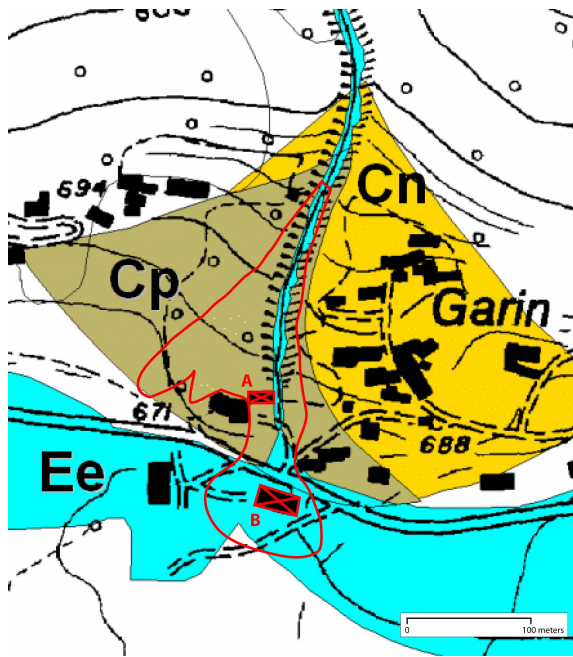
**Fig. 5.** Hazard mapping on the Villar Pellice fan. The area shown in the picture is taken by PAI (Autorità di Bacino del Fiume Po, 2001) and has the same extension of the box in Fig. 1. In this picture, the areas that are shown are classified by PAI as areas at risk: Cp – area characterised by high debris flow hazard and partially protected; Cn – area characterised by medium debris flow hazard; Ee – area characterised by very high water flood hazard. The red line shows the limit of debris flow deposits; A and B are the two destroyed houses.

From the viewpoint of territorial planning, the available data and the field surveys carried out on the Cassarot torrent, allowed hazard mapping of the debris fan on a local scale, as indicated in Fig. 5. The mapped areas in Villar Pellice, that could be reached by a debris flow, were partially confirmed by the 2008 event. In particular, one of the destroyed houses (house A in Fig. 5) was in an area where the debris flow hazard was classified as “high” and “partially” protected (Cp areas, Fig. 5), while in the adjacent areas the hazard was classified as “medium” (Cn areas, Fig. 5). The other destroyed house (B, Fig. 5) was in an area where the flood hazard was classified as “very high” (Ee areas, Fig. 5).

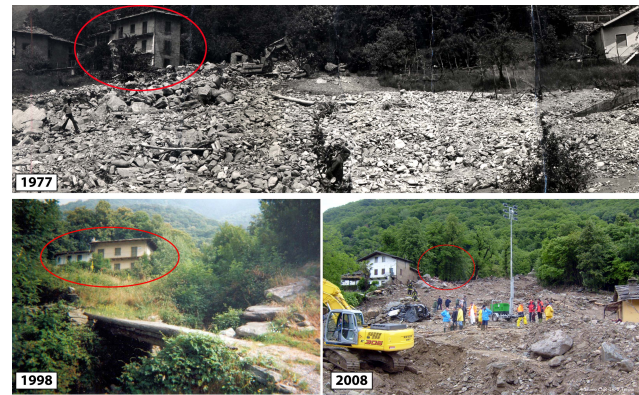
**Fig. 6.** Comparison of different images of the Garin alluvial fan: after the 1977 event – as the image shows, the debris flow affected a part of the fan without causing any damage to the house destroyed in 2008. In 1998 – the image shows the house destroyed in 2008 as it was until the day before the 2008 event; the image presents a very different situation compared to the following and it is particularly important because it allows us to evaluate which was the morphological context in which those who carried out an evaluation of the hazard of the area had to operate. The 2008 picture shows the post-event situation in all its drama.

In the specific case we are dealing with, the evaluation of the hazard was maybe underestimated (Fig. 6); the morphological evidences on the field and previous phenomena did not adumbrate such a high hazard level. These type of fans, thus, represent an open issue as far as the risk management is concerned, because their diffusion and their potential low activation level lead to the application of non-structural measures that require emergency management essentially based on the evacuation of the areas at risk. The application of such a strategy represents, however, a strong criticality, given the strict time intervals for the interventions and the difficulties in reaching the sites during the events. The idea of a preventive, generalized evacuation of all the sites at risk cannot be considered as an alternative solution because the areas that should be evacuated are very often too large, such as the area that the ARPA assigned the code 3 to for the May 2008 event: evacuating all the sites that had risk conditions similar to that of the Cassarot creek would have been impossible.
