# Rockslides on limestone cliffs with subhorizontal bedding in the southwestern calcareous area of China

**Abstract.** Calcareous mountainous areas are highly prone to geohazards, and rockslides play an important role in cliff retreat. This study presents three examples of failures of limestone cliffs with subhorizontal bedding in the southwestern calcareous area of China. Field observations and numerical modeling of Yudong Escarpment, Zengzi Cliff, and Wangxia Cliff showed that pre-existing vertical joints passing through thick limestone and the alternation of competent and incompetent layers are the most significant features for rockslides. A “hard-on-soft” cliff made of hard rocks superimposed on soft rocks is prone to rock slump, characterized by shearing through the underlying weak strata along a curved surface and backward tilting. When a slope contains weak interlayers rather than a soft basal, a rock collapse could occur from the compression fracture and tensile split of the rock mass near the interfaces. A rockslide might shear through a hard rock mass if no discontinuities are exposed in the cliff slope, and sliding may occur along a moderately inclined rupture plane. Th

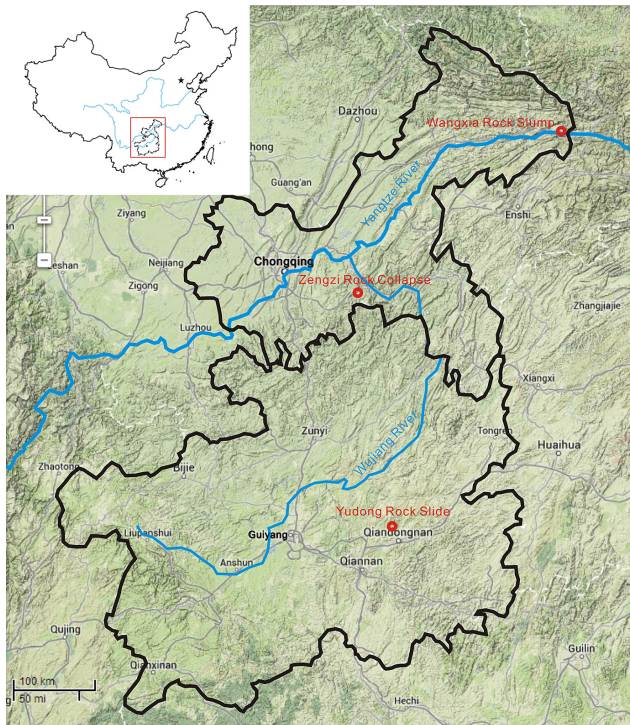
**Figure 1.** Locations of three rockslides: Wangxia rock slump, Zengzi rock collapse, and Yudong rockslide.

Different types of rockslides have been observed in thickly and subhorizontally bedded limestone escarpments. Gently inclined bedding is unfavorable for large translational slides. Slope failures – including slide, collapse, and slump – are discussed below in detail to explain their mechanisms. Three examples are given: the Yudong Escarpment, Zengzi Cliff, and Wangxia Cliff (Fig. 1).

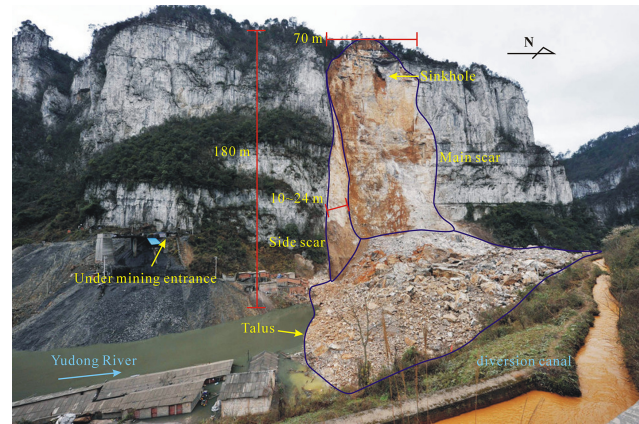
Figure 3. Photograph showing an overview of Yudong rockslide I.

The Yudong Escarpment is about 220 m high, and the slope angle is more than 80°. The steep slope faces in the direction 100–130° SE, and the dip direction is 325° NW, with slightly inclined bedding. The outcrop consists of thickly

bedded  $P_2^1$  limestone and underlying  $P_2^1$  coal measures. The Yudong Escarpment lies in the gentle eastern flank of the Yudong syncline, which strikes NNE. As a result, a set of NNE-trending joints and a conjugate set of NW-trending joints are present in the rock mass. The orthogonal 130/70° and 80/75° joints cut the 325/9° rock beds into prism- and tower-shaped blocks on the edge of the cliff. The jointed limestone is moderately weathered, and the uniaxial compression strength of intact rock reaches 30 MPa. The coal measures are composed of thickly bedded argillaceous shale and coal seams. Coal extraction has been active in the soft basal unit, and the goaf is about 200 m deep behind the cliff face. The 18 February Yudong rockslide originates from one of these unstable blocks with a volume of about  $30 \times 10^4 \text{ m}^3$ . Several types of karst are observed in the rockslide area, including sinkholes, karst tunnels, and dissolution fissures. A remote sensing image taken the day after the rock collapse shows a sinkhole at the crest with a diameter of 2.2 m immediately behind the fall. The pipe flow in the tunnels and cracks induce static and dynamic pressure, acting on the unstable rock block and changing the stability. However, because of abundant vegetation, the sinkhole is not visible in a previous image that was taken in the summer of 2012 (Fig. 4). The intense karstic erosion of a yellowish-orange color has been observed on the vertical scar. The selective karst widens and connects the pre-existing steep joints so that the area of the rock bridge covers less than 30% of the main scar (Huang, 2013). The directed scratches indicate the brittle failure of the rock bridges and consequent fall of the rock mass. The rockslide's left two scars originate from joints. The main scar is nearly parallel to the cliff face and about 80 m wide. The upper part of the main scar is a subvertical plane, and the lower parts are planar and dip out of the cliff. The conjugate side scar is about 24 m wide and perpendicular to the cliff face (Fig. 2).

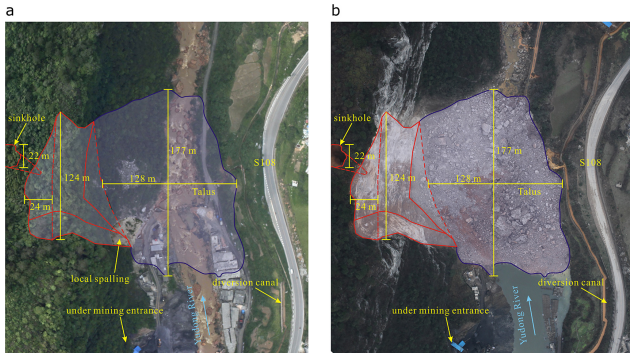
**Figure 4.** Aerial photos of rockslide Itaken in summer 2012 (a) and on 19 February 2013 (b). The zoning of the depleted mass and talus is projected in (a) prior to the catastrophe. The abundant vegetation and steep terrain make it difficult to distinguish the potential failure. However, there were signs of local spalling at the toe of the cliff face (a). A 22 m diameter sinkhole was exposed in winter, which connected with the main back scar of the rockslide (b).

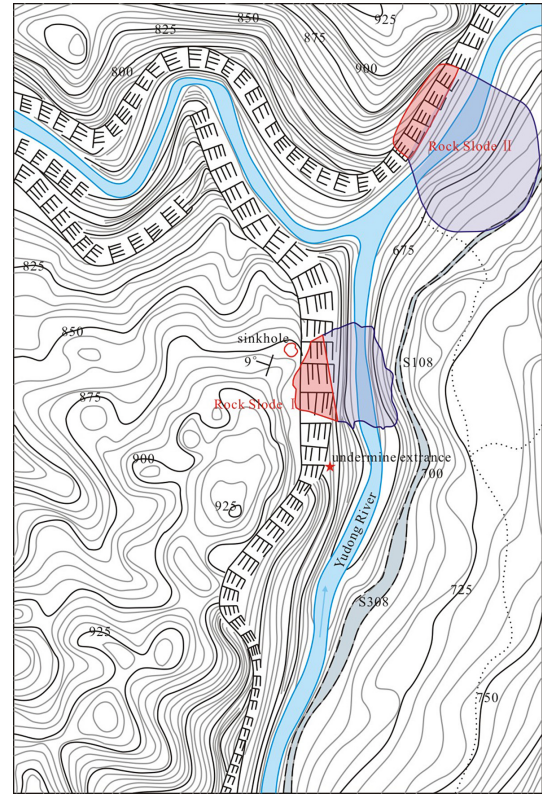
**Figure 5.** Rockslide II is located north of rockslide I and has the same geological conditions, except for undermining. The volume of the talus of rockslide II is  $30 \times 10^4 \text{ m}^3$ . It blocked the Yudong River and covered 80 m of the S308 road.

Another massive rockslide (II) (Fig. 5) occurred on 16 April 2013, about 100 m away from the 18 February rockslide (I). The morphology of the vertical scar of rockslide II is

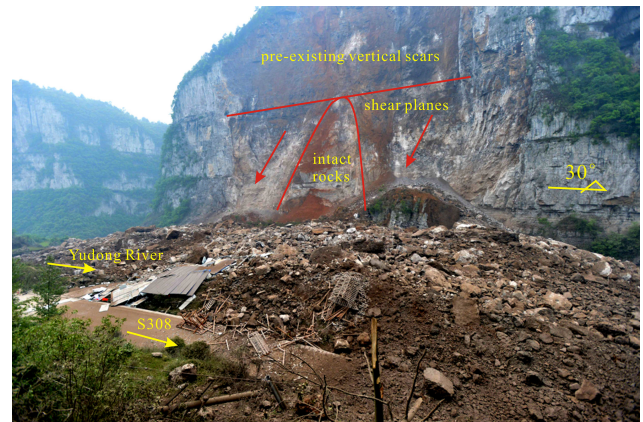
**Figure 6.** Photograph showing rockslide II at Yudong. The pre-existing vertical scars are coated with karst of a yellowish-brown color, while the rupture surfaces are white and gray, indicating brittle failure and planar sliding through the limestone.

similar to that of rockslide I. The lower rupture surface forms a steep and irregular scar (Fig. 6). These two rockslides have the same failure mechanism of a steep back scar separating the unstable block from the escarpment and the block breaking through the toe, leading to free fall of the rock mass. The rupture surface implies a plane slide involving shear failure through the rock mass. There is little or no shear displacement along the rupture surface, and the velocity is very high. The brittle failure of the rock mass in the toe area can be explained by the brittle failure of the rock mass under uniaxial compression tests. In other words, it is largely dependent on the mechanical properties of the rock mass at the toe. The toe is sheared along random discontinuities of limited persistence traced by the rupture surface (Fig. 7).

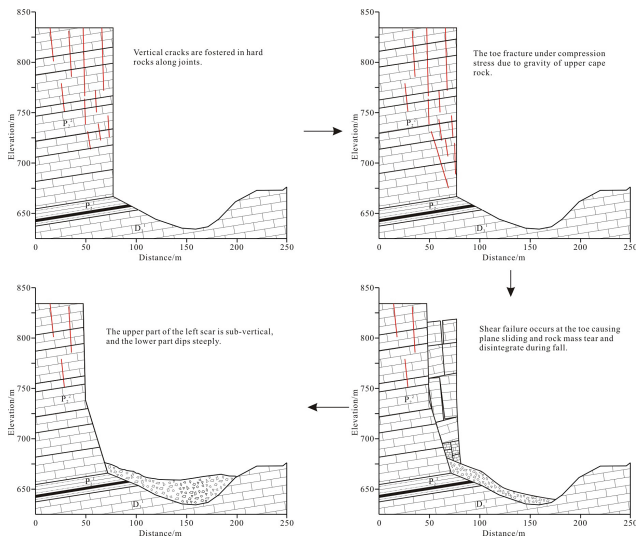
**Figure 7.** The evolutionary process of toe shear and planar sliding of the Yudong rockslides.

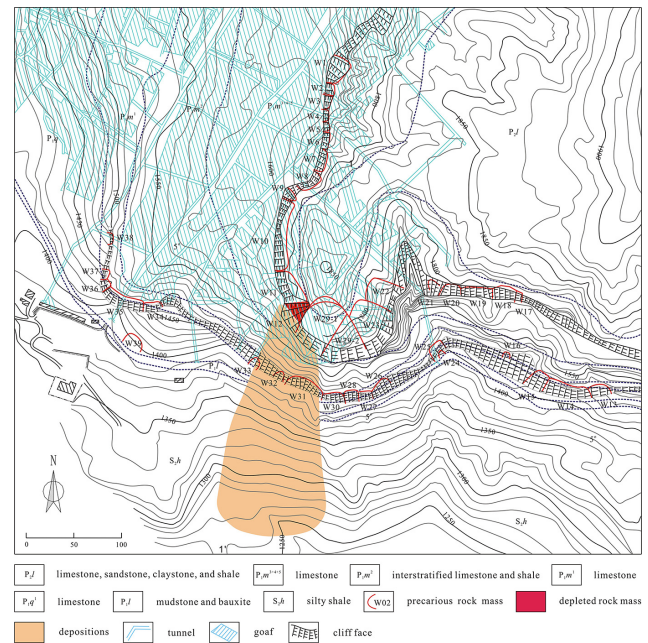
**Figure 8.** Topographic map of the Zengzi Cliff area and the distribution of precarious rock masses on its edge. Room and pillar mining has been conducted in the  $P_1j$  sequence since 1983, and the goaf extends from south to north. The depth of the goaf is about 100–120 m for the first step and 350–400 m for the second step.

Zengzi Cliff lies in the gentle and wide core of the Mount Jinfo syncline, Nanchuan County of Chongqing, in a “hard-on-soft” landform. The vertical limestone consists of two platforms separated by softer rock (Fig. 8). Two major tectonic joints in the hard rocks strike at 40° N–50° E and 30° N–50° W, with dip angles of 70–88°. These two sets of joints are approximately orthogonal to each other and perpendicular to bedding. The bedding trends at 300–305° with a very low inclination (4–7°). The upper platform is U-shaped; hence, the steep slope varies from anaclinal to plagioclinal and cataclinal in different parts of the edge. Beneath the cliff, S<sub>2</sub> silty shale forms a soft base and a gentle slope (20–30°). Talus occurs everywhere under the cliffs, indicating that cliff failure occurs as scarp retreat.

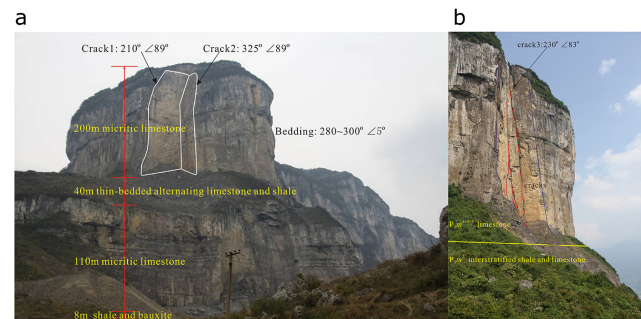
**Figure 9.** (a) Alternating strata of hard rocks and weak rocks; (b) cracks (red lines) originated near the interface between the hard cap and weak base and propagated uphill.

Rocks frequently fall in the Zengzi Cliff area. On 12 August 2004, a massive rock collapse occurred in the upper platform, which is about 200 m high (Fig. 9). The depleted mass is a prism block shaped by subvertical joints and bedding.

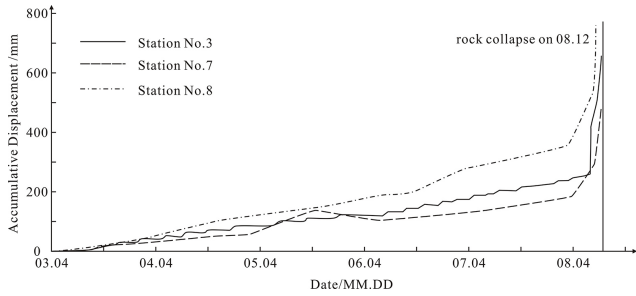
**Figure 10.** Cumulative displacement of monitoring stations at the crest of Zengzi Cliff in 2004 (Ren et al., 2005).

Mining activity has been conducted for decades, but community monitoring started only in 2001. The opening velocity of the head scar was very slow from 2001 to 2003 (Ren et al., 2005). It increased to  $4\text{--}15\text{ mm }10\text{ d}^{-1}$  in the period between April and July 2004 (Fig. 10), and signs of pre-collapse (rockfalls) were repeatedly observed. At that time, the government issued warnings and evacuated residents and workers. The velocity abruptly increased from 10 August, and the increment reached 658 mm on the last day. The process of the Zengzi rock collapse was captured on video: the tower dropped vertically and disintegrated while falling. It is unusual that the failure initiated in the bottom of the hard block rather than the underlying soft strata. The splitting of the hard rock mass at the toe led to tower collapse. The curved surface in the soft strata would have been carved by collision.

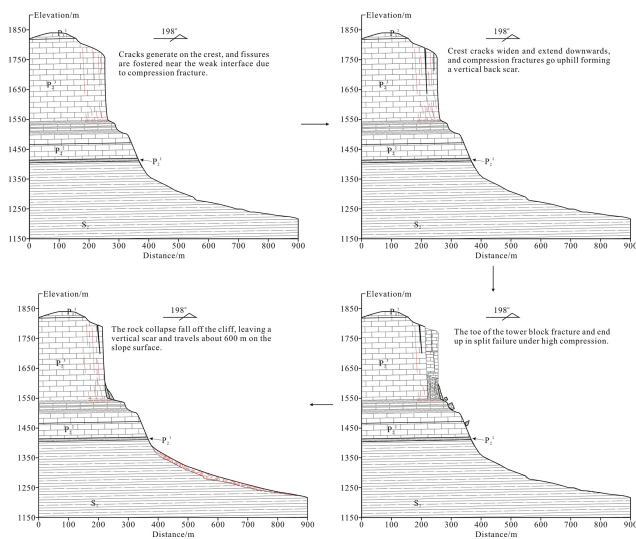
**Figure 11.** Failure process of the Zengzi rock collapse, involving toe splitting and tensile failure.

prone to tensile splitting near thin, weak planes. Compression fracturing and tensile splitting are important failure mechanisms for subhorizontally bedded slopes. The Zengzi Cliff collapse exposed back scars in the nearby deformable rock mass, which propagated uphill (Fig. 9b), and a fractured rock mass was observed near the shale interface.

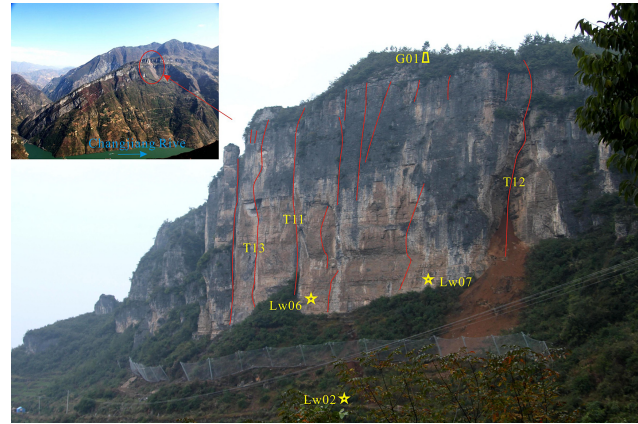
**Figure 12.** Overview of Wangxia Cliff prior to the catastrophic rock slump. G01 represents a GPS station, and Lw02–Lw07 indicate the displacement monitoring stations. The rock slump of 21 October 2010 was controlled by vertical scars T11 and T12. The red lines represent fissures in the rock mass.

cliff steps. A country road passes over the slope below the 70–75 m high limestone escarpment, which contains several isolated slab- and prism-shaped blocks. On 21 October 2010, a prism with a volume of  $7 \times 10^4 \text{ m}^3$  became a rock slump failure.

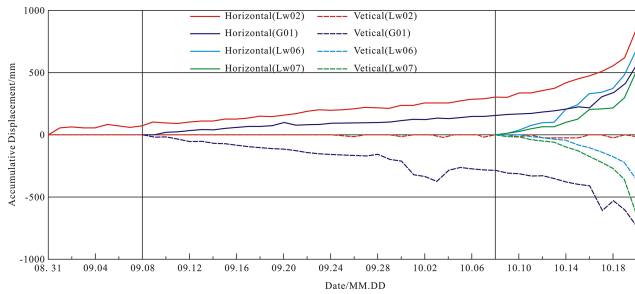
**Figure 13.** Cumulative displacement at monitoring stations at the Wangxia rock slump (Le et al., 2011).

It is worth mentioning that there is a good correlation between the acceleration of displacement and concentrated rainfall. Because of cracks and fissures in the limestone,

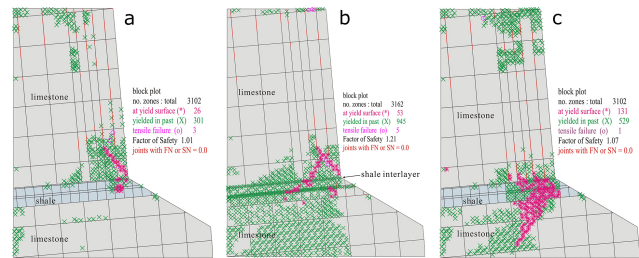
**Figure 15.** Plastic state and joint opening for rockslide initiation in cliff slopes.

The natural stress field is characterized by a tensile zone on the crest and stress concentration at the toe. When a thick incompetent basal layers is present, the jointed slope tends to fail as a slump. A yielding curved surface gradually emerges in the basal layers under long-term gravitational compression of the upper cap rock. A large plastic zone is present in the weak basal layers and nearby hard rock mass (Fig. 15c). The horizontal movement of the weak stratum is prominent. Pre-existing joints in the hard rock mass widen upward and slip with the ductile flow of the basal layers. The movement of the massive unstable rock mass is dominated by subsidence in the crest area and back tilting at the toe (Fig. 16c).

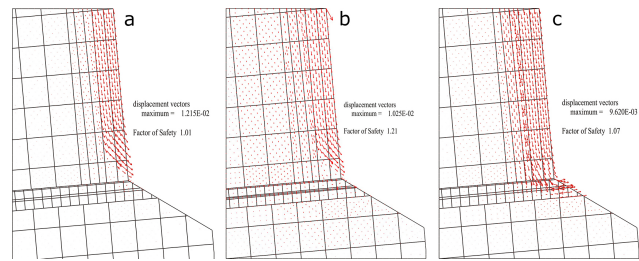
**Figure 16.** Displacement vectors of the initial failures of cliff slopes.

disturbance during geologic evolution, the horizontal-to-vertical-stress ratio is generally less than 1 (Zhang et al., 1994). This indicates that it is possible for a weak interlayer with a frictional angle less than  $45^{\circ}$  to shear horizontally. Under these circumstances, the plastic zone ranges over the interlayer as well as the overlying competent rocks. The rock mass at the toe is in a plastic state as a result of compression fractures. Two yield surfaces dipping in opposite directions are formed (Fig. 15b), similar to tensile failure behavior for some brittle rock samples. The displacement prior to collapse is limited, and remarkable squeezing-out is unlikely to be observed in the toe area (Fig. 16b).

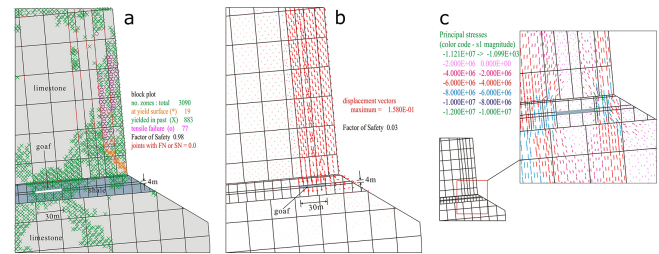
**Figure 17.** Numerical simulations of mining in cliff slopes.

the extraction is directly beneath the cliff, the rock mass is subjected to a small constraint; hence, cliff failure breakout through the fractured rock mass between the goaf and open face is feasible (Fig. 17b). The maximum principal stress on both sides of the goaf increases, while that of the overlying rocks decreases (Fig. 17c).
