# Earthquake hazard and damage on traditional rural structures in Turkey

**Abstract.** During the last earthquakes in Turkey, reinforced concrete structures in the cities and masonry structures in the rural part were exposed to damage and failure. Masonry houses such as earthen, brick and stone structures are composed of building blocks with weak inter-binding action which have low tension capacity. Bending and shear forces generate tensile stresses which cannot be well tolerated. In this paper, the performance of masonry structures during recent earthquakes in Turkey is discussed with illustrative photographs taken after earthquakes. The followings are the main weakness in the materials and unreinforced masonry constructions and other reasons for the extensive damage of masonry buildings. Very low tensile and shear strength particularly with poor mortar, brittle behaviour in tension as well as compression, stress concentration at corners of windows and doors, overall unsymmetry in plan and elevation of building, unsymmetry due to imbalance in the sizes and positions of walls and openings in the walls, defects in construction such as use of substandard materials, unfilled joints b

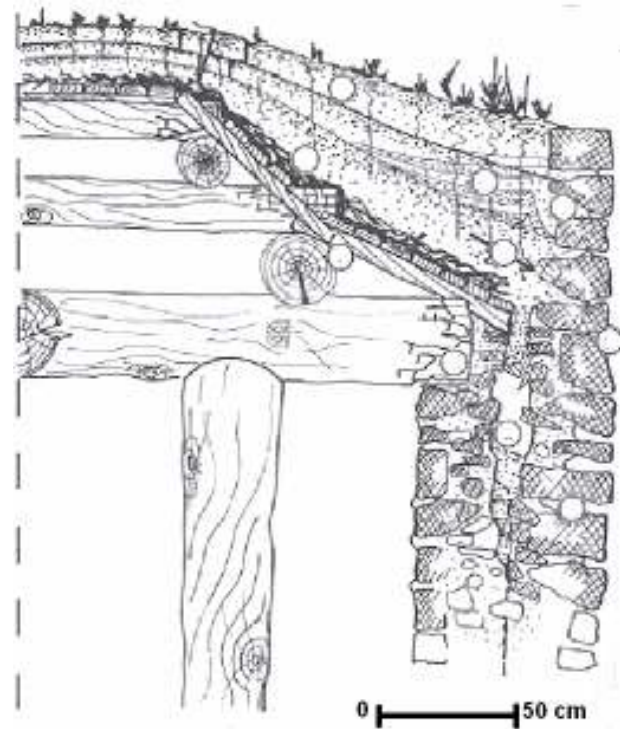
With just a few exceptions all the different rural structural types used a timber joist system of varying degrees of complexity to support the soil roof covering. The load carrying timber most widely used in the roof was Kavak-Poplar (Fig. 17). In some stone and earthen (kerpic) structures, wooden roof beams are supported by vertical wooden logs. In all but the newest of structures beams and columns were round or sub-round in section. This column logs can be placed within the wall or out of the walls but in the rooms (Fig. 18). The connections of column logs with roof beams are not adequate. The beams were supported on columns which were flat topped or in a few cases hollowed out to form a saddle bearing surface. In no cases were rigid fixing mechanisms between columns and beams observed. The trunks are generally without its bark. This made connections and good bearing surfaces between them virtually impossible, for example, where two horizontal beams cross at right angles and one of them simply rests upon the other. Round sectional

**Fig. 17.** Wooden frame of stone building in eastern Anatolia (Hughes, 2000).
