19 May 2011 Kütahya – Simav earthquake and evaluation of existing sample RC buildings according to the TEC-2007 criteria

M. H. Arslan¹, M. Olgun¹, M. A. Köroğlu², I. H. Erkan¹, A. Köken¹, and O. Tan¹

Abstract. This study examines the damage caused to reinforced concrete structures by the 2011 earthquake that occurred in Simav, Turkey. The study briefly reports on post-earthquake field observations, tectonic characteristics of the earthquake area, geotechnical characteristics of the field, and seismic characteristics of the earthquake. The main part of the study comprises a field study, material experiments, and performance analyses of two reinforced concrete buildings that survived the earthquake with medium level damage. The building performance was calculated and assessed according to the Turkish Earthquake Code requirements for existing building stock, and recommendations were made based on the findings.

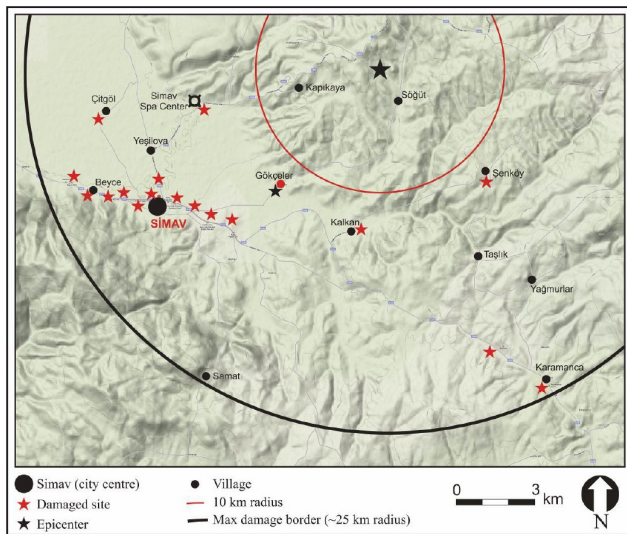
Fig. 5. Distribution of damaged areas in and around Simav (Inel et al., 2011).

Significant amounts of damage were observed in buildings located on clayed units with young lacustrine sediment, even though they were located away from the epicenter. These regions cover especially the northern part of the center of Simav. In standard penetration tests (SPT) conducted in these clay units, general average N_{30} values ranged between 7 and 13 (Inel et al., 2011). Considering these values, the unit can be classified as C or D soil group according to disaster regulations. Accepting that the unit thickness does not generally exceed 15 meters, territorial soil class falls within the Z2–Z3 interval. In addition, in some regions with low construction density, as the clay unit thickness exceeds 10–15 m, the territorial soil class is Z3–Z4. Shear wave velocity (V_s) measured in this level is around 250 m s^{-1} . Due to these features, high soil amplification values are observed in these settlement areas.

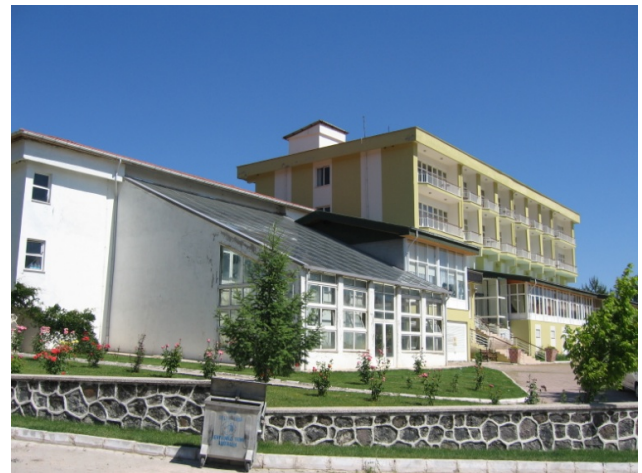
Fig. 8. Building facade and lateral facade (case study 1).

The building used as case study 1 is located in the Simav district of Kütahya Province. It comprises 5 stories: 1 basement, 1 ground story, 1 installation story, and 2 typical stories. The building was constructed in 1990. The facade of the building is shown in Fig. 8. The load-bearing system of the building was planned as a reinforced concrete frame. The floor system of the building was beam slab with slab thickness of 12 cm. In situ measurements of columns, which are the vertical bearing elements, determined that the columns

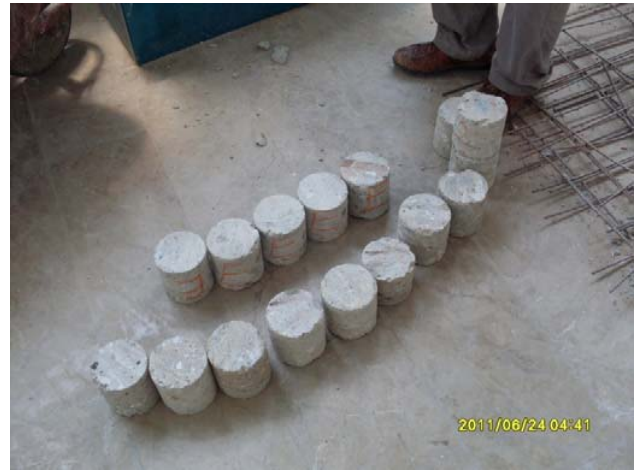
Fig. 13. Obtained core samples.

$$f_{cm} = \frac{\sum f_c}{m} = 11.48 \text{ MPa}, \quad \sigma_c = \left[\frac{\sum (f_{cm} - f_c)^2}{m} \right]^{1/2} = 3.38 \text{ MPa}, \quad f_c = f_{cm} - \sigma_c = 8.10 \text{ MPa}$$

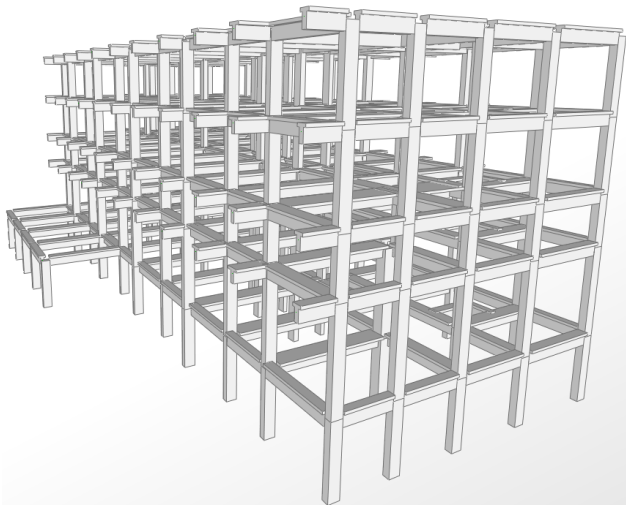
Fig. 14. Case study 1 (3-D structural model).

Structural analysis was conducted to determine soil, material and dimension information. For the performance analysis, SAP2000 was used. The 3-D image from the program is presented in Fig. 14.

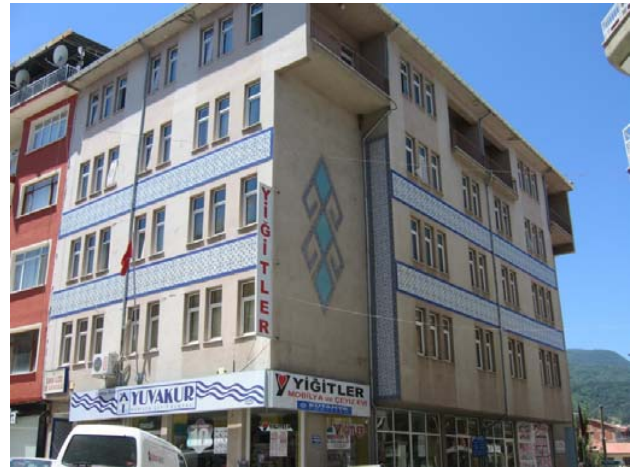
Fig. 18. Lateral facade of the building.

The building used as case study 2 is located in the Simav district of Kütahya Province. It comprises 6 stories: a basement, ground story, and 4 typical floors. The building was constructed in 1997. The facade of the building is shown in Fig. 18. The load-bearing system of the building was planned as a concrete framework. The floor system of the building was beam slab, with slab thickness of 12 cm. Floor heights were 3.00 m in the basement, 3.50 m in the ground story, and 3.00 m in typical floors. In situ measurements of columns, as load-bearing elements, showed that they are 25 cm \times 70 cm, 30 cm \times 70 cm, 30 cm \times 80 cm, 30 cm \times 180 cm, 30 cm \times 150 cm, 30 cm \times 200 cm, and 20 cm \times 200 cm rectangular sections. The elevator shaft in the load system was planned as a shear wall. The beams were 20 cm \times 60 cm and 30 cm \times 60 cm.

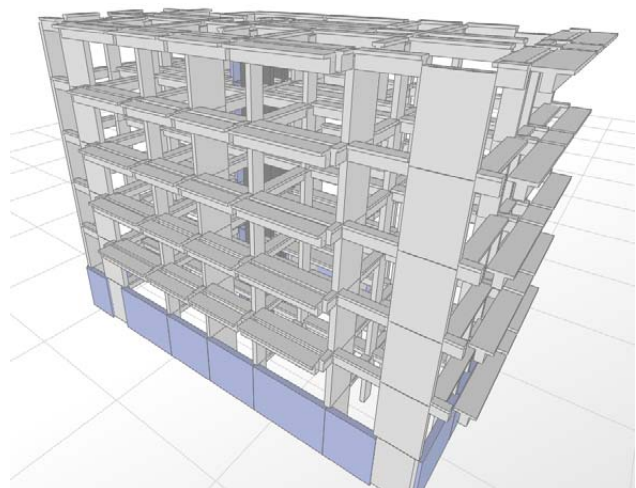
Fig. 20. Case study 2 (3-D structural model).

These data were used to develop a three-dimensional model of the building. For performance analysis, SAP2000 was used. The 3-D image from the program is presented in Fig. 20.

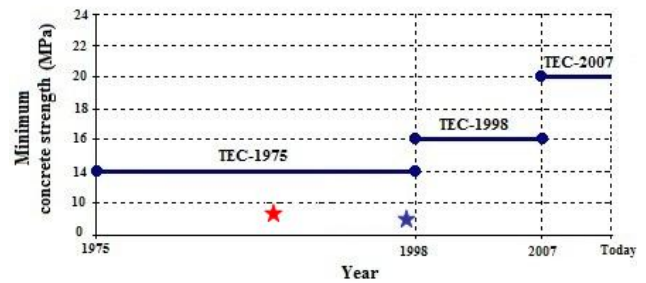
- Concrete mechanical properties are far from current building and earthquake codes. As seen in Fig. 24, the average core values of the related buildings are very low. In figure, variation of minimum concrete compressive strength to the TEC norms is also given.

Fig. 24. Strength values of concrete used in the 1st (red star) and 2nd (blue star) building and the change of lower limit of concrete compressive strength according to regulations.
