Construction and design defects in the residential buildings and observed earthquake damage types in Turkey

M. T. Cogurcu

Selcuk University, Engineering Faculty, Department of Civil Engineering, Konya, Turkey

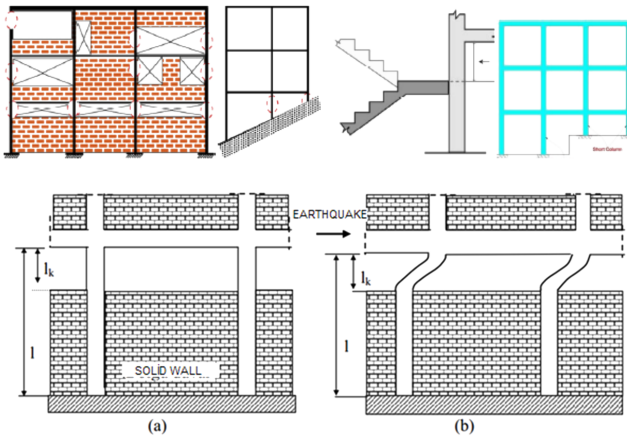
Short columns form in structures mainly because of brick walls that are not load bearing. Brick walls (partition walls) are considered to be dead loads in structural analysis. However, brick walls that are accepted as non-load-bearing contribute to load transfer in the frame under horizontal loads as diagonal struts. They increase the rigidity of the frame and limit horizontal displacement. In some situations, ribbon windows can be made in the upper parts of brick walls just under the beam. This situation is frequently encountered in the illumination of halls in dormitories and training centers as well as in basements. However, partial brick walls extending from column to column will prevent the horizontal translation of columns and cause the formation of short columns (Fig. 4).

Figure 4. Short column behavior and formations in structures due to various causes.

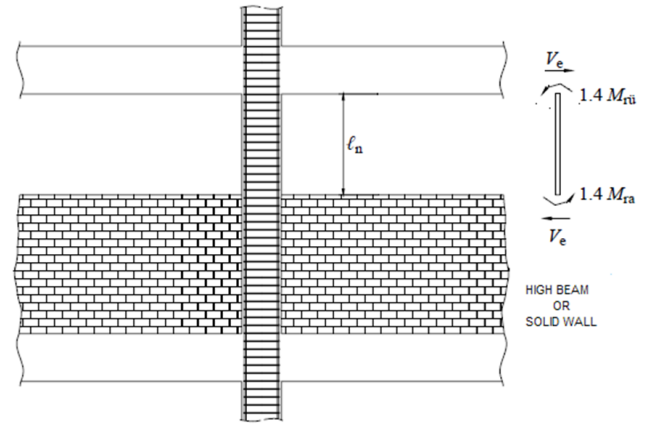
l_n is taken to be the length of the short column. However, the calculated shearing force will provide the conditions given in Eqs. (2) and (3). Throughout the short column, the minimum lateral reinforcement and settlement conditions described by the confinement zones of columns in TEC 2007 are applied. The lateral reinforcements are maintained for story height in columns that become short columns by remaining between infilled walls (Fig. 5).

Figure 5. TEC 2007 (TEC, 2007).

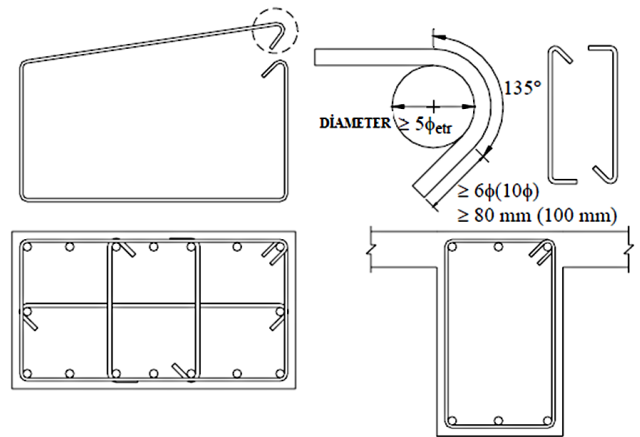
According to the TEC 2007, special earthquake stirrups and special earthquake ties must be rearranged in beam and column confinement zones near beam–column joints. Column stirrups must be continued through the columns within the beam–column joints. Stirrup hooks that satisfy the earthquake code are shown in Fig. 12.

Figure 12. Stirrup hooks designed according to earthquake code (TEC, 2007).

Making stirrup hooks with 90° angles is straightforward. Bending stirrup hooks to an angle of 135° increases the production time and labor costs. Because the importance of the correct angle has not been well understood, defective manufacturing has been very common.

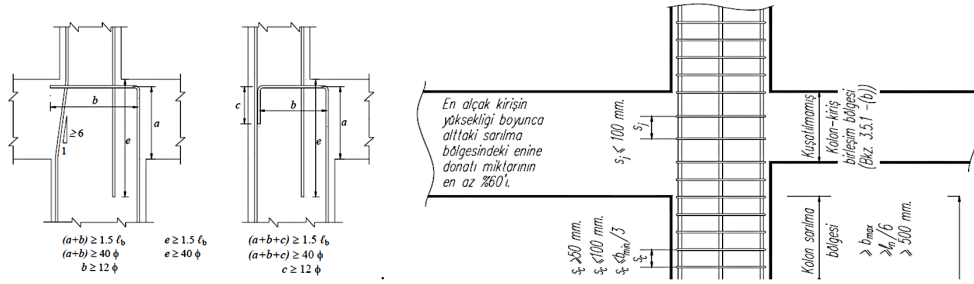
The most constraining zones within the framework under earthquake loads are column-beam joint regions. These zones must withstand both the reversible moment and the axial load resulting from the column and reversible moments that the connected beams are exposed to. The increased frequency of stirrups used in the confinement zones of columns in these zones must be continued exactly. Moreover, columns and beams connected in this zone should provide enough overlapping length to provide longitudinal reinforcements. The decisions related to overlapping length for longitudinal reinforcements at joint region in the TEC 2007 are given in Fig. 15.

Figure 15. TEC 2007 (TEC, 2007).

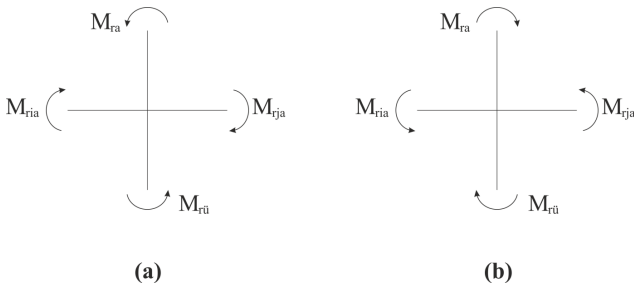
Figure 17. Bearing capacity moments affecting the node point (Ersoy U. and Ozcebe G., 2004).

ity loss of the columns will cause the collapse of the structure. However, even when hinges form in all of the beams, the building may not collapse. Repair or reinforcement after an earthquake by adding hinges to columns is difficult and may be economically impossible, but repair and reinforcement of a damaged building by adding hinges to beams is easier. For these reasons, the TEC 2007 states that “in a load-bearing system consisting of only frameworks or a combination of partitions and frameworks, the total bearing capacity moments of the columns integrating at each column-beam node point (Fig. 17) must be at least 20 % more than the total of the bearing capacity moments in cross sections of the column surfaces of beams integrated at that node point”.

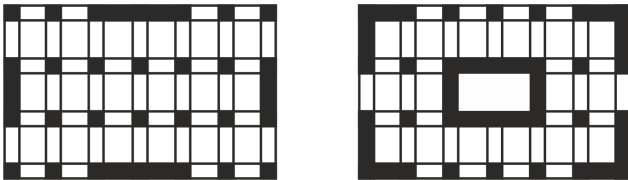
1. In order to provide maximum torsional rigidity in the construction, shear walls should be distributed around the construction. In Fig. 24, suitable partition placements with high torsional rigidity are shown.
2. Shear walls should be arranged in the floor plan so that most of the floor loads are transferred to the basis as axial force. In this way, the reinforcement required for the bending moment in the partition is reduced.
3. In multi-story buildings, putting the earthquake resistance into few partitions exposes the basis system to a big earthquake effect at a few points. This situation should be avoided because it requires an expensive heavy basis system.
4. Shear walls should be placed in both directions (Aktan and Kirac, 2010).

Figure 24. Suitable partition placements (Aktan and Kirac, 2010).
