# Experimental study on the behaviour of nonductile infilled RC frames strengthened with external mesh reinforcement and plaster composite

**Abstract.** The aim of this paper is to report on an experimental study about Turkish Earthquake Code on suggested strengthening method. The proposed method uses existing brick infill walls and the strengthening is done with the application of external mesh reinforcement and plaster. 5 nonductile 1/2 scaled, one bay, two storey RC specimens were tested under a reversed cyclic loading. The first two specimens were reference specimens and the other ones were strengthened with the proposed method. The specimens contained several design and construction mistakes such as low concrete quality and improper steel detailing. Strength, stiffness and storey drifts of the test specimens were measured. The results of the test on these frames were compared with the reference specimens. The effects of the reinforced mesh plaster application for strengthening on behaviour, strength, stiffness, failure mode and ductility of the specimens were investigated. Unexpected failure modes were observed during the testing and the results were summarized in this paper.

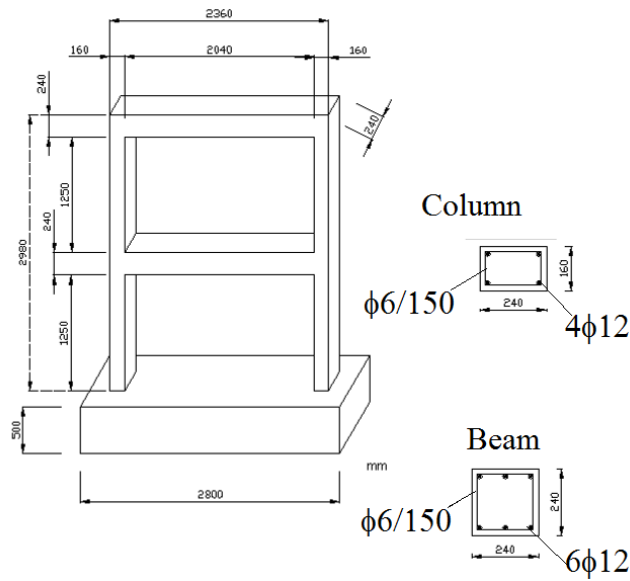
(a) general details

(b) stirrup spacing

(c) column bottom lap splice detail

(d) top storey beam-column joint detail

(e) middle storey beam-column joint detail

**Fig. 1.** Dimensions and details of the test specimens.

The total height of the specimens was 3 m. The column dimensions were 160 × 240 mm and the beam dimensions were 240 × 240 mm. In the columns the longitudinal reinforcement consists of four 12 mm diameter plain bars ( $\rho = 0.0082$ ). In the beams, three tension and three compression reinforcements were placed. In total, six 12 mm diameter plain bars were used as longitudinal reinforcement (effective depth of the beam  $d = 24 - 2 \times 1 = 22$  cm,  $b_w = 22$  cm,  $\rho' = 0.0064$ ). Plain bars with a diameter of 8 mm spaced at 150 mm were used as closed stirrups in both the beams and columns. Since specimens were 1/2 scaled models of the real structure, 150 mm stirrup spacing corresponds to the 300 mm interval in real RC members. The longitudinal reinforcements in columns were lap spliced, both at foundation level and first (middle) storey level. The lap length was chosen as 200 mm. Dimensions and reinforcement details of the test frames are shown in Fig. 1. Also in Fig. 1, reinforcement details of the joints and stirrup spacings were illustrated.

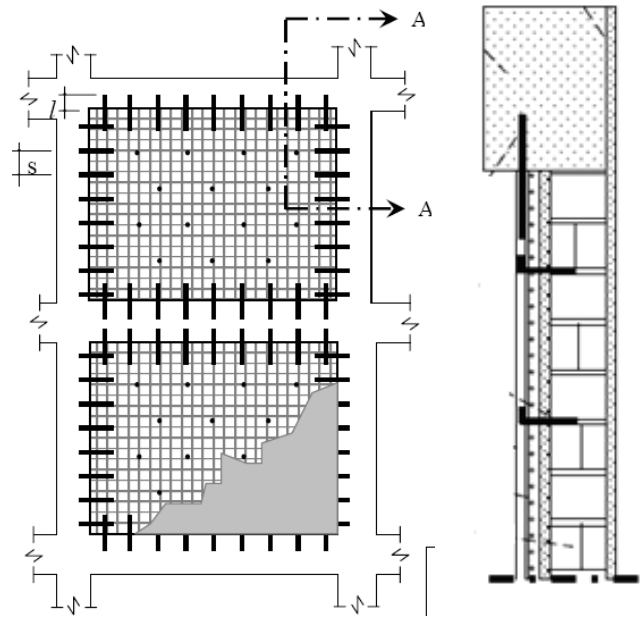
**Fig. 2.** Plastered walls with welded external mesh and plaster composite (TEC-2007).

The external mesh reinforcement consisted of 16 × 16 mm square meshes with 1.1 mm diameter steel. The shear connections between the frame and infill walls were established with dowel reinforcements. These dowels were attached to the inner faces of the beams and columns with 160 mm intervals in horizontal and vertical directions. The 10 mm diameter bars were used as dowel reinforcement and they were anchored to the RC members with epoxy. Holes, which were drilled on the inner faces of the frame members, were cleaned. The mesh reinforcement was placed on the infill wall and the dowels were inserted into epoxy injected holes. The infill wall reinforcement was also 1/2 scaled. Since both reinforcement and wall was scaled down, the ratio was not changed and chosen as  $\rho_v = \rho_h = 0.009$  in both vertical and horizontal directions.

The plaster mixes were prepared according to the proportion given in TEC-2007. Both sides of the wall were plastered with the prepared plaster material. The thickness of the plaster was 15 mm and the total thickness of the masonry wall with plaster was 130 mm. The thickness of the plaster was 1/2 scaled and in real application it is approximately 30 mm. The representative illustration of the strengthening application is given in Fig. 2. In a real application an older plaster layer exists and strengthening was applied over the older plaster layer. In experimental studies, the strengthening was directly applied over the infills, the contribution of the old plaster was ignored.

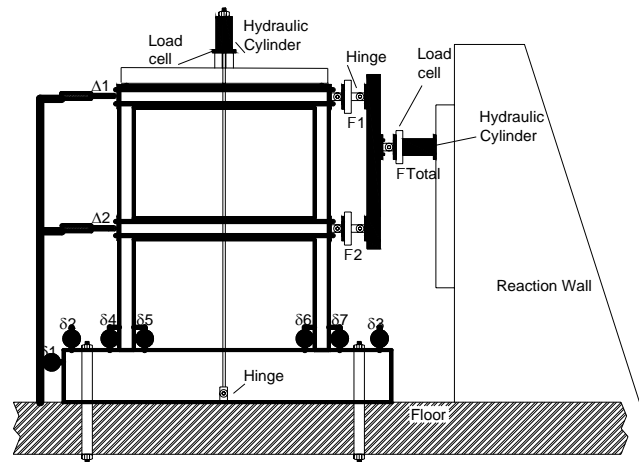
**Fig. 3.** Test setup, loading system and instrumentation.

The laboratory of the University contains a strong floor with 600 mm thickness and having uniformly distributed holes with 70 mm in diameter. There is also a strong reaction wall, with a 12 m height. Specimens were cast in a horizontal position and then lifted to a vertical position. Production of the specimens in the vertical position created form and scaffolding problems, making the leveling of the form of the specimens very difficult. In another experimental programme, authors produced two specimens, one of which was casted in a vertical position and another in a horizontal position. No clear differences under lateral loading was observed. So authors preferred the horizontal casting for ease of production. The specimens were built on stiff reinforced concrete foundations and bolted to the rigid floor through holes with high strength steel bolts. The lateral loading equipment consisted of a hydraulic jack with a 1000 kN capacity and three loadcell with a 500 kN capacity. Tests were conducted under reversed cyclic lateral loading simulating seismic action. Lateral load was applied to specimens at the storey levels. Cycles were named as forward and backward cycles and forward cycles were assumed to be positive. Axial load was also applied to the top of the columns with two hydraulic cylinders and was measured with two loadcells. A special apparatus was manufactured to apply axial load. The representation of the test setup, loading system and instrumentation is shown in Fig. 3.

The instrumentation setup consisted of LVDT's, and data acquisition system. The specimens were instrumented with LVDTs (linear variable differential transformers) to measure top and middle story displacements. During the tests, story displacements and the lateral loads were saved to the computer and monitored simultaneously. Cyclic lateral displacement excursions were imposed to simulate the seismic demand. The lateral load was applied with a rigid steel beam such that 1/3 and 2/3 of the total load was applied on the middle and top storey, respectively. Loading cycles consisted of preyield and post yield cycles. In the elastic range several cycles were applied with a load controlled history. Beyond the elastic limit, displacement controlled cycles were applied. The maximum displacement capacity of the test setup was 100 mm which corresponds to the 3% drift ratio. During the loading cycles, when target load or displacement was reached, the loading was stopped and new initiated cracks and crack propagation were marked on the specimens and failure mechanisms were observed.

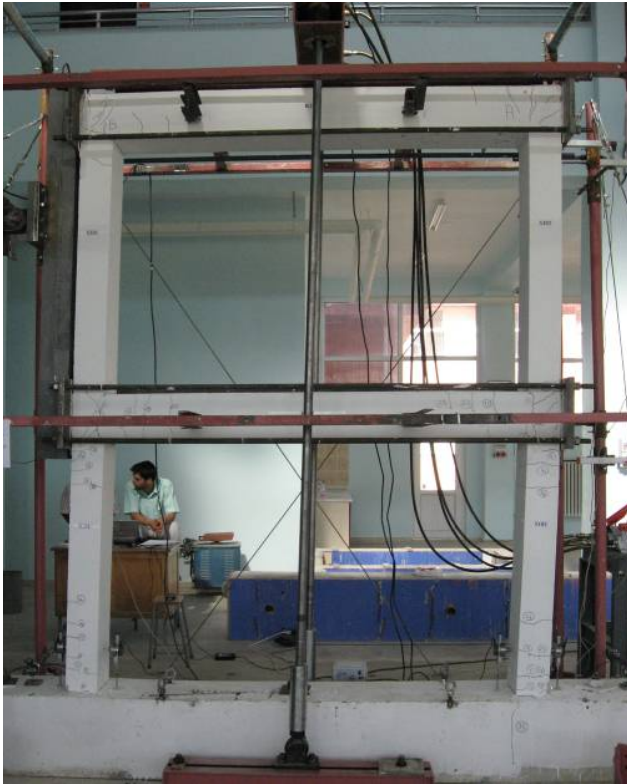
Fig. 4. Reference bare frame RFB1.

A reference specimen with no infill wall was prepared and tested to understand the bare frame capacity and named as RFB1 (Fig. 4). Load-top displacement hysteresis curve of the specimen is represented in Fig. 5. The displacement levels of the initial elastic cycles did not generate any nonlinear deformation in the structure and the loops followed a straight

line. The maximum load carrying capacity of the specimen was determined as 34.5 kN. Plastic hinges were formed in the beam-column joints. No obvious failure point can be determined in specimen RFB1. Several flexural cracks were observed both on the beams and the columns. The onset of stiffness degradation was identified by simultaneous formation of tension cracks at the bottom of the columns.

As observed from Fig. 4, the  $\Delta 1$  and  $\Delta 2$  readings were not displayed linear increase. Actually, before the occurrence of the plastic hinges, the variation is linear, but after the elastic limit, several plastic hinges were formed in the ends of beams or columns and linearity was disturbed.

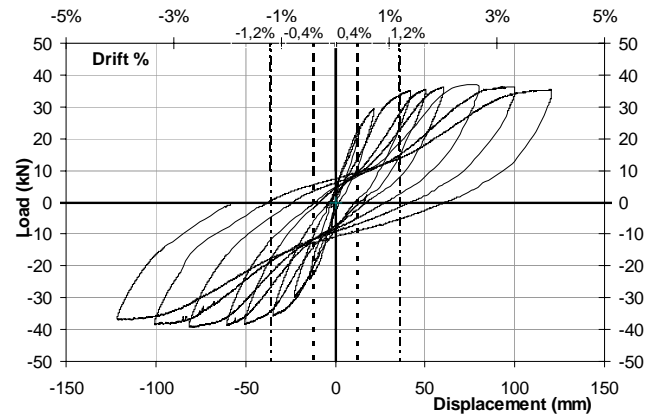
Fig. 5. Load-top displacement hysteresis curve of reference bare frame RFB1.

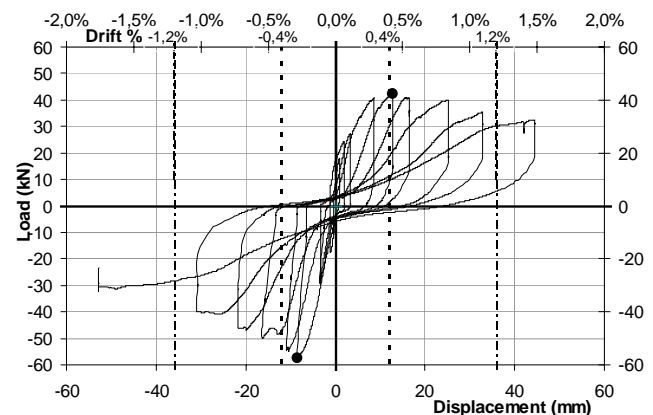
Fig. 6. Load-top displacement hysteresis curve of reference infilled frame RISPS2.

During the testing, it was observed that, at low levels of lateral forces, the frame and infill wall behave monolithically. However, as the lateral force level increases, the frame deforms in a flexural mode while the infill corners damaged. In the early stages of the loading, the frame with infill wall displayed higher in-plane stiffness and strength. The mentioned increase can be seen from the hysteresis curves of the specimen RISPS2 (Fig. 6).

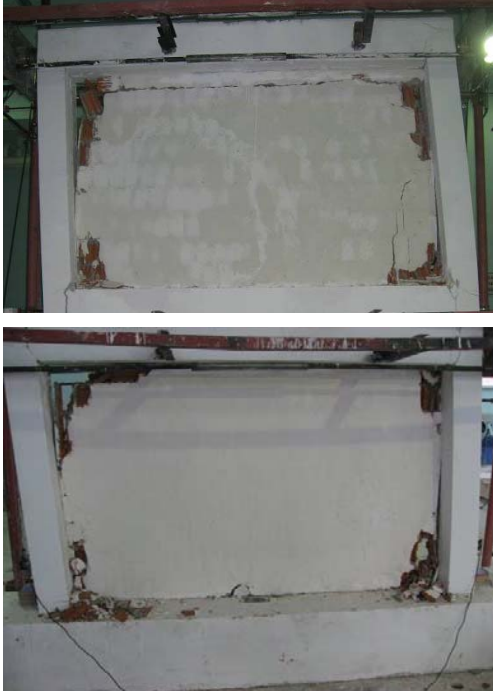
Fig. 7. Reference infilled frame RISPS2.

In the test of the specimen RISPS2, fifth mode of the failure was observed. The corners of the wall panels damaged and crushed. Separation of the infill from the frame was obvious at the higher displacement levels. Both upper and bottom wall panels damaged. The failure mode and specimen at the end of the test is given in Fig. 7. RISPS2 specimen survived 22% higher lateral load than RFB1 specimen.

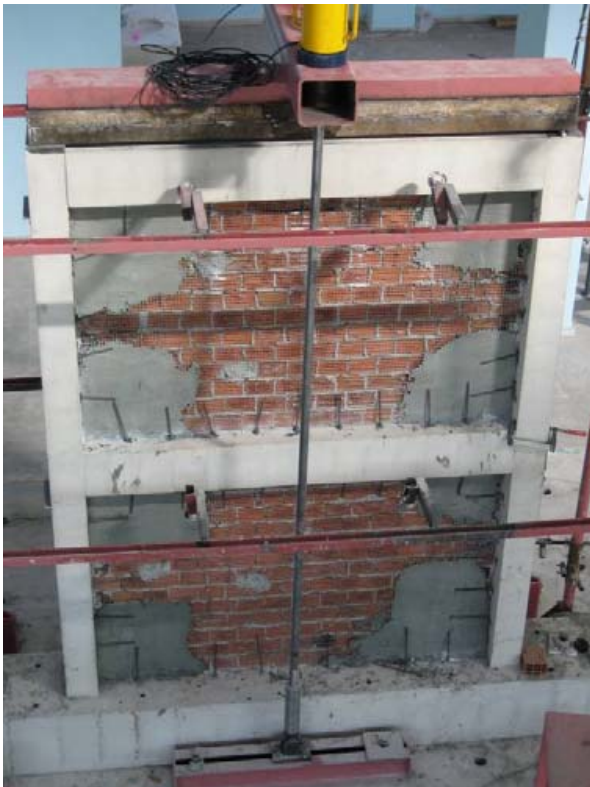
Fig. 8. Strengthening of specimen SPS1.

Third specimen was named as SPS1. The frame properties and infill configuration was the same with RISPS2 specimen. The strengthening scheme was applied as explained before (Fig. 8).

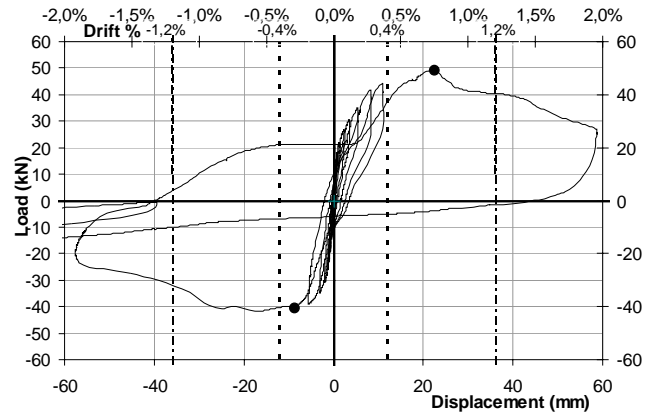
Fig. 9. Load-top displacement hysteresis curve of SPS1.

Although specimen SPS1 survived 16% higher maximum lateral loading, its performance was evaluated as poor. The dowels or shear keys below the middle beam disintegrated from the plaster and lateral displacement of the frame suddenly increased. At this time there was also a sudden drop in the load carried by the system. The failure point of the dowels-wall-plaster composite can be clearly seen from the last cycle of the load-displacement hysteresis curve (Fig. 9).

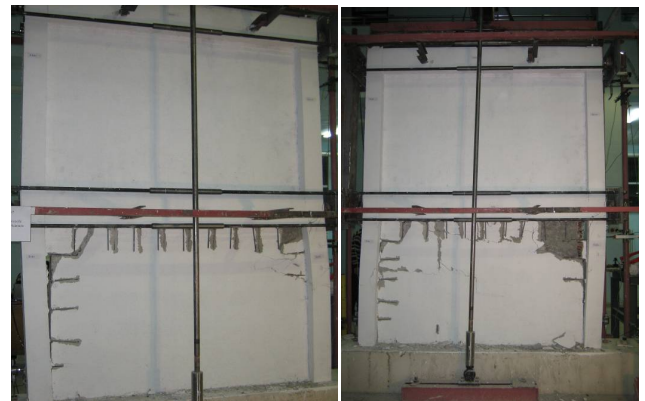
Fig. 10. Failure mode of specimen SPS1.

After the failure of the dowels, the testing could not continue. The failure mode of the specimen is given in Fig. 10. During testing, the wall panels of specimen SPS1 showed a higher stiffness contribution to the frame than the RFB1 and RISPS2. Also the ultimate lateral load carrying capacity of the SPS1 was increased as compared to SPS1 and RISPS2. Several flexural cracks were observed on the beams and columns. But below the first storey beam, premature and sudden failure of the wall-plaster-dowel interface was observed. The plaster cover over the dowels disintegrated and no more shear transfer between the beam and the wall were possible. This failure mode was

very sudden and brittle in nature. The full capacity of the mesh-plaster-wall composite could not be used due to this premature failure. After the failure, the specimen showed similar load-displacement characteristics with the RISPS2 specimen. This failure was attributed to inadequate plaster thickness and at the end of the test, it was decided to increase the thickness of the plaster. This specimen lost 55% of its lateral load carrying capacity immediately after failure of the dowel anchorage with the mesh plaster composite.

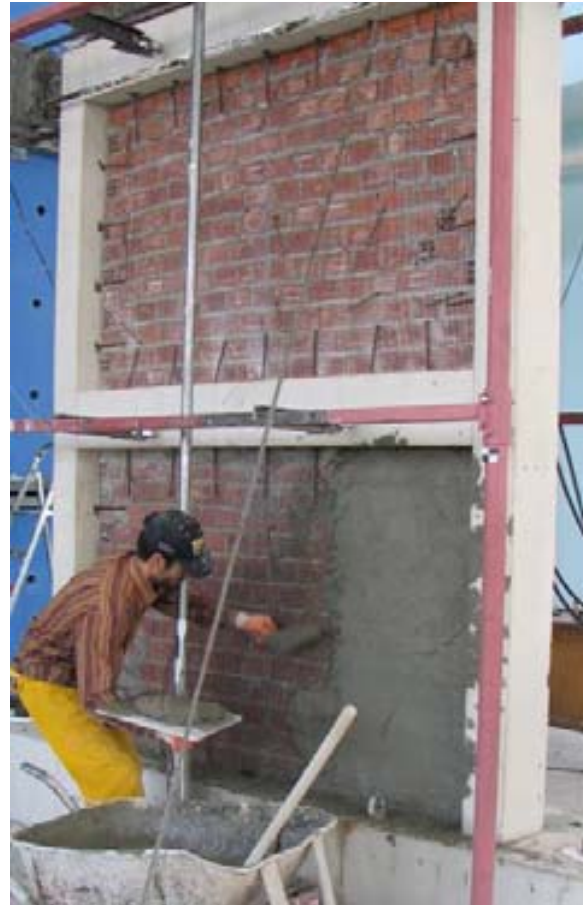
Fig. 11. Preparation of specimen SPS2.

After obtaining a dowel-plaster anchorage failure in specimen SPS1, the thickness of the plaster was increased to 30 mm in specimen SPS2 (Fig. 11). Other properties were the same as SPS1. During the test of SPS2, no damage was observed on the wall panels, but instead some minor cracks formed. Serious cracks were observed on both column bases. These cracks were also extended through the bottom of the lower wall panel (Fig. 12).

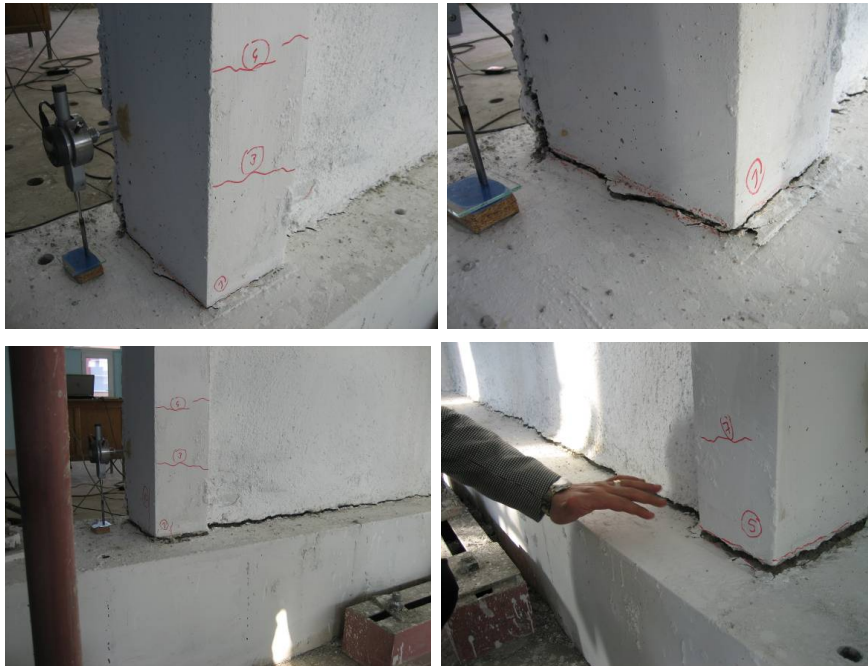
Fig. 12. Slip failures at the bottom of the columns.

The lateral load-top storey displacement hysteresis curves are presented in Fig. 13. The maximum lateral load obtained during the testing was 63.2 kN, which was 82% higher than bare frame and 50% higher than the reference infilled specimen. The wall panels contributed to the load carried by the system and also increased the stiffness of the frame, but failure of the panel could not be obtained. The reason for the failure attributed to the slippage of the reinforcing bars at the bottom of the columns. The low concrete strength, plain undeformed bars and insufficient lap splice length at the joint created such a failure mode.

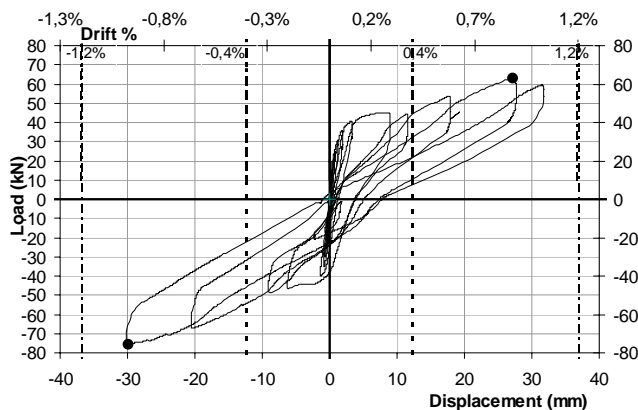
Fig. 13. Hysteresis curves of specimen SPS2.

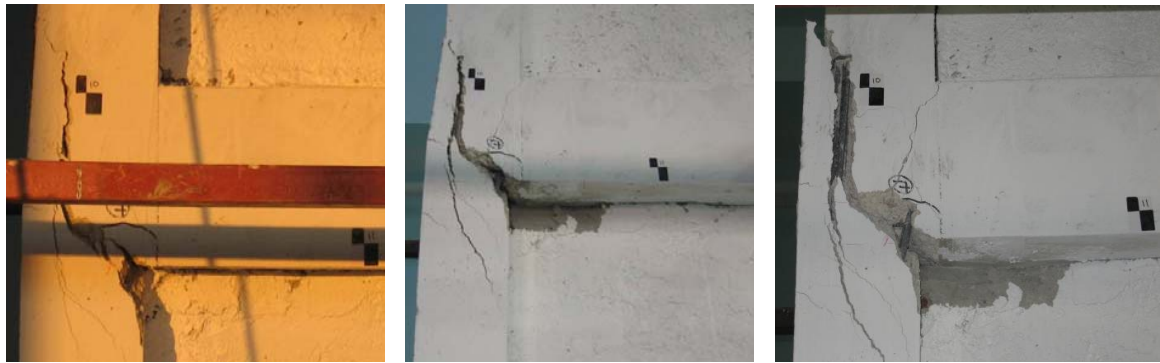
Fig. 14. Failure of the left beam-column joint.

Specimen SPS3 was prepared according to the results obtained in the SPS2 testing. The bottom joints of the columns were improved by increasing the lap length of the longitudinal reinforcements. The 200 mm lap length was increased to 420 mm ( $20f \times 1.5$ ) lap length which was applied in the Turkish Earthquake Code. Other properties were as SPS2. The maximum lateral load carried by the system was obtained as 69 kN. No lap splice failure was observed at the bottom of the columns. Also dowel-plaster failure did not form. The specimen survived a 10% higher lateral load than SPS2. On the other hand, as the load levels increased, several cracks were concentrated on the middle beam-column joint and those cracks determine the failure mode. Middle joints were seriously damaged and the lateral load carried by the system dropped drastically. Left and right joint failure photos are given in Fig. 14 and 15, respectively.

The column stirrups did not exist in the beam column joints. Also lap splice length of the column's longitudinal reinforcement was insufficient at those points. In addition to these detailing mistakes, another effective parameter to the failure was poor concrete quality. The lateral load at the joints was transferred to the foundation, through diagonal struts along the wall panel. As a result, inclined inner forces were acting on the joints. Since the joints did not have enough confinement and strength, they failed. The failure point of the joints can also be seen from load hysteresis curves (Fig. 16).

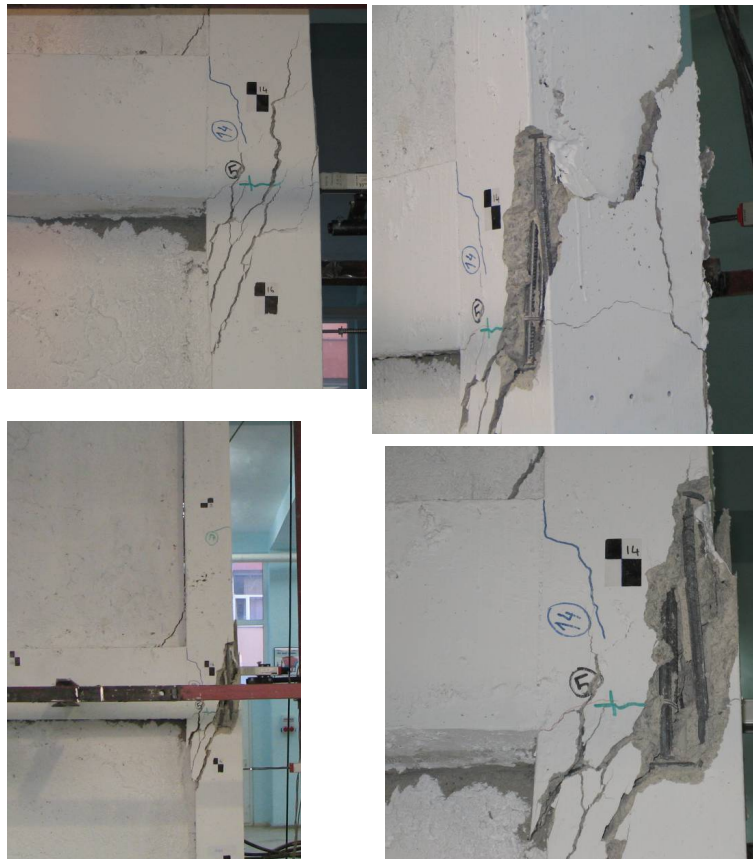
Fig. 15. Right beam-column joint failure.

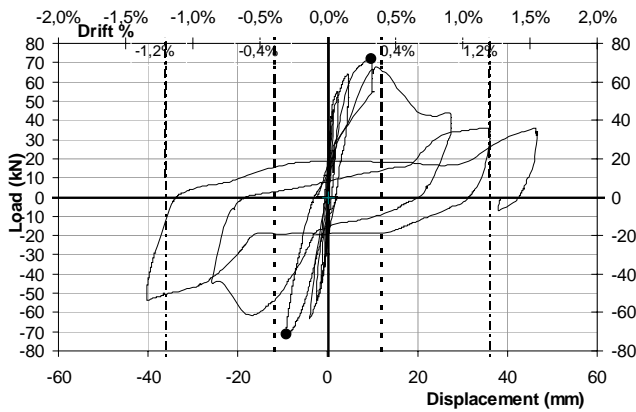
Fig. 16. Hysteresis curves of specimen SPS3.

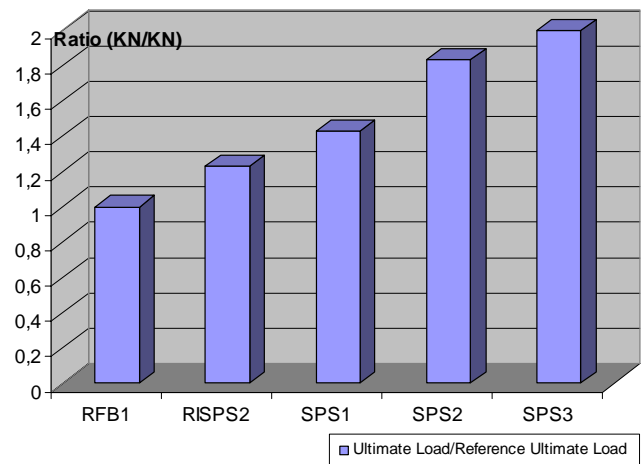
Fig. 18. Ratio of specimen ultimate load to the reference empty specimen's ultimate load.

Also in Fig. 18, the comparison ratio of the ultimate lateral loads to the reference empty specimen RFB1 is given in a clustered column type chart. This figure lets us compare the relative performance of the specimens.

The maximum ultimate load was obtained in Specimen SPS3 and a relatively low ultimate load capacity was observed in Specimen SPS1. From this figure, the contribution of the infill can be seen (RISPS2) as compared to the bare frame capacity. By examining Figs. 17 and 18, it can be concluded that, both the strength and the stiffness were significantly improved by introducing external mesh reinforced infill.

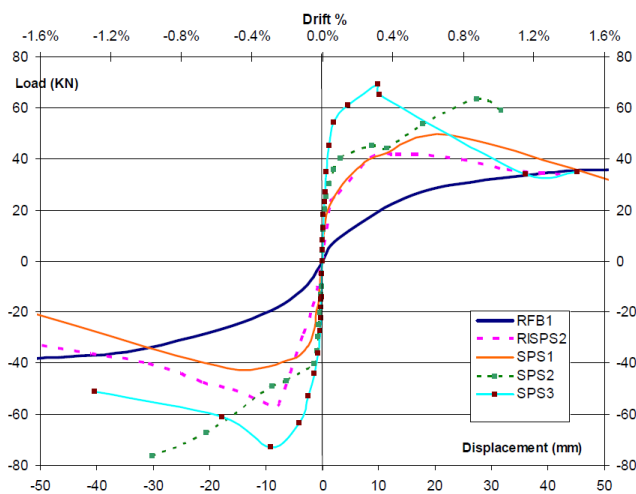
Fig. 17. Comparison of envelope curves.

The lateral load-top displacement characteristics for all the specimens are presented and compared in this section. The comparison of the behaviour of the test specimens is made in terms of lateral strength, stiffness, maximum storey drifts and energy dissipation characteristics. The envelopes let us compare the relative performance of the specimens. To enable the comparison among the test specimens studied here, the load-displacement envelopes are plotted by connecting the maximum peak points of consecutive hysteresis curves. The response envelope curves of the strengthened specimens are given in Fig. 17 together with that of the reference bare frame and reference infilled specimen. These plots have a better representation of the rate of stiffness degradation. As can be seen from this figure, strength and stiffness of both strengthened frames were significantly higher than those of the reference specimens.

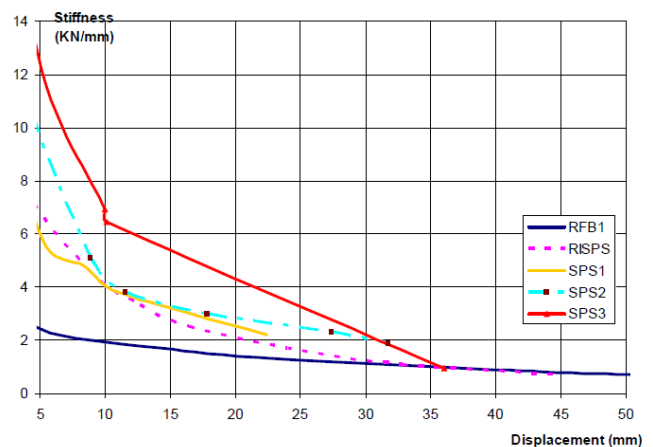
Fig. 19. Comparison of stiffness degradation.

With the increase in displacement and in the number of cycles, the hysteretic loops tend to be inclined. This modification corresponds to a reduction in stiffness. This characteristic permits a quantification of the damage (Colomb et al., 2008). The stiffness values of the hysteresis loops were evaluated and they are presented in graphical form in Fig. 19. The horizontal axe of the graphic is the maximum displacement of the cycle. The rate of stiffness degradation can also be calculated from these plots. The post yield behaviour is signified by monotonic degradation of stiffness. The stiffness of the strengthened specimens was significantly higher than the stiffness of the bare frame and reference infilled specimen.

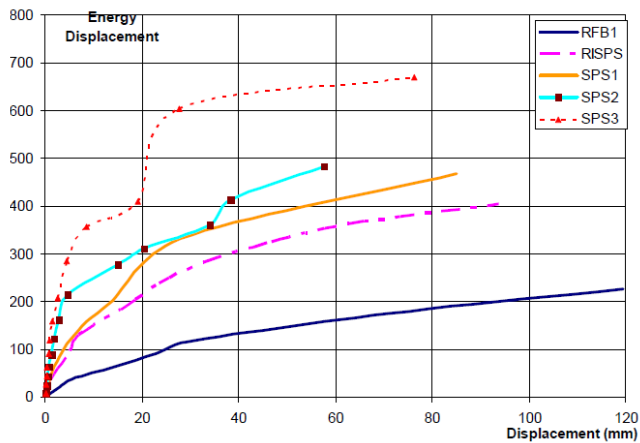
Fig. 20. Energy consumption comparisons.

The ability of the structure to survive an earthquake depends on its ability to dissipate the input energy. The energy dissipation with hysteretic damping was determined by calculating the areas enclosed by the hysteretic load-displacement loops. An estimate of the dissipated energy can

be found by the area inside the load-displacement hysteresis loops. The width of the loop also depends on the maximum cycle displacement. Since imposed displacements were not the same for all specimens, energy dissipation values were normalized by dividing them into the corresponding cycle displacement. Cumulative energy values were evaluated by successive summation of the values. Figure 20 depicts the variation of cumulative dissipated energy as a function of cycle displacements. It may be noted that a wider loop (i.e. a large difference in ordinates in the ascending and the descending paths) would signify higher hysteretic damping.

Reference specimens dissipated the smallest amount of energy. Also specimen SPS1 displayed the poorest energy dissipation performance among the strengthened specimens. The energy dissipation capacity of strengthened specimens was significantly improved by the increase in the thickness of the plaster. Specimen SPS3 dissipated the largest amount of energy among the others (Kilic, 2009).
