# Electrical resistivity monitoring of simulated piping and hydraulic fracturing within a dam structure

In this study, we attempted to monitor the changes in electrical resistivity values of earth dam material while a saddle dam is dismantled for the construction of emergency spillways of Dae-chung dam. Two artificial sub-horizontal boreholes were drilled into the embankment structure to simulate piping along the two artificial flow channels. And, after the simulated piping test was finished, we were carried out using injecting with grouting cement fluids on the dam crest. One was to develop a piping detection technique measuring electrical resistivity of earth dam by monitoring, and the other was to estimate reinforcement of dam by grouting, which electrical resistivity lower enough to yield resistivity contrast.

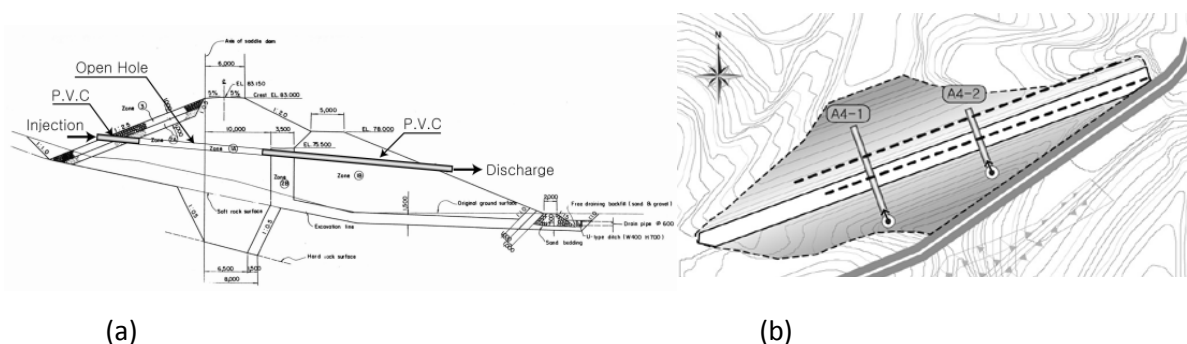
**Fig. 1:** The boreholes were installed for simulated piping test in saddle dam, (a) Plan map, (b) Cross-section of the saddle dam.

We should try to approach for the various aspects of the situation. First, two artificial sub-horizontal boreholes with diameter of 75.7 mm were drilled into the dam structure to simulate piping along the two artificial flow channels. The boreholes were installed with open-holes, each one at different level (Figure 1(a)). It was tried to identify for resolution of electrical resistivity data. And we had installed the PVC pipe for preventing progressive collapse in the filter zone (Figure 1(b)). The piping test had been conducted for 72 hours, except replacing flow-meters. And it was measured an injection charges, discharge and turbidity during piping test.

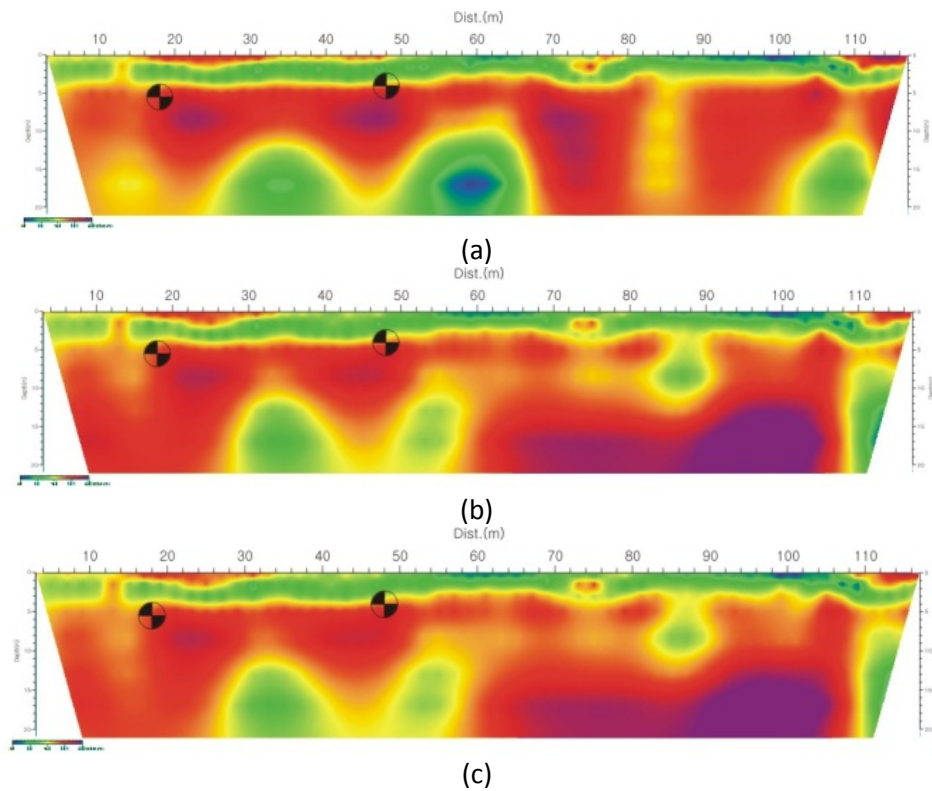
**Fig. 2:** Time-lapse images of electrical resistivity survey of Phase 0 in the crest (a), and the measurement of Phase 2 (b), and when Phase 9 measurement was completed (c).

But there were a certain difference the result of Phase 0 and Phase 1 (Figure 2). As a whole, resistivity distribution aspect of profiles for Phase 2 to Phase 9 looks similar results. The ranges of electrical resistivity values were 100-400  $\Omega\text{m}$  around boreholes, and the RMS error was 4.6-7.5% ranged each phases in the crest. Phase 1 showed the better image than Phase 0 in lower depth zone. The data acquired in Phase 1 unfortunately showed too little electrode separation index to get subsurface image from them. Therefore, one set of monitoring data was assembled using the data from Phase 2 to 10 excluding Phase 1.

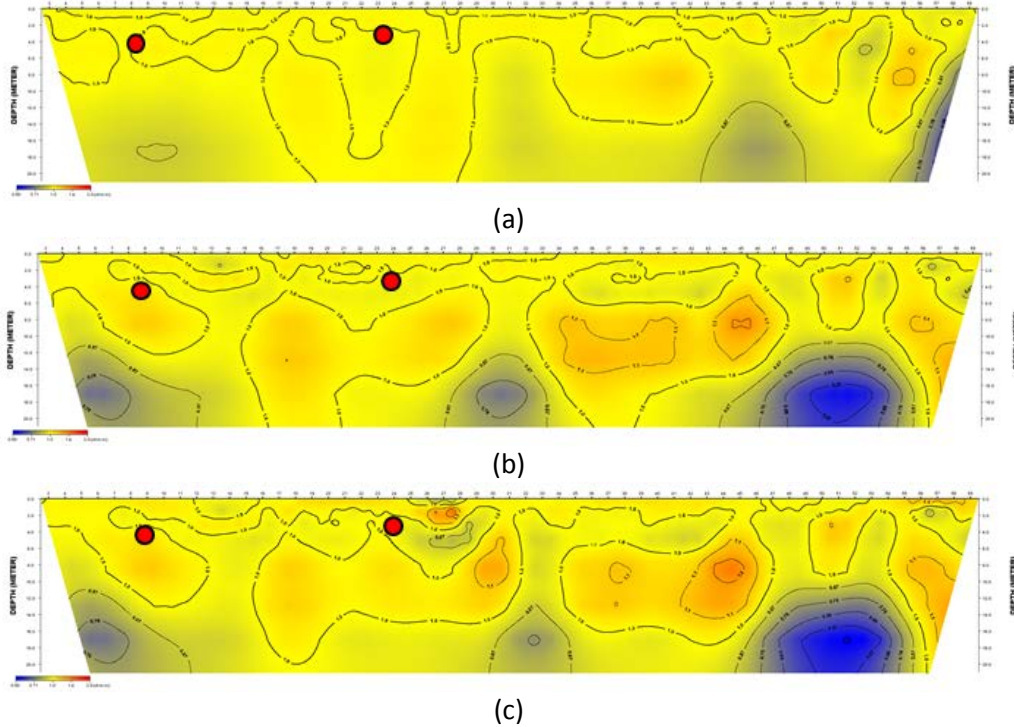
**Fig. 3:** Resistivity changes of Phase 3 (a), Phase 6 (b), Phase 8(c) expressed in terms of the resistivity ratio between each phase and Phase 1.

In order to image around boreholes, the different images were analyzed for each phases. Figure 3 show the ratio of resistivity changes for Phases 2 to 9 divided by Phase 1. This ratio was calculated simply by dividing every resistivity values for each grid of one profile by that of corresponding grid of the other. If the resistivity change ratio is 1, it is never any change in the phases. And less 1 indicates a decrease in resistivity values, while above 1 indicates an increase. There wasn't changed a ground condition during piping test. Therefore the boreholes area must be imaged as an anomalous zone having the value less than 1 during piping test. We could easily recognize that the electrical resistivity ratio showed many artifacts, while difference images appeared with false anomalies of resistivity increasing. These figures indicate the ratio of resistivity change around the boreholes is very low, less than 5%. So it is really difficult to detect leakages, since the ratio of resistivity change is less than RMS error by inversion.

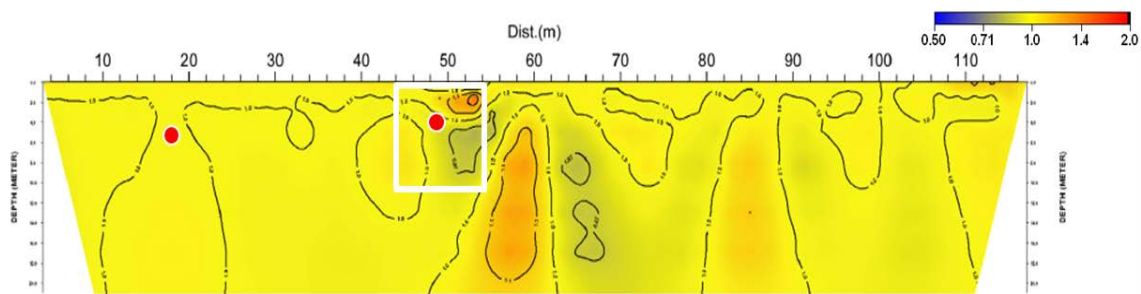
**Fig. 4:** The resistivity change ratio of the Phase 8/Phase 6 on the dam crest.

The ratio of resistivity change was very low until Phase 6. Therefore, we changed two kind of ground condition for a big change of resistivity. First, Phase 8 was saturated around 24 hours in the boreholes for piping test. Second, we collapsed the right borehole. Figure 4 shows the resistivity change ratio of Phase 8/Phase 6 on the dam crest. White rectangle indicates the zone of borehole was collapsed by water injection, and left borehole isn't collapse. The resistivity change ratio is 1~3 % range around borehole (A4-1), but white rectangle area is decreasing with 28%. The detection of leakage could be difficult to conclude that the resistivity change ratio was decreased. Because the resistivity change ratio was appeared that increasing or decreasing of resistivity value during piping test.

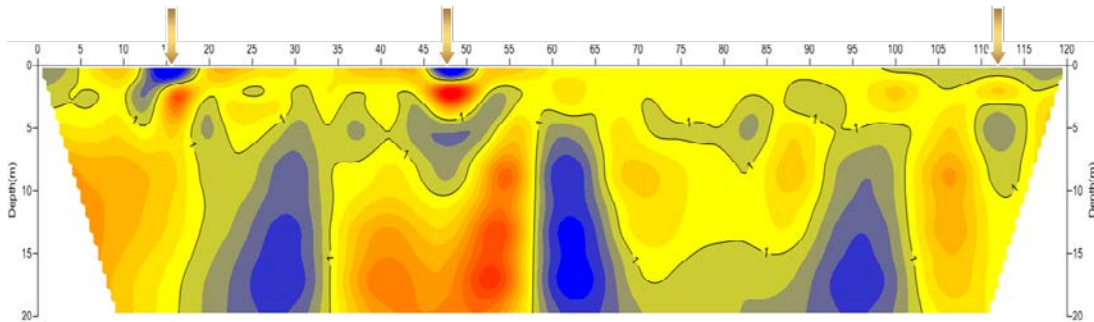
**Fig. 5:** The resistivity change ratio for Phase 10/Phase 1 on the dam crest after hydraulic fracturing.

After the simulated piping test was finished, we was analysed the resistivity change ratio for the hydraulic fracturing test. Figure 5 shows the resistivity change ratio of Phase 10/Phase 1 on the dam crest after hydraulic fracturing. The most obvious change of ground condition is observed near to the location of 47 m, while little change near 16 m and 112 m. The anomalies of resistivity

decrease on and the surface are mainly attributed to the overflow of ground material which was observed in field. The effect of hydraulic fracturing was visually identified after applying phenolphthalein solution since the solution changes its color after reacting with grouting cement. An injected cement of pillar-shaped would be turned magenta by applying phenolphthalein solution. The scale of the grout materials wasn't big, but it was confirmed to spread widely in around injected boreholes during destruction from the saddle dam.
