## Mechanical and optical tests of Zeiss THEO 010 and 020 nonmagnetic theodolites during the IAGA workshop 2018 at Conrad Observatory

Jürgen Matzka, Thomas Wenger, Jörg Krüger, Achim Morschhauser

During the IAGA workshop 2018 at Conrad observatory, 30 nonmagnetic theodolites of the Zeiss THEO series were tested for their mechanical and optical properties. Next to an inspection of the instruments, the horizontal circle error (collimation error) and the vertical circle error were determined with the help of a surveyor's level. While half of the instruments were fine, the others were in need of adjustment or repair. Typical problems requiring repair are sluggish vertical axes and mechanical problems of the coaxial fine-tuning. Typical adjustment problems are the position of the image in the microscope and collimation and vertical circle errors.

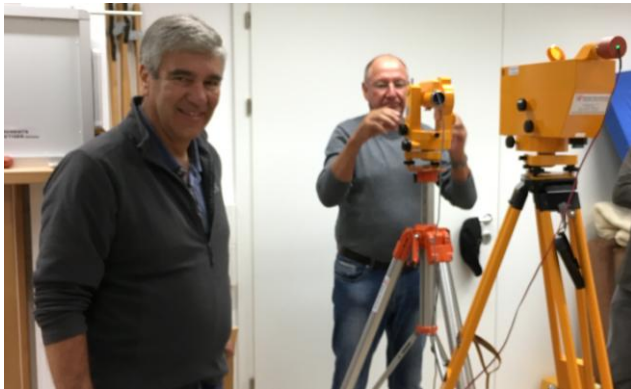
The tests were performed by JK who was responsible for final control and adjustment at Carl Zeiss Jena. The tests started by mounting the theodolite on a tripod opposite of a surveyor's level (Figure 1) and a first visual inspection of the instrument.

Figure 1: Test of a steel-free converted Zeiss THEO 020A theodolite during the IAGA Workshop 2018. From left to right: Alan Berarducci, Jörg Krüger, Theo 020A, Carl Zeiss Jena Ni 002 collimator with green light source at ocular.

**Test with surveyor's level.** A Zeiss Ni 002, the most accurate surveyor's level (compensator) by Carl Zeiss Jena (0.2 mm on 1 km or 0.04'' deviation) was used to determine horizontal (collimation) or vertical circle errors of the theodolites tested (Figure 1). By looking with the telescope to be tested into the objective of the Ni 002, a cross hair identical to the THEO cross hair can be seen. A tilt of the cross hair and an error of the vertical index can be diagnosed by this method. The angular difference between face left/face right (sensor up/sensor down) observations of that cross hair is noted. Small errors could be corrected by adjusting the cross hair of the THEO. In this process, all spirit levels were adjusted.
