Field Trip Guide Book - D04

GEOSCIENCE FOR CULTURAL HERITAGE SAFEGUARD IN FLORENCE

D04

P. Canuti, R. Fanti, P. Malesani, E. Pecchioni

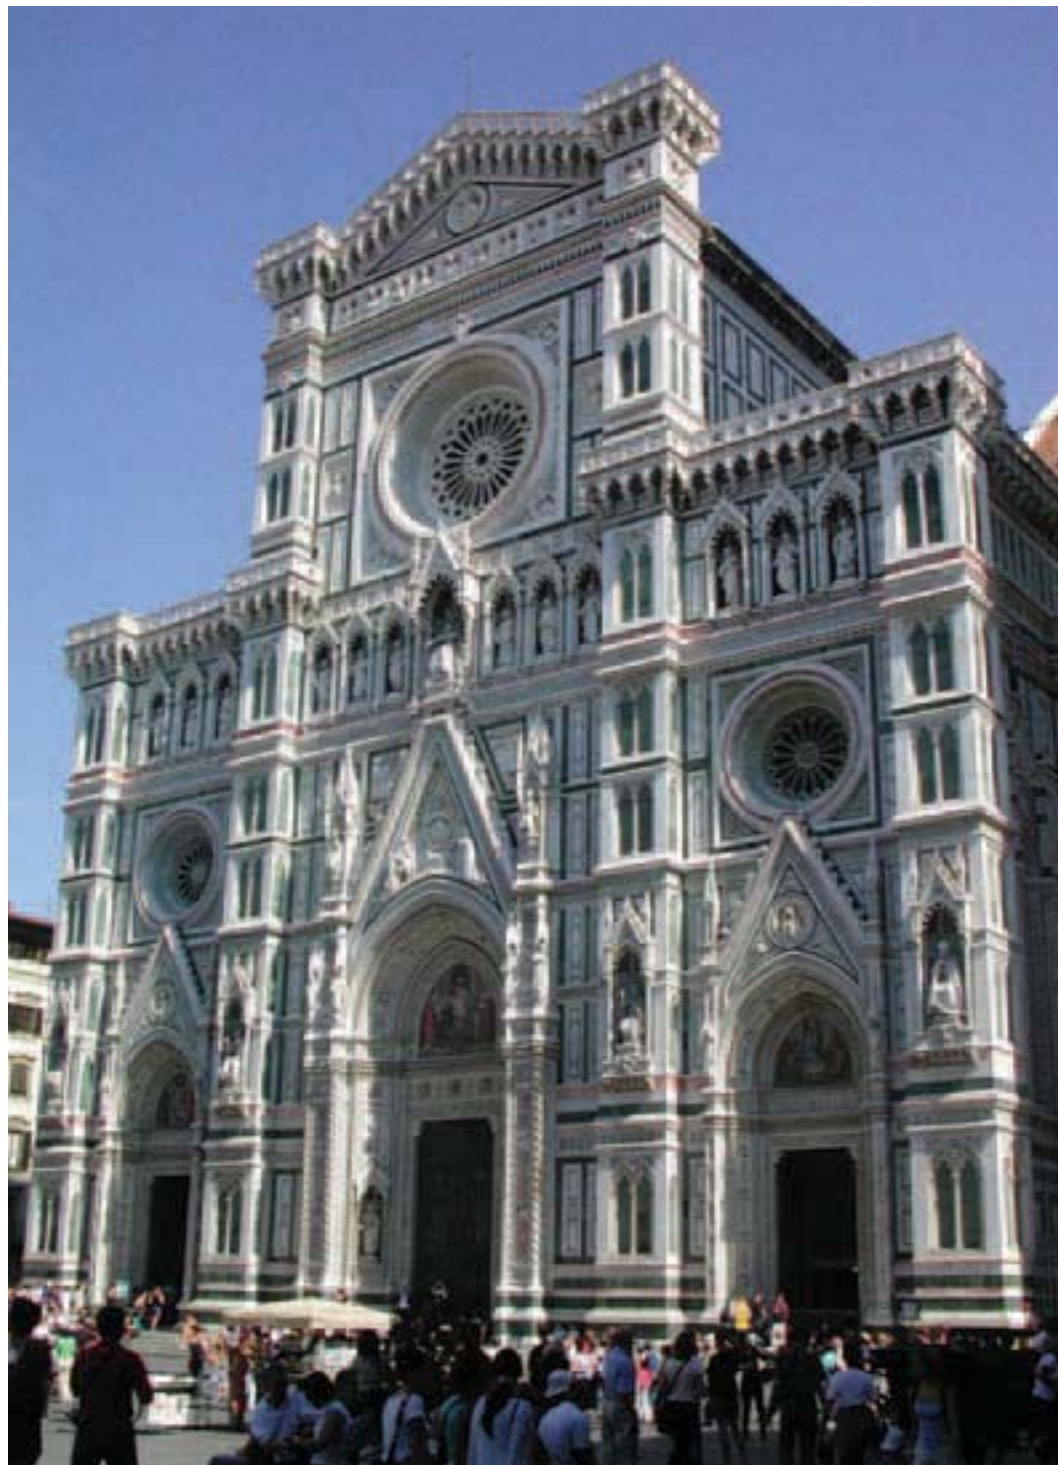
Figure 1 - Cathedral of S. Maria del Fiore

The itinerary to visit the historical center of the city starts from the Cathedral of Santa Maria del Fiore (structurally completed in 1436) (Fig.1). The materials used for the original construction were, for the "red marbles" the marly limestones of San Giusto di Monterantoli (Cintoia in the Chianti mountains), as well as the marly limestones from Monsummano in Valdinievole (Pistoia), Carrara marbles for the "white", and serpentinite from Figline di Prato (Prato) for the "green" (AA.VV. 1987).

There is a difference in the case of the façade, which was built later (1887): the "green" of serpentinites was extracted from Figline di Prato and used along with the "red", which came from several quarries, above all in the Grosseto area, at Villa Collemantina (Garfagnana-Lucca), and at Monsummano and in the Perugia area; while for the "white", after several visits to Carrara and Serravezza, an agreement was reached with G.B. Sancholle Henraux, who provided the marble from his quarries at Serravezza (Lucca) at cost price. On the façade, already two restorations have been carried out since then in order

to counteract the bad decay of the marble with its typical accompanying black crusts. The condition of the sides of the Duomo are better: the Apuan marble used, is more durable because of its petrographical characteristics (Barsottelli et al., 1998; Bianchini et al., 1999).

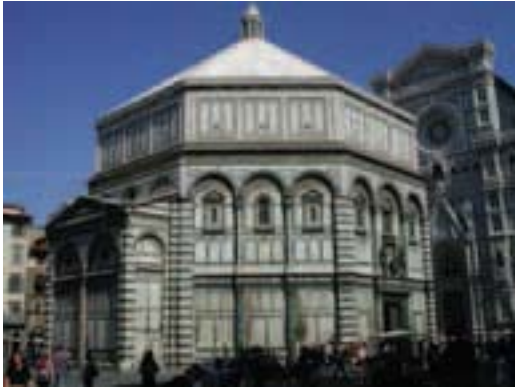
Figure 2 - S. Giovanni Baptistery

Is the S. Giovanni Baptistery, in front of the Cathedral (Fig. 2). It was realized in marble and serpentinite; it is octagonal in plan, with an extension to the west, and doors on the south, north, and east sides. The Baptistery is an ancient construction going back to 1056, but only in the middle of the XII century was it covered with Proconnesian marble and serpentinite from the Prato area (Rodolico 1953; AA.VV., 1993). On the Baptistery, several poorly judged restorations were carried out with waxes, and these are responsible for the yellowing of the white marble.

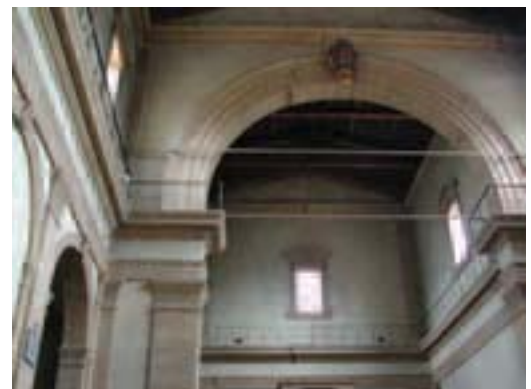
Figure 6 - The interior of San Salvatore al Monte: on the arch, some old restored cracks are evident.

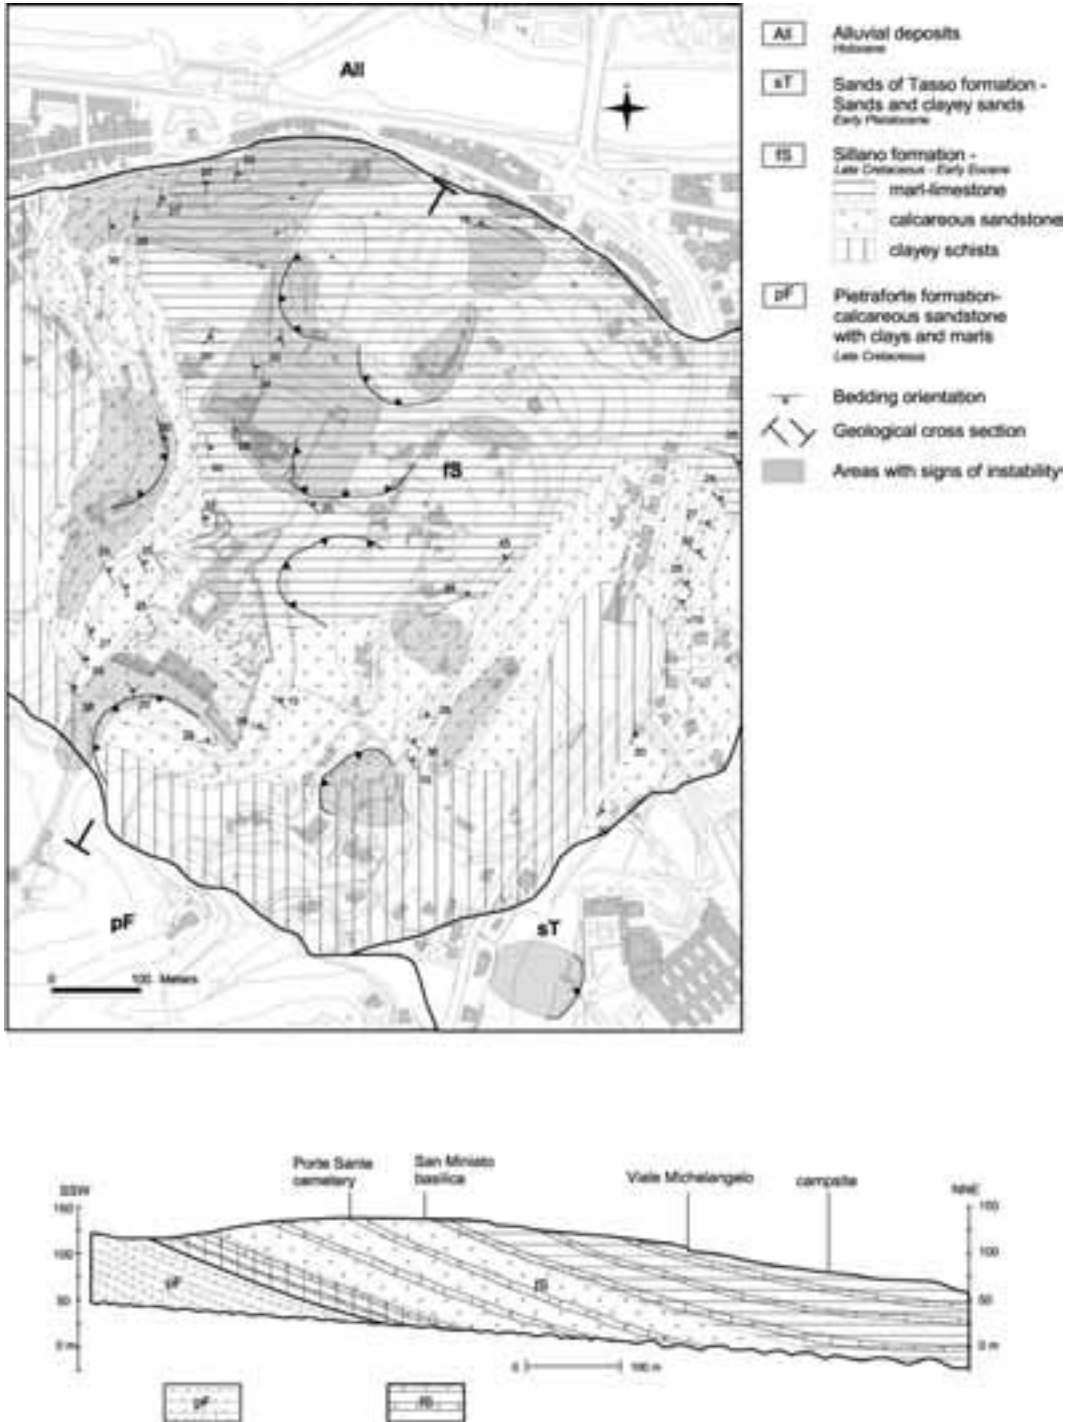
Figure 9 - Geologic and geomorphologic map of Monte alle Croci

(Cretaceous-Lower Eocene), and are known as the Sillano formation (also named the Vallina formation), and are constituted of shales with interbeds of limestone, marls and sandstones: in the area, it is possible to distinguish three units, on the basis of the prevailing lithology (Fig. 9).

The rock layers are discontinuous and immersed in a clayey matrix, with a stratigraphical orientation of bedding parallel to slope, and dipping NE, with angles of between 20° and 30°. The Pietraforte formation, consisting of cemented sandstones, borders the southern sector of the area, and is partially overlapped by Pleistocene lacustrine sands (Sabbie del Tasso formation) (Focardi, 1991).

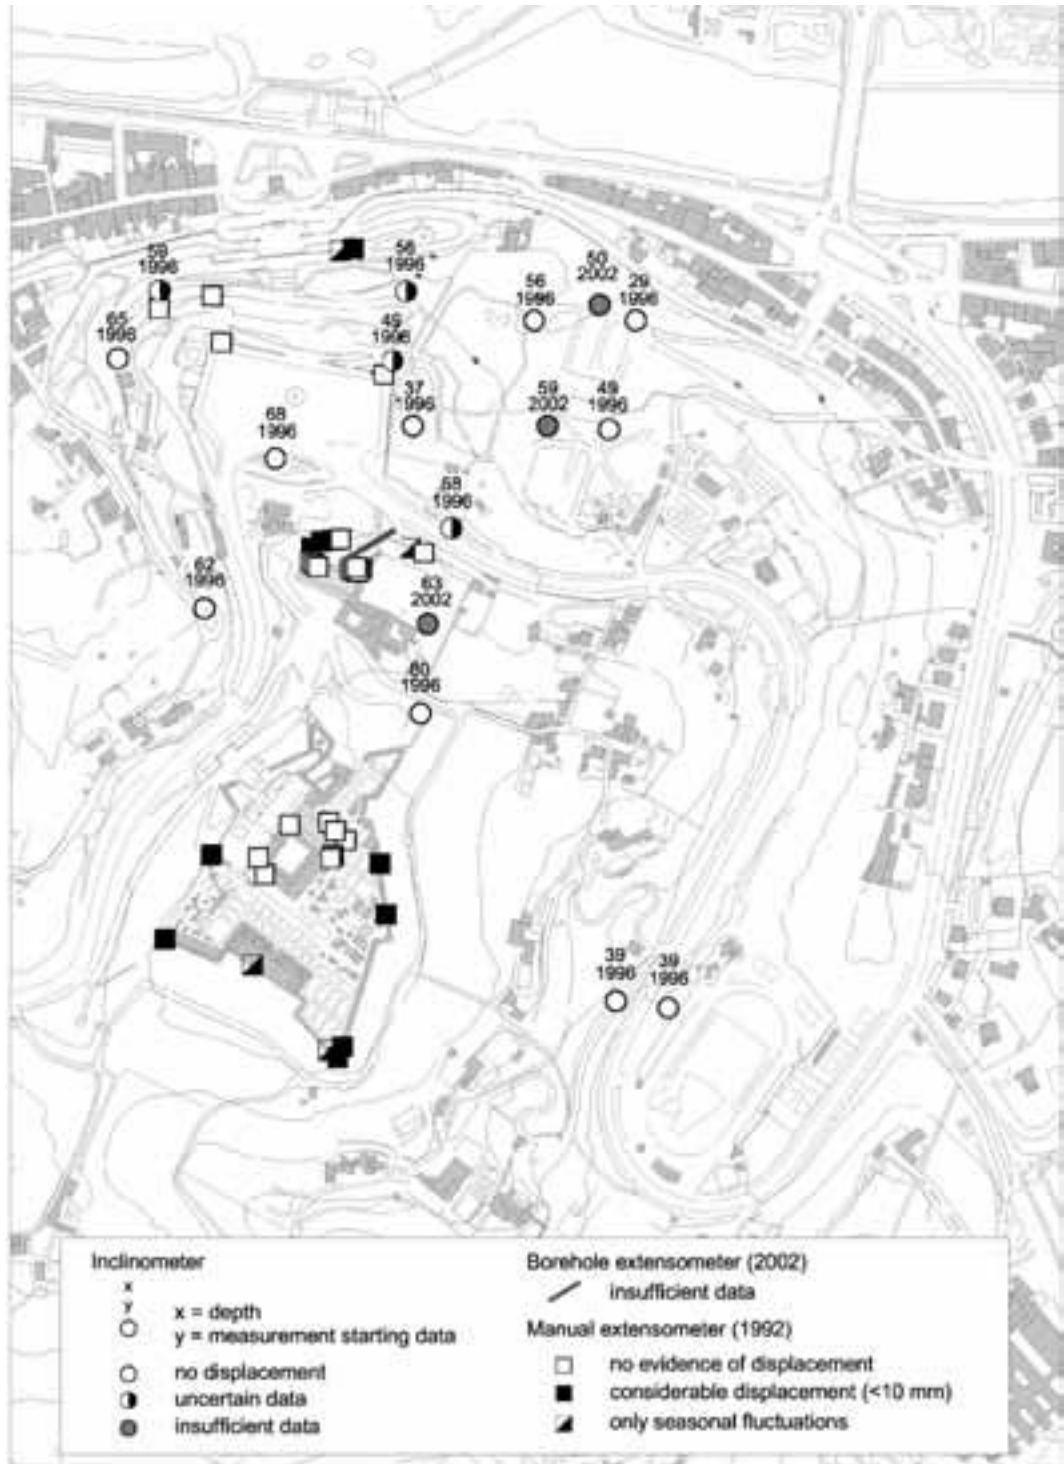
Figure 10 - Underground and superficial field surveys

The most recent series of modern site investigations started with the works of the Giordano Commission in the 19th century, and continued during the 20th century with some drilling and structural deformation surveys. The most recent episodes of slope instability (in 1973 and 1989), induced the authorities to arrange an extensive campaign of underground and superficial field surveys, in order to understand better the geometry, geology, geotechnical properties, causes and possible evolution of phenomena in the area (Fig. 10).

Most of the instruments are still active, even if the results of field surveys carried out in the past are often difficult to understand, especially comparing data with superficial evidences. In particular, some inclinometric records are difficult to interpret correctly, due to a non-verticality of the tubes involved, and their imperfect cementation in the terrain (Agostini et al., 2002a; 2002b; Agostini and Fanti, 2003).

As a general rule, it can be stated that both inclinometers and extensometers have indicated good stability for the highest portion of the hill, where the Basilica of San Miniato is sited.
