Landscape analysis for multi-hazard prevention in Orco and Soana valleys, Northwest Italy

L. Turconi¹, D. Tropeano¹, G. Savio², S. K. De³, and P. J. Mason⁴

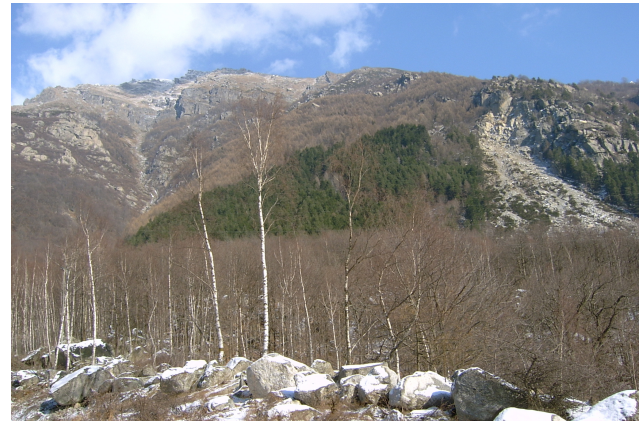
Figure 2. Frontal view of a minor catchment left to the Orco stream in which slope instability processes can be seen towards the right; these have been re-activated in October 2000. In the foreground, mountain birches can be seen, on the left side of the catchment, in a 75-year-old reforested area (photo 25 February 2005).

Forest management in the Orco and Soana Valleys began in the 1900s, even on slopes which are difficult to manage and unsuitable for rapid root establishment. On 7 September 1925, the National Forestry Corporation began a general restoration programme to prevent slope degradation and flooding in several sub-catchments of the region. Such work continued up to and after the Second World War, but ceased in the early 1970s (according to CNR-IRPI archives). For example, the Rio Frera catchment, which was widely populated by larches until a half century ago, still appears in fairly good condition with regard to plant health, in spite of wildfire damage (Fig. 2).

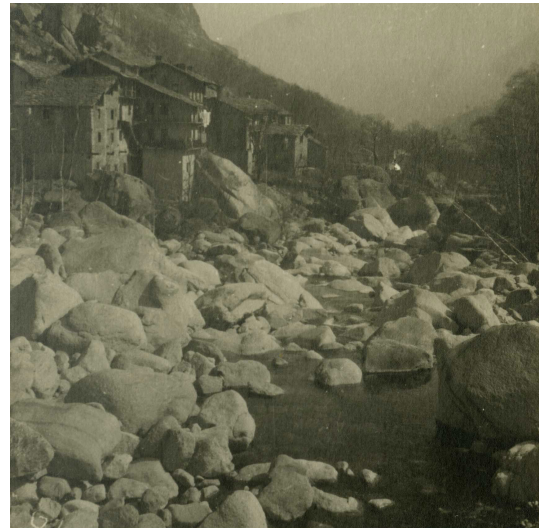
Figure 3. A village in the high Orco basin: very coarse deposits in the main channel as depicted in an old photograph (year 1952).

The hazard damage database has been generated from old and recent bibliographic sources, newspaper articles, pictures (e.g. Fig. 3), unpublished documents of CNR-IRPI and several public archives, including communes of the Orco Valley and from the online archives of Regione Piemonte. A systematic attempt has been made to examine the historical evidence of instabilities (largely from field and aerial photographs) and to verify numerous descriptions of ancient slope failures (many of which date back to the middle of the 17th century). It includes old nomenclature of stream channels that might have changed in morphology and description of protection works (Fig. 2). To analyse the effects of the events we have exploited the detailed historical research of the CNR-IRPI and other researchers, from documents in national archives, libraries and other public bodies, and correlated them through interviews with local residents and eyewitnesses. A substantial chronology (unpublished) of the events which have produced damaging effects since AD 1030 in the region of the Western Alps (including the Orco Valley) has also been produced. All natural hazard events of the last 40 years have been regularly surveyed and published by the authors. Surveys aimed to find and describe causes, pro-

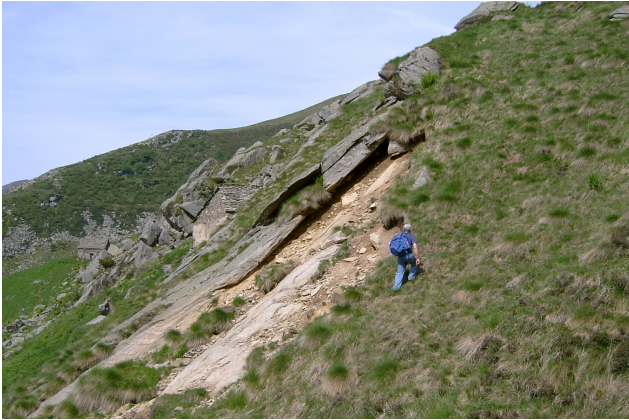
Figure 5. Right slope of a major catchment in the Orco Valley, near the stream head: a rock fall/soil slip process triggered by the extreme rainfall event of October 2000. The matrix-dominated nature of the materials is noteworthy and is connected to weathering products of the bedrock (photo 11 June 2004).

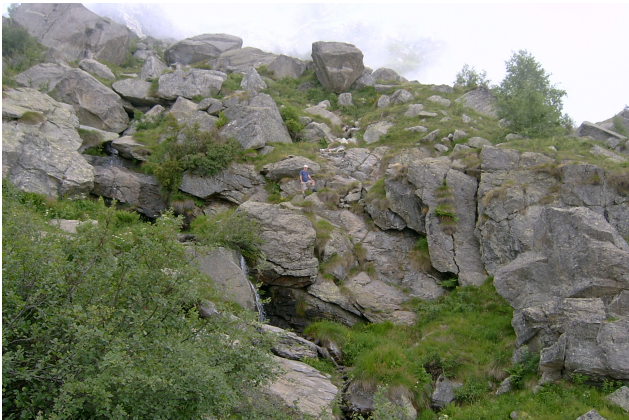
Figure 6. In a steep-sloping sub-catchment in the upper Orco Valley, the right slope, affected by a deep-seated gravitational process, is underlain by disjunctive earth blocks and extremely uneven ground surface (photo 12 July 2004).

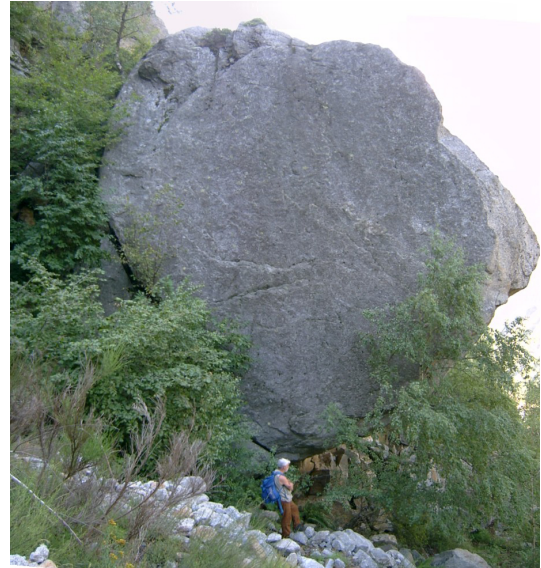
Figure 7. An example of the huge, disjunctive stony blocks outcropping on the left slope of the Orco Valley, behind a settled area a few hundred metres downslope (photo 21 July 2004).

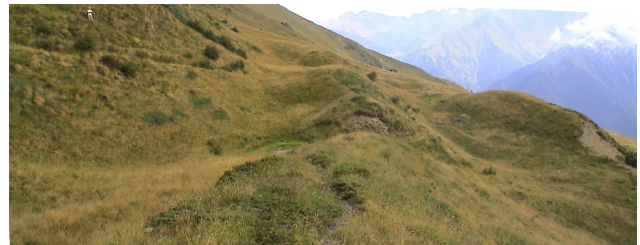
Figure 8. Watershed of tributary of the Soana stream, incised in a deep-seated slope collapse deposit; typical features include trenches and counterslope surfaces, often with emergent water (photo 31 July 2003).

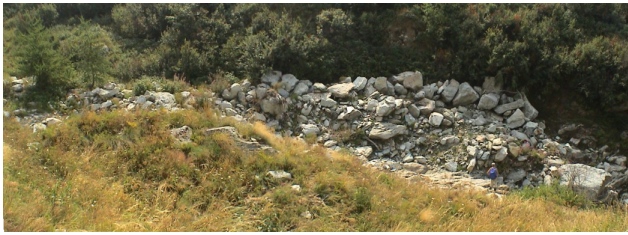
Figure 9. Residual deposit of a debris flow (October 2000), which shows typical inverse gradation, along a left tributary of the Soana stream (photo 8 August 2003).

This has been sub-divided into three classes (TR1, TR2 and TR3) according to their increasing probability of occurrence. Processes involved are channel overdeepening, bank erosion and especially debris flows; an example is provided in Fig. 9.
